RADIOLOGIC AND ENGINEERING ASSESSMENT

DOE ID NO.: GJ-01390-RS
ADDRESS: 2025 NORTH 21ST STREET

AUGUST 1985

BENDIX FIELD ENGINEERING CORPORATION
P.O. Box 1569
Grand Junction, Colorado 81502

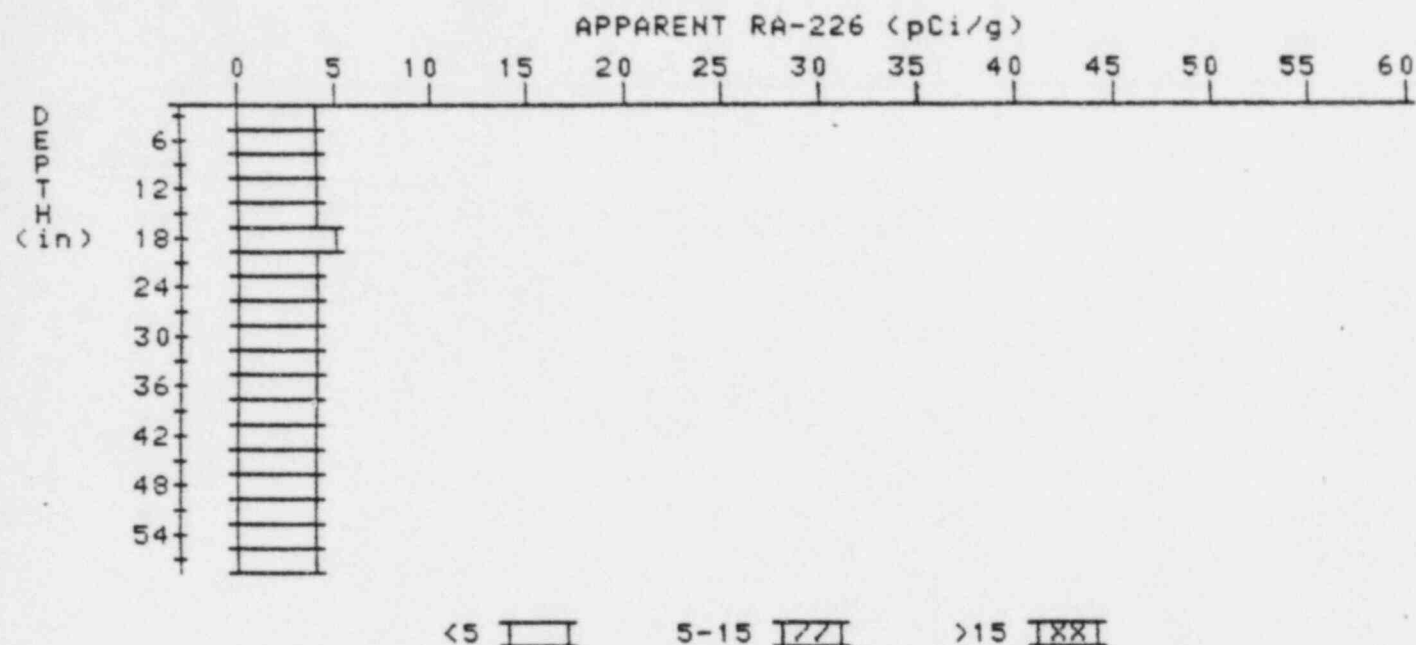
PROPERTY NUMBER: GJ-01390-RS
HOLE NUMBER: 11
LOCATION: 205262

Depth (in)	Apparent Radium-226 (pCi/g) Undeconvolved	Apparent Radium-226 (pCi/g) Deconvolved
3	3.6	3.6
6	3.8	3.8
9	4.0	4.2
12	4.1	4.3
15	4.1	3.9
18	4.2	4.6
21	4.1	3.9
24	4.1	4.1
27	4.1	4.1
30	4.1	4.1
33	4.1	4.3
36	4.0	3.8
39	4.0	4.0
42	4.0	4.0
45	4.0	3.8
48	4.1	4.3
51	4.1	4.3
54	4.0	3.8

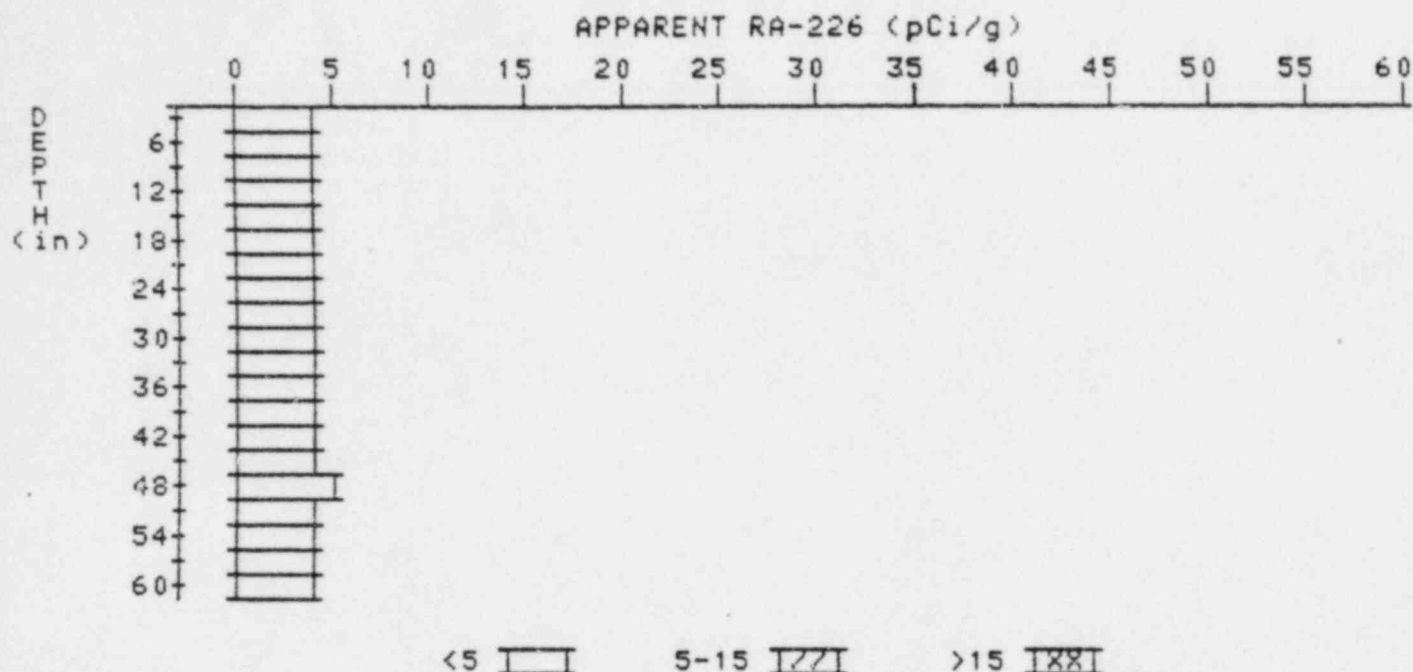
PROPERTY NUMBER: GJ-01390-RS
HOLE NUMBER: 13
LOCATION: 232262

Depth (in)	Apparent Radium-226 (pCi/g) Undeconvolved	Apparent Radium-226 (pCi/g) Deconvolved
3	3.9	3.9
6	4.0	4.2
9	4.0	4.0
12	4.0	3.8
15	4.1	4.5
18	4.0	3.6
21	4.1	4.5
24	4.0	3.8
27	4.0	4.0
30	4.0	4.0
33	4.0	4.0
36	4.0	4.0
39	4.0	3.8
42	4.1	4.3
45	4.1	3.9
48	4.2	4.6
51	4.1	3.9
54	4.1	4.3
