RADIOLOGIC AND ENGINEERING ASSESSMENT

DOE ID NO.: GJ-12297-RS
ADDRESS: 2871 ORCHARD AVENUE

JULY 1985

BENDIX FIELD ENGINEERING CORPORATION
P.O. Box 1569
Grand Junction, Colorado 81502

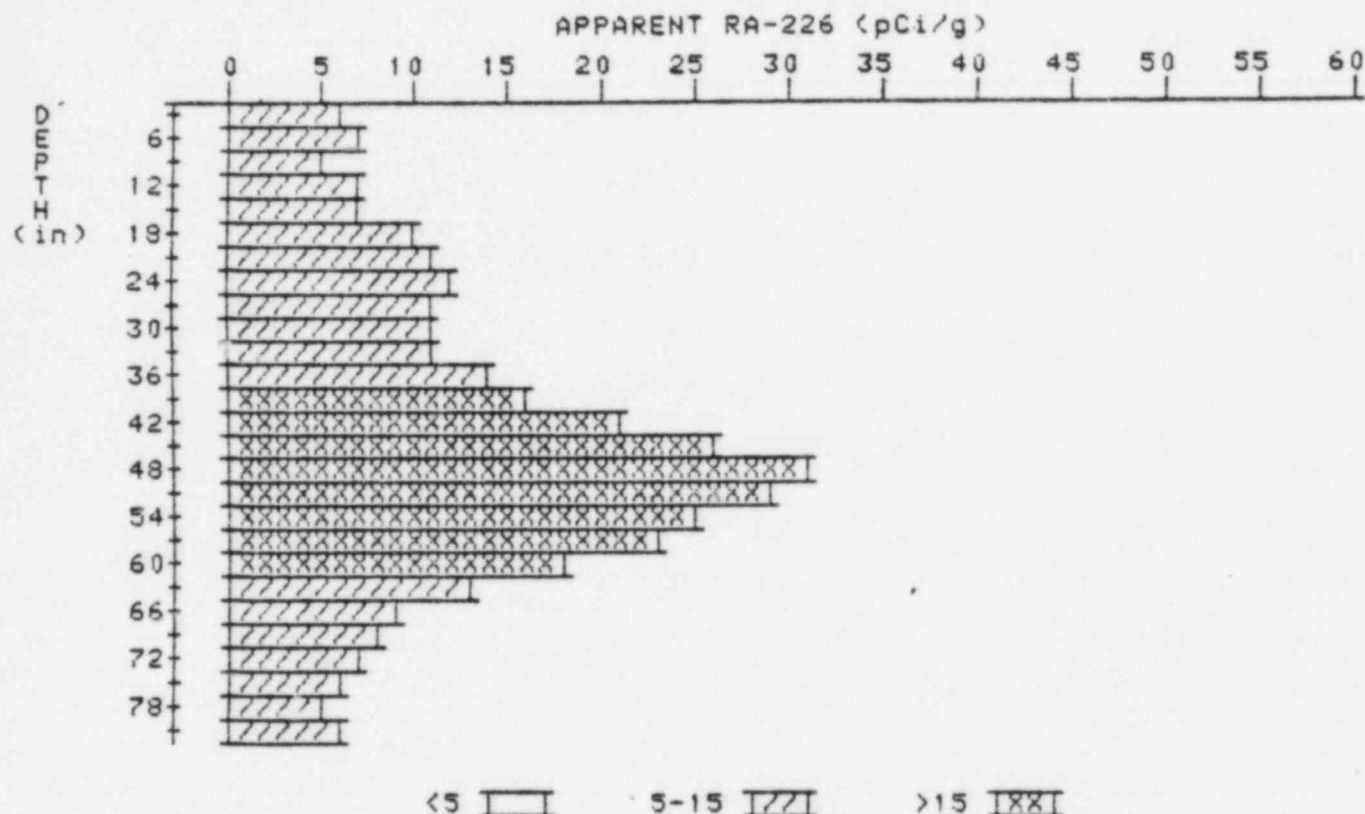
1

Borehole number 1, along the street shows contamination to a depth of 66 inches. A 10-foot by 70-foot area was called because of another property on the same side of the street and a few properties east where deep contamination was also discovered. As mentioned in the previous pages, it is probably a deep utility line or drain that extends all along the south side of Orchard Avenue in this area.

If the Department of Energy determines that the water line deposits should be removed, it is recommended that Area A be removed as part of a remedial action project GJ-97004-OT. This project would be performed in cooperation with the City of Grand Junction if water line improvements are made in this area. Remedial action project GJ-97004-OT would be the most efficient and cost-effective method of tailings removal. It would allow for identification of tailings involvement of other adjacent properties along the utility and their removal under a single subcontract utilizing a utility subcontractor.
