RADIOLOGIC AND ENGINEERING ASSESSMENT

DOE ID NO.: GJ-01293-MR
ADDRESS: 2236 TEXAS AVENUE

AUGUST 1985

URANIUM MILL TAILINGS REMEDIAL ACTION PROJECT OFFICE

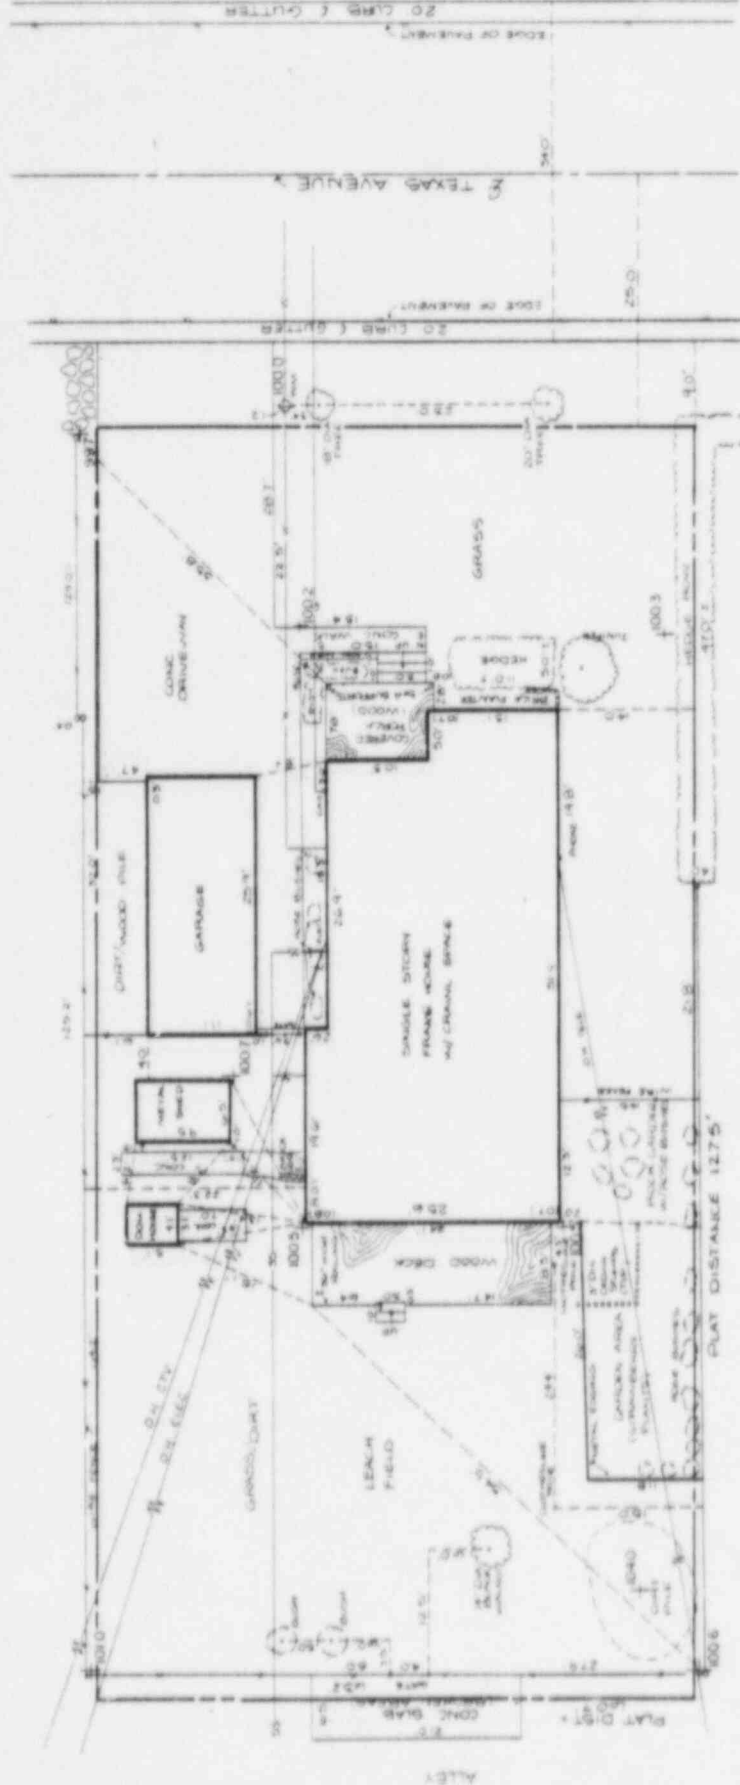
FIGURE 2.2 SITE PLAN

Structures, utilities, landscaping, and other special features of this property are included in Appendix Figure 2.2.

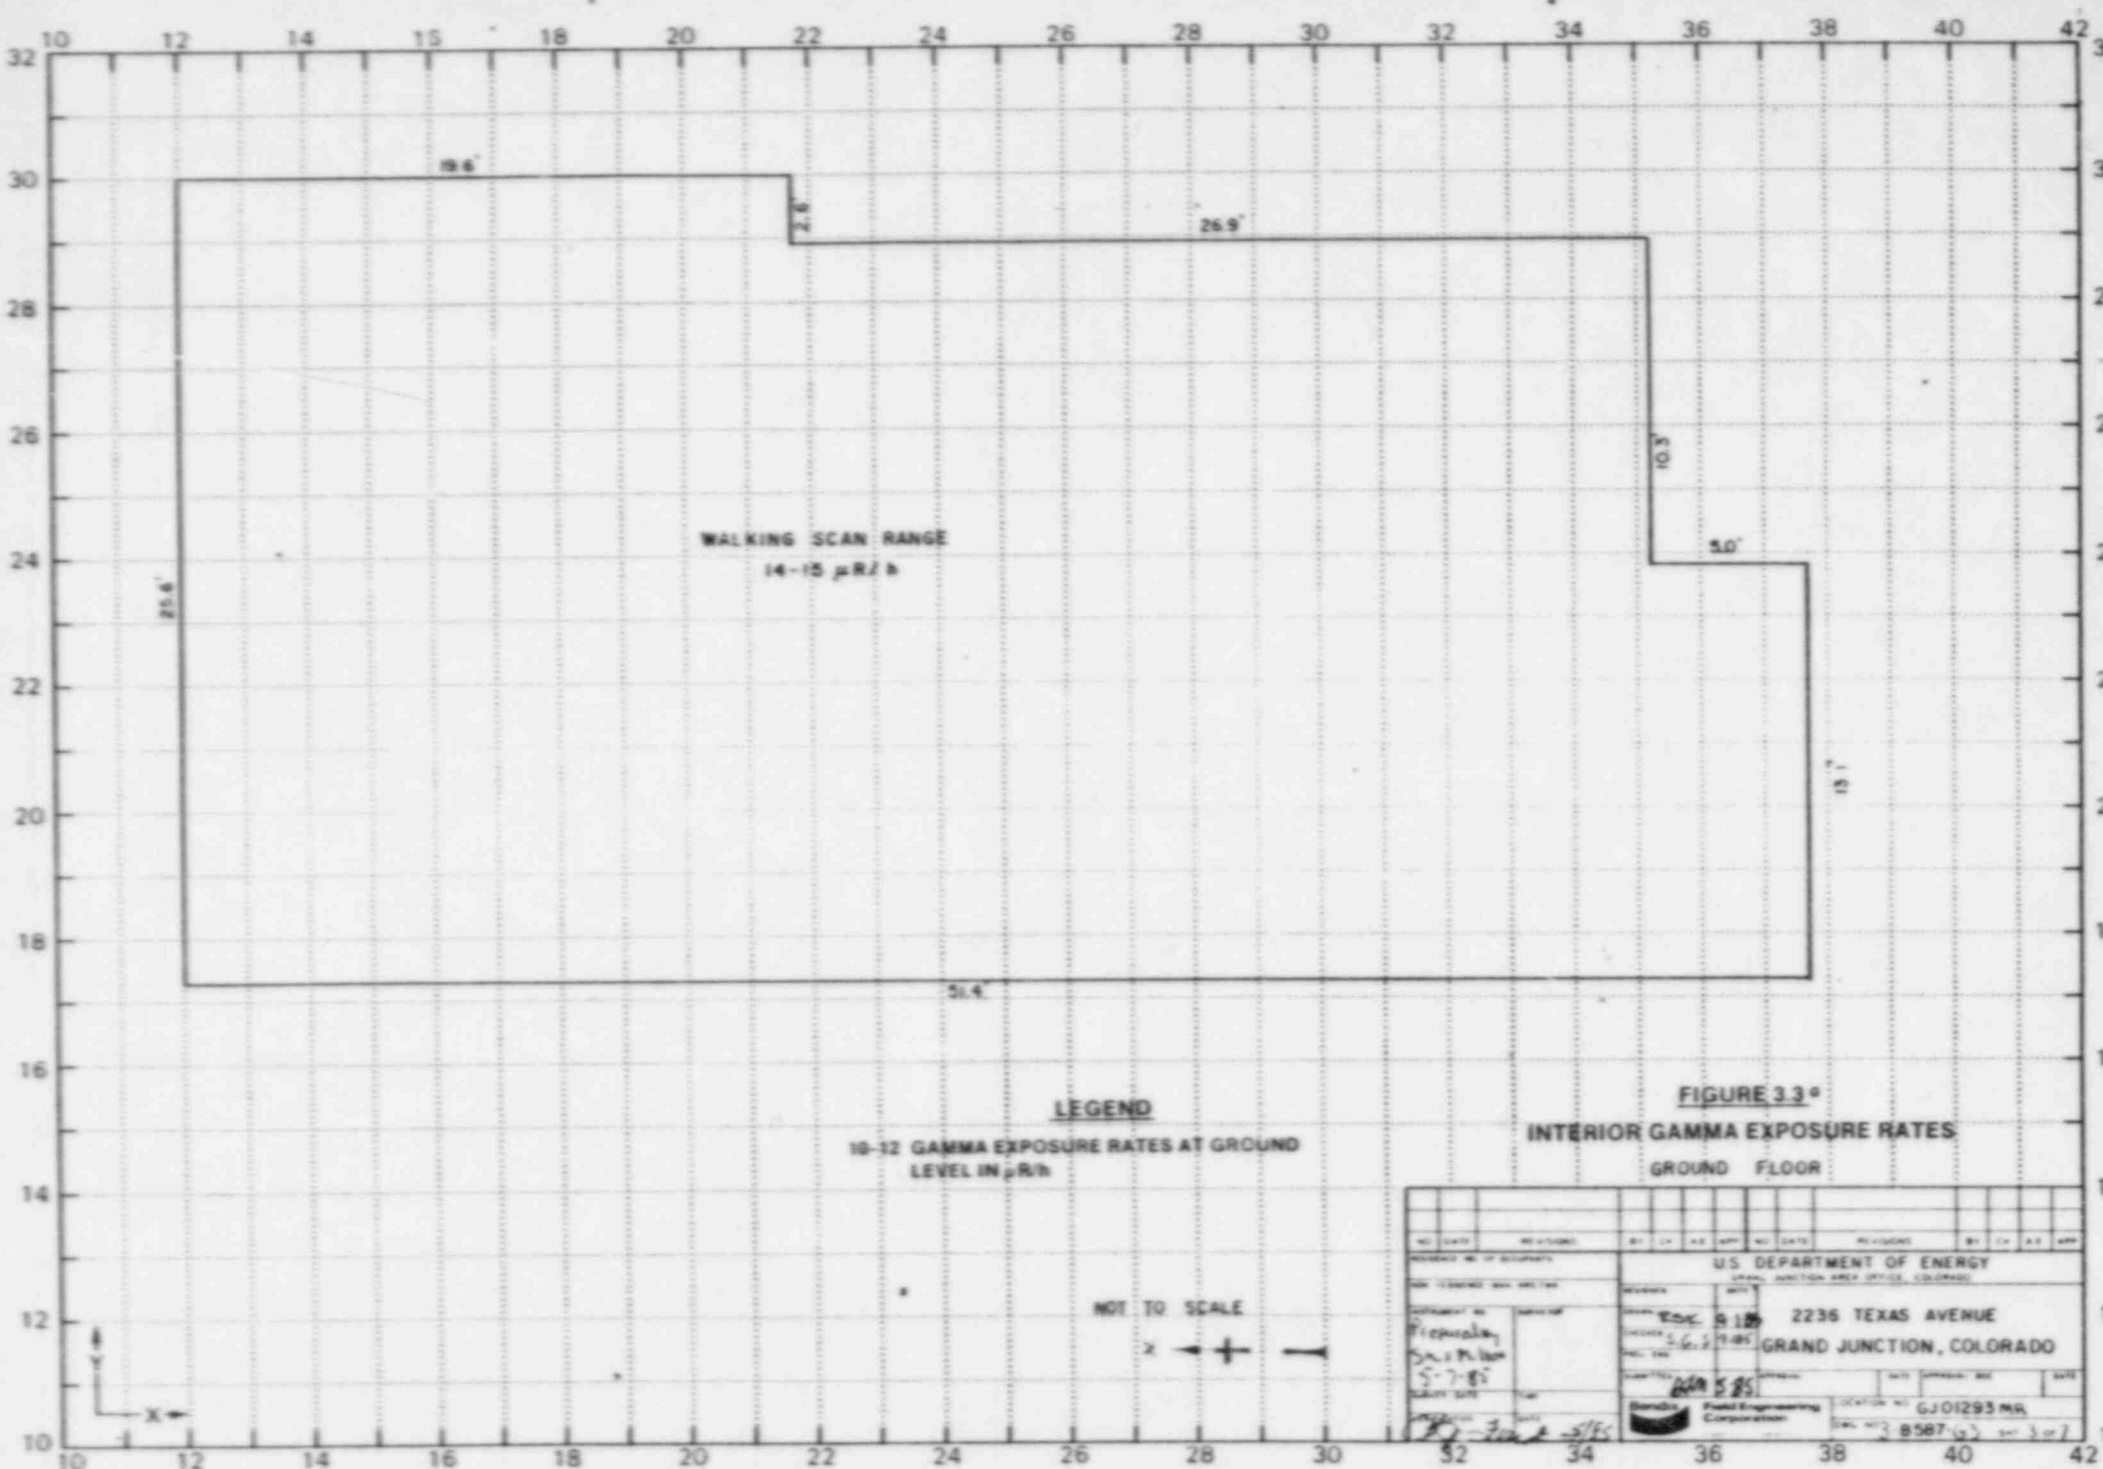
FIGURE 3.3°
INTERIOR GAMMA EXPOSURE RATES
GROUND FLOOR

Interior radium-concentration measurements are presented in Appendix Table 3.2. Interior gamma exposure-rate measurements are summarized in Appendix Table 3.3. Appendix Figures 3.3a and 3.3b show interior exposure rates and locations of these measurements.

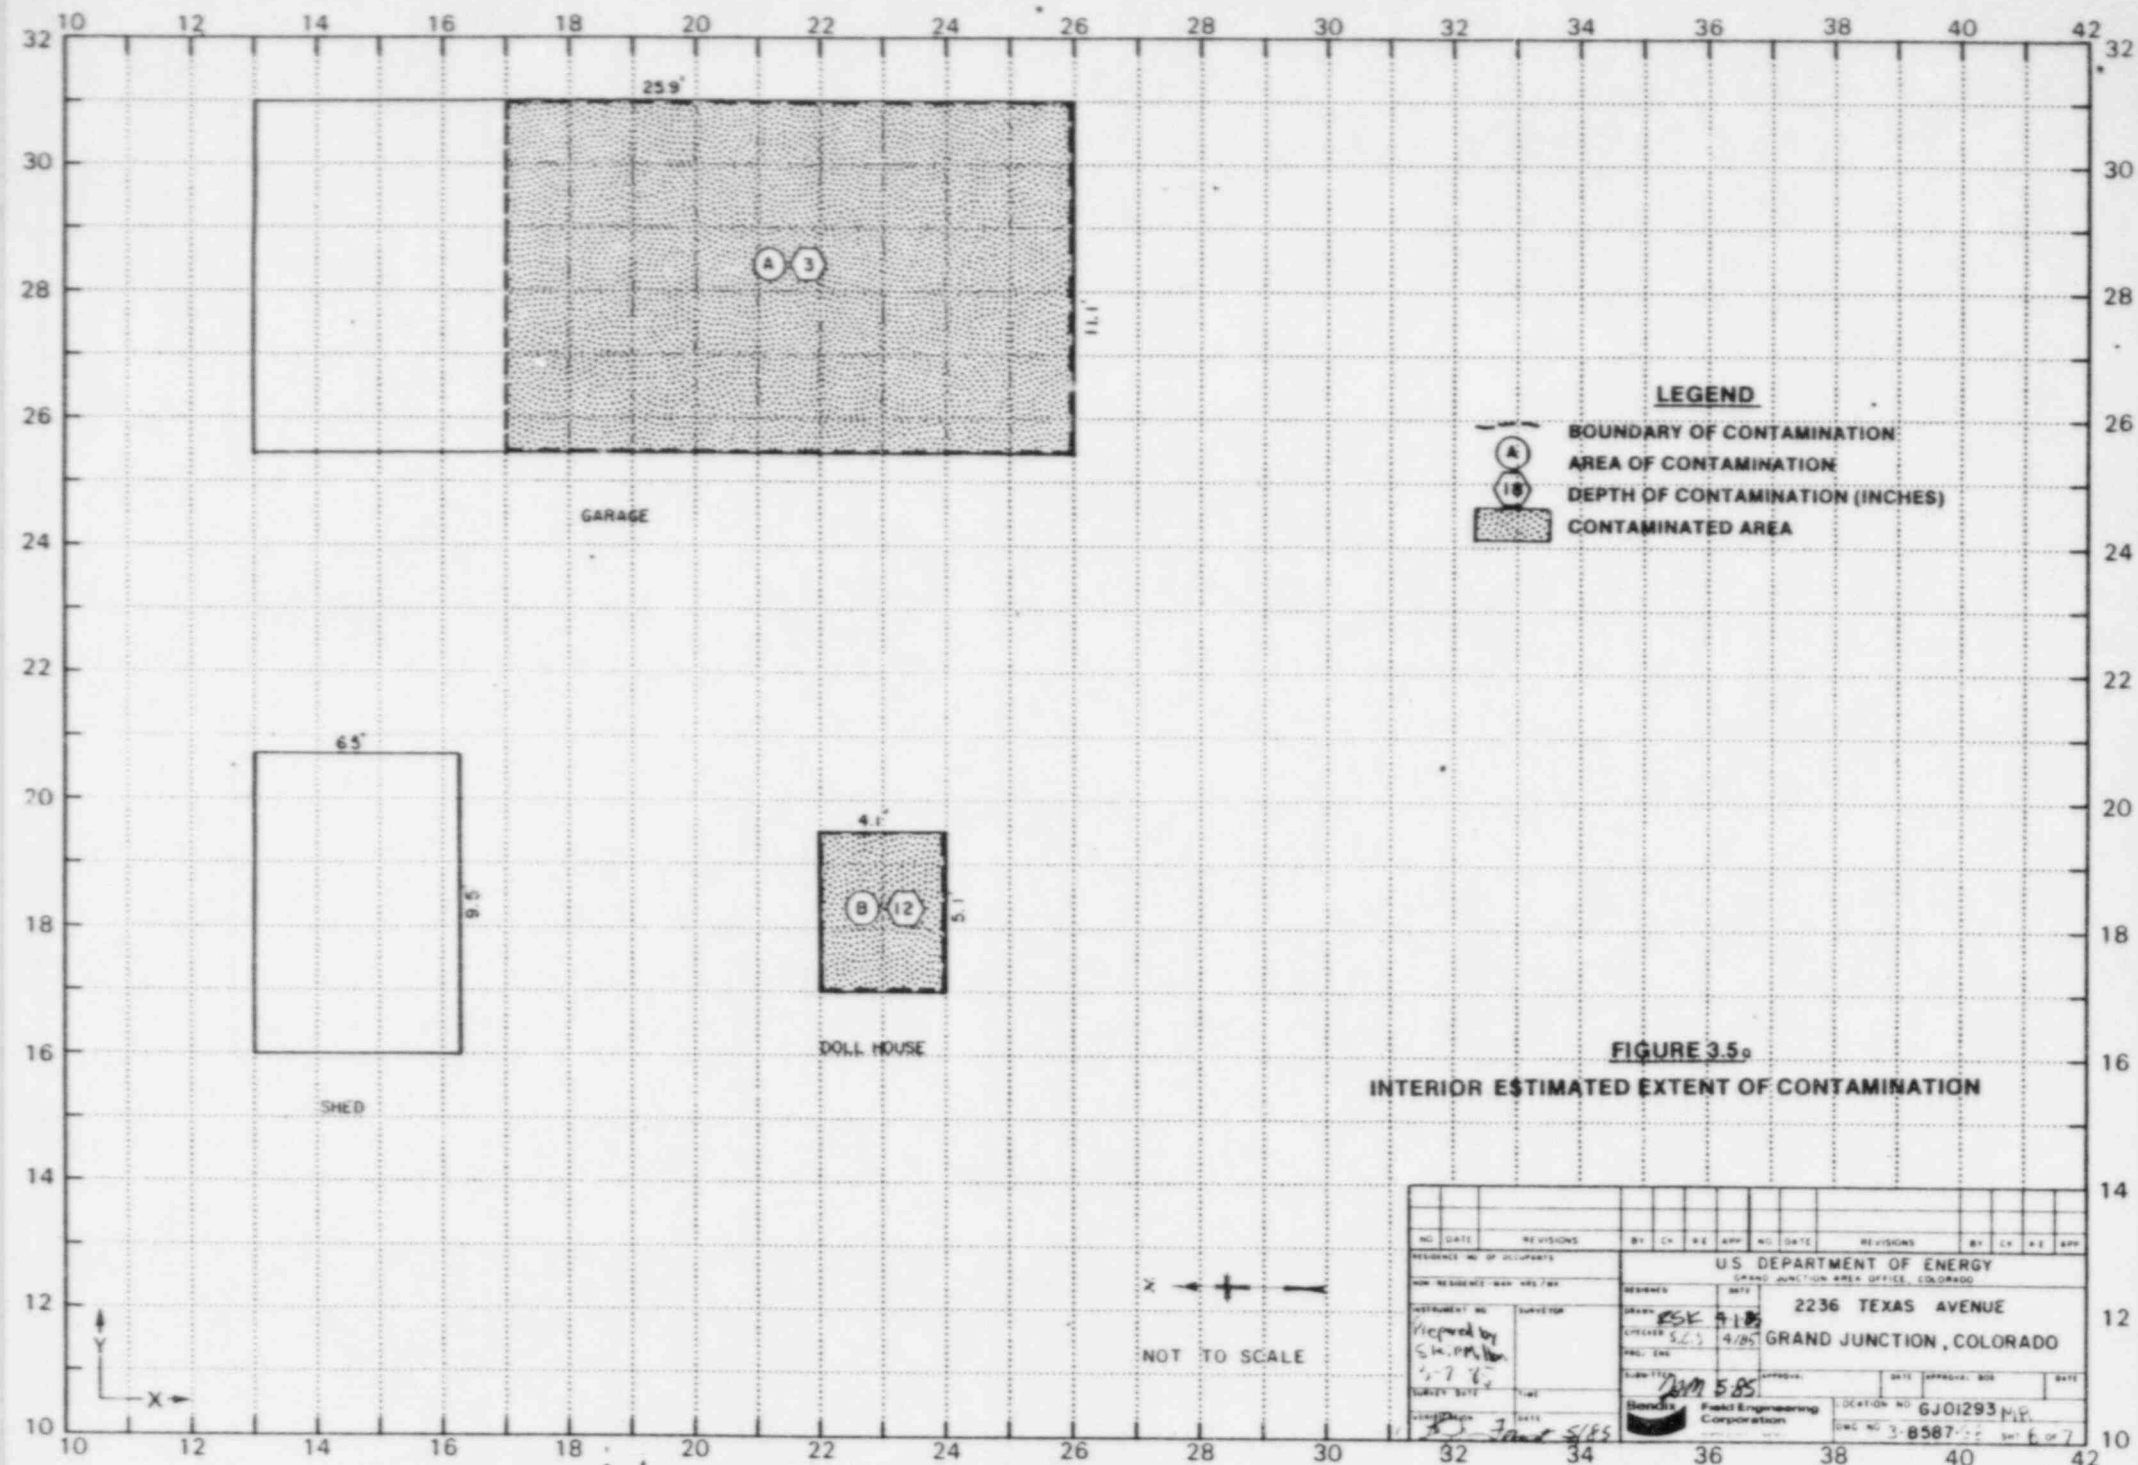
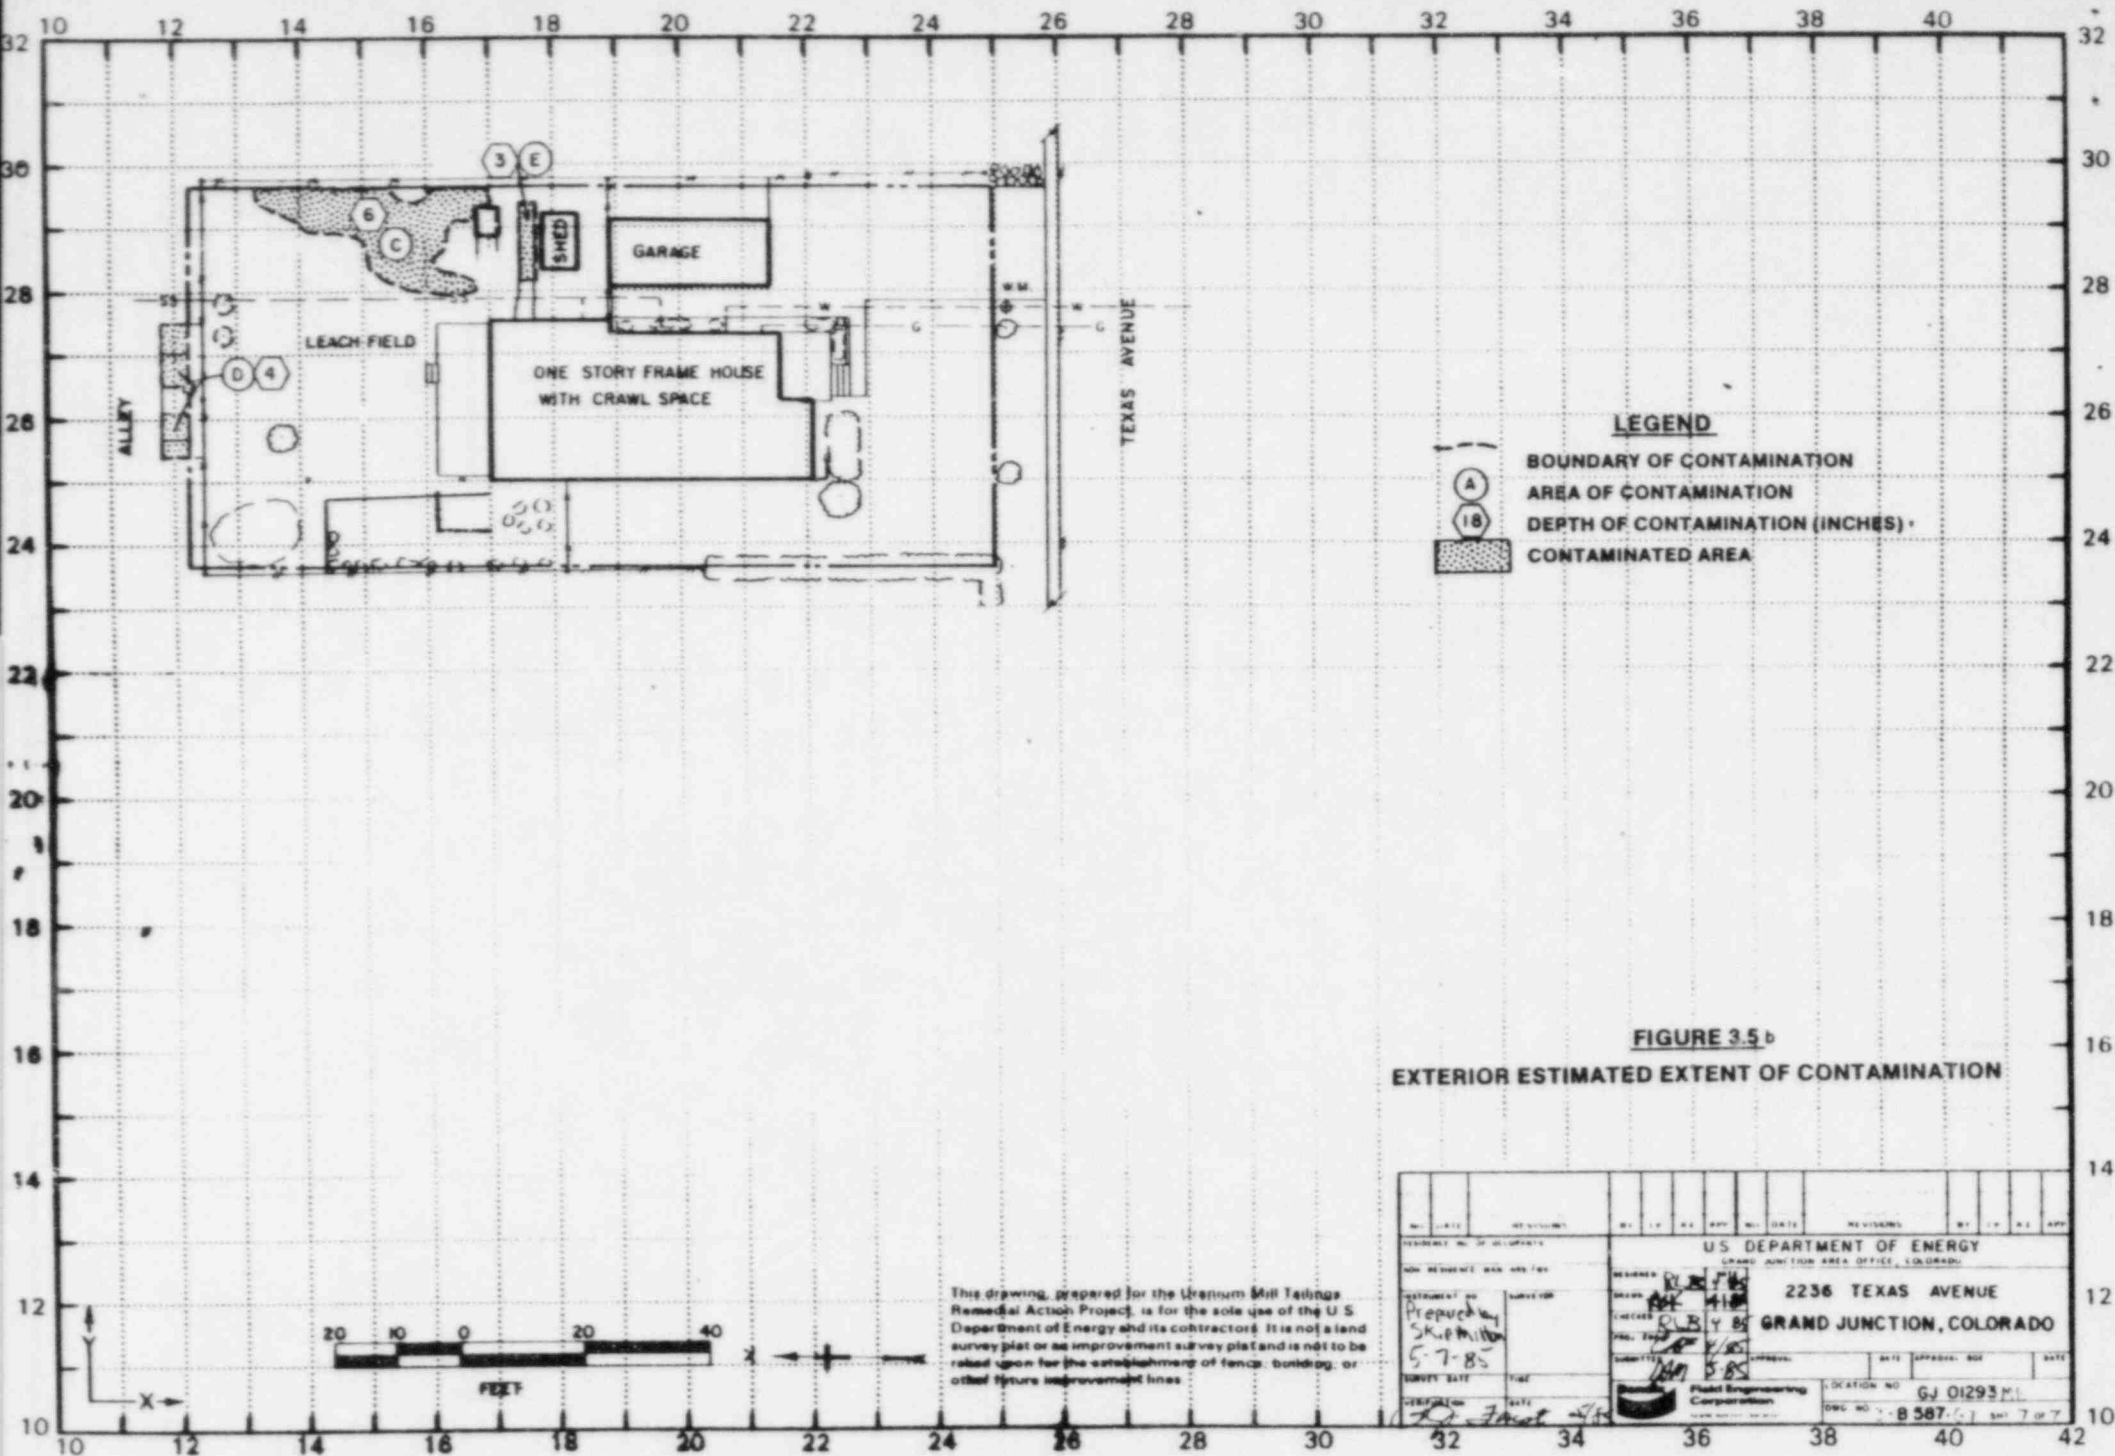
Appendix Figures 3.5a and 3.5b show identified areas and estimated depths of contamination on this property, based on assessments of all measurements taken. As noted in these figures, areas recommended for remedial action that contain identified residual radioactive materials are:

- (AREA A) The 3-inch-thick concrete slab in the southern portion of the garage is contaminated (approximately 198 sf).
- (AREA B) Under the wood floor of the doll house, contamination extends to a depth of 12 inches, measured from ground level (approximately 20 sf).
- (AREA C) Northeast of the primary structure, contamination extends to a depth of 6 inches (approximately 391 sf).
- (AREA D) North of the primary structure, four of five 4-inch-thick concrete slabs are contaminated (approximately 68 sf).
- (AREA E) The three-inch-thick concrete sidewalk north of the shed is contaminated (approximately 36 sf).

The recommended remedial action for this property, DOE ID No. GJ-01293-MR, includes removal of all areas identified as containing radioactive material (as discussed in Section 3.5 and shown in Appendix Figures 3.5a and 3.5b) and transport of removed material to the disposal site.
