RADIOLOGIC AND ENGINEERING ASSESSMENT

DOE ID NO.: GJ-03566-RS  
ADDRESS: 1436 NORTH 23RD STREET

AUGUST 1985

URANIUM MILL TAILINGS REMEDIAL ACTION PROJECT OFFICE

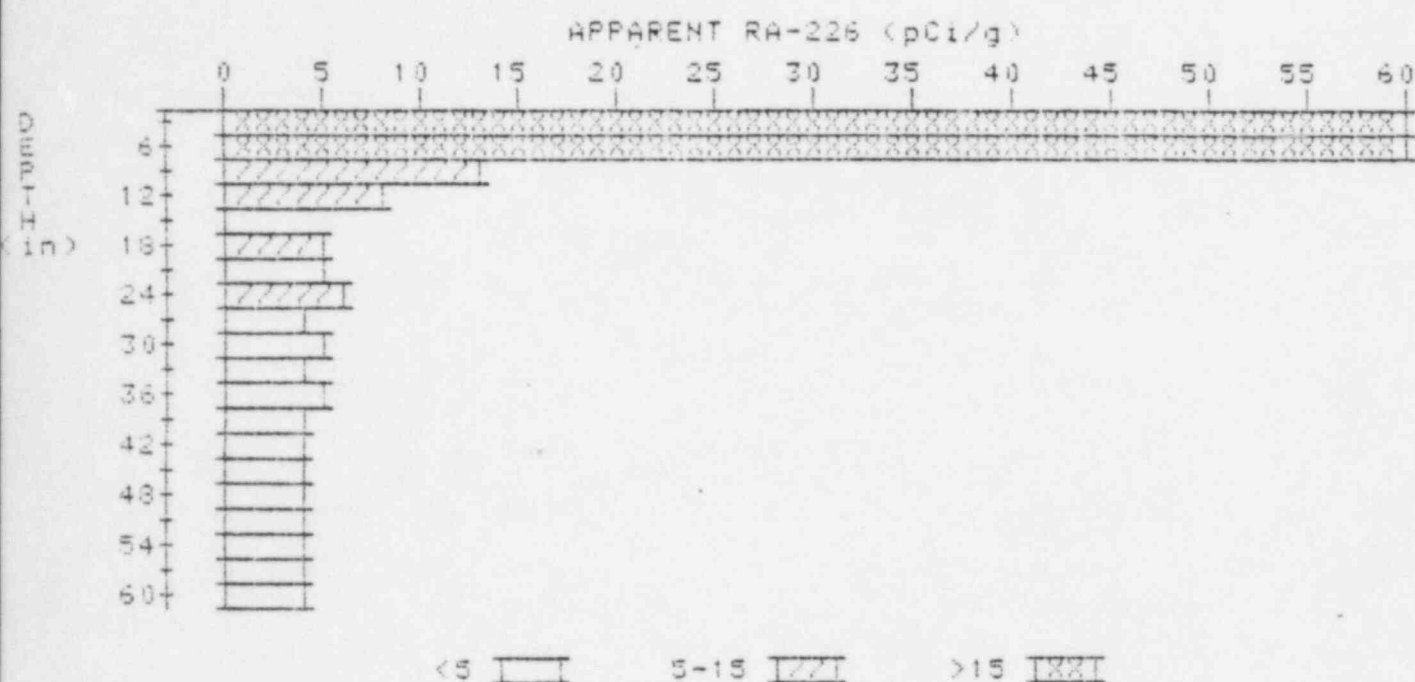
# APPARENT RADIUM-226 CONCENTRATION 13 DECONVOLUTION GRAPH

Loc #	Grid Location	Depth (in.)	Meas. Type	In Situ Ra-226 (pCi/g)		Chem Ra-226 (pCi/g)	Comments
				Tot. Ct	Spectr.		
13	190240	03	TC	71.8		*	Carport
		06	BH	63.9	64.7	*	DC = 12 inches
		09	TC	35.6		*	Based on the
		12	BH	19.9	16.4	*	deconvolution graph
		15	TC	10.7		*	
		18	BH	7.8	5.9	*	
		21	TC	6.4		*	
		24	TC	5.8		*	
		27	TC	5.1		*	
		30	BH	4.8	2.6	*	
		33	TC	4.6		*	
		36	TC	4.5		*	
		39	TC	4.4		*	
		42	TC	4.3		*	
		45	TC	4.1		*	
		48	TC	3.9		*	
		51	TC	3.9		*	
		54	TC	3.8		*	
		57	TC	3.8		*	
		60	TC	3.8		*	
14	190258	03	TC	28.2		*	Patio
		06	BH	35.4	42.8	*	DC = 12 inches
		09	TC	23.2		*	Based on the
		12	BH	13.9	12.8	*	deconvolution graph
		15	TC	9.3		*	
		18	TC	6.9		*	
		21	TC	5.7		*	
		24	BH	5.1	3.2	*	
		27	TC	4.7		*	
		30	TC	4.6		*	
		33	TC	4.3		*	
		36	TC	4.3		*	
		39	TC	4.6		*	
		42	TC	4.2		*	
		45	TC	3.9		*	
15	193250	00	DC	11.0		*	Enclosed patio
16	194246	00	DS	18.5		*	East side of carport
17	196260	00	DS	6.5		*	Enclosed patio

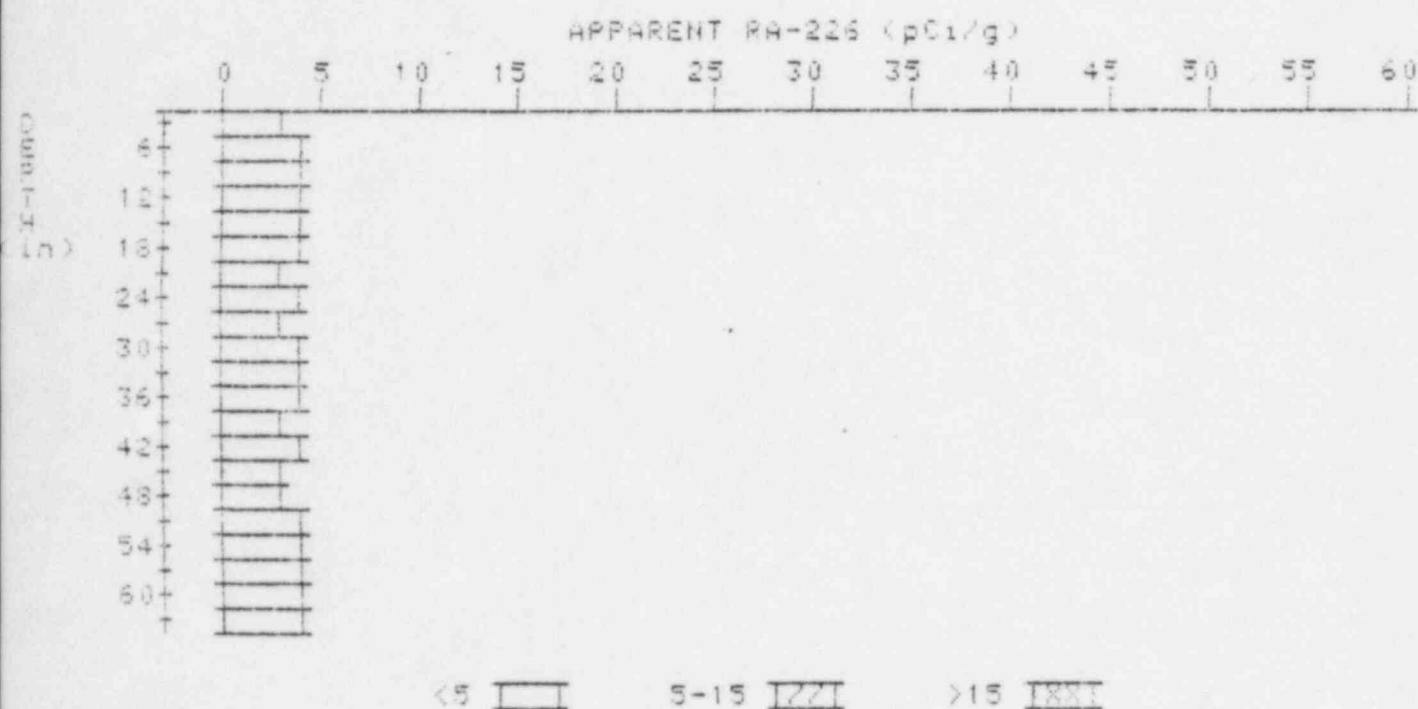
# APPARENT RADIUM-226 CONCENTRATION 21 DECONVOLUTION GRAPH

I believe the unknown utility line is probably an abandoned sewer line.
