RADIOLOGIC AND ENGINEERING ASSESSMENT

DOE ID NO.: GJ-00712-RS  
ADDRESS: 1522 ELM AVENUE

APRIL 1985

BENDIX FIELD ENGINEERING CORPORATION  
P.O. Box 1569  
Grand Junction, Colorado 81502

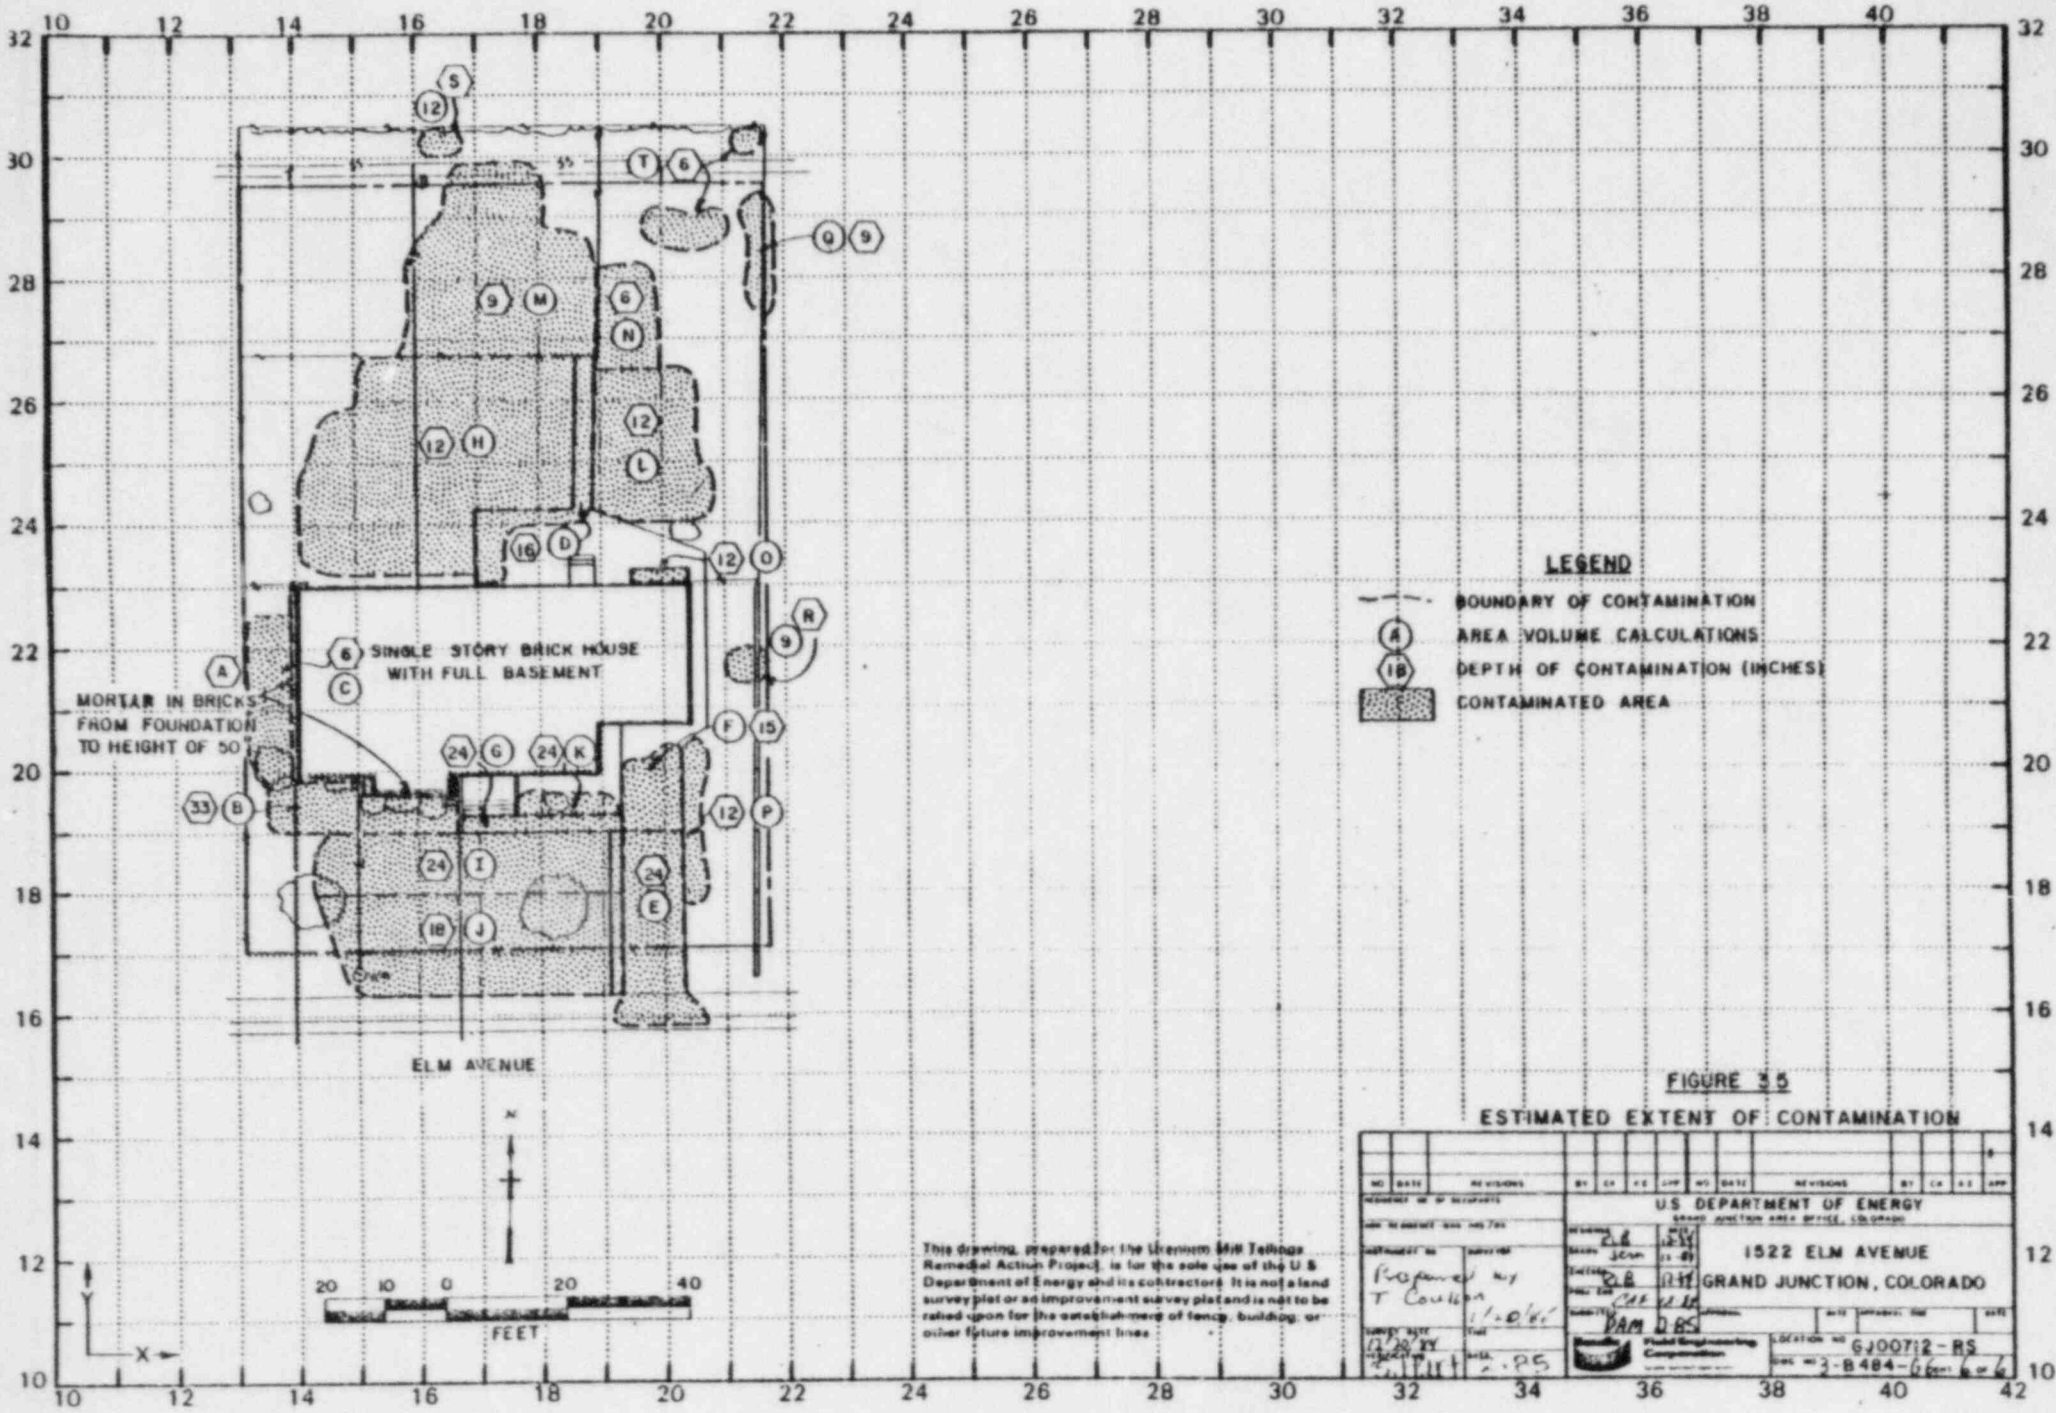
Appendix Figure 3.5 shows identified areas and estimated depths of contamination on this property, based on assessments of all measurements taken. As noted in this figure, areas recommended for remedial action that contain identified residual radioactive materials are:

- (AREA A) The mortar and/or the bricks in the facing are contaminated to a height of 50 inches. This contamination extends 2 feet east of the northwest corner of the primary structure, around the west and south walls as far as the northwest corner of the porch. This remedial action was performed by CDH under GJRAP and is not part of the UMTRA Program.

- (AREA B) A deposit 33 inches deep is adjacent to the south side of the primary structure (approximately 243 sf).
- (AREA C) Adjacent to the west side of the primary structure, contamination is 6 inches deep (approximately 216 sf).

- (AREA D) Based on information collected in Area G, contamination is 12 inches deep under the north sidewalk and the north and west edges of the patio. The patio slab is 4 inches thick. Total depth of contamination is 16 inches. This area appears to have been recontaminated during removal of flagstone patio and replacement of concrete patio (approximately 177 sf).

- (AREA E) Contamination under the concrete driveway is 20 inches deep. The concrete is 4 inches thick. Total depth of contamination is 24 inches (approximately 340 sf).

- (AREA F) Contamination under the north portion of the concrete driveway is 11 inches deep. The concrete is 4 inches thick. Total depth of contamination is 15 inches (approximately 130 sf).

- (AREA G) Contamination under the sidewalk south of the primary structure extends to an estimated depth of 20 inches, based on information collected in Area I. The concrete is approximately 4 inches thick. Total depth of contamination is 24 inches (approximately 81 sf).

- (AREA H) A large deposit north of the primary structure west of the sidewalk is contaminated to a depth of 12 inches (approximately 1,320 sf).
- (AREA I) The middle of the south yard is contaminated to a depth of 24 inches (approximately 500 sf).

- (AREA J) The south yard, north of the city sidewalk, is contaminated to a depth of 18 inches (approximately 752 sf).
- (AREA K) Contamination was found in the rock garden between the south sidewalk and the primary structure. This area was not disturbed at the request of the occupants. Based on information collected in Area I, this contamination is estimated to extend to a depth of 24 inches (approximately 68 sf).

- (AREA L) The deposit on the east side of the north sidewalk is contaminated to a depth of 12 inches, based on information collected in Area G (approximately 450 sf).

- (AREA M) A section of the north yard is contaminated to a depth of 9 inches (approximately 821 sf).
- (AREA N) A small deposit northeast of the primary structure is 6 inches deep (approximately 170 sf).

- (AREA O) A planter in the patio north of the garage is contaminated to a depth of 12 inches (approximately 20 sf).
- (AREA P) A deposit east of the driveway is contaminated to a depth of 12 inches (approximately 108 sf).

- (AREA Q) A deposit along the east property line is contaminated to a depth of 9 inches (approximately 90 sf).
- (AREA R) A small deposit next to the east retaining wall is contaminated to a depth of 9 inches (approximately 42 sf).

- (AREA S) A small deposit next to the north fence is 12 inches deep. (approximately 35 sf).
- (AREA T) Two small deposits in the northeast corner of the backyard are contaminated to a depth of 6 inches (approximately 95 sf).

The recommended remedial action for this property, DOE ID No. GJ-00712-RS, includes removal of select areas identified as containing radioactive material (as discussed in Section 3.5 and shown in Appendix Figure 3.5) and transport of removed material to the disposal site.
