U.S. NUCLEAR REGULATORY COMMISSION

Report No. 040-06563/96002(DNMS)  
Docket No. 040-06563  
License No. STB-401  
Licensee: Mallinckrodt, Inc.  
3600 North Second Street  
St. Louis, MO 63147  
Date: November 21, 1996  
Inspectors: David W. Nelson, Radiation Specialist  
Donna Moser, Project Manager  
Approved By: B. L. Jorgensen, Chief  
Decommissioning Branch  
Attachments: 1. General Layout  
2. Building 235 East Pad Drawing  
3. Drawing of 235 East Brick Wall

EXECUTIVE SUMMARY  
Mallinckrodt, Inc.  
Report No. 040-06563/96002(DNMS)

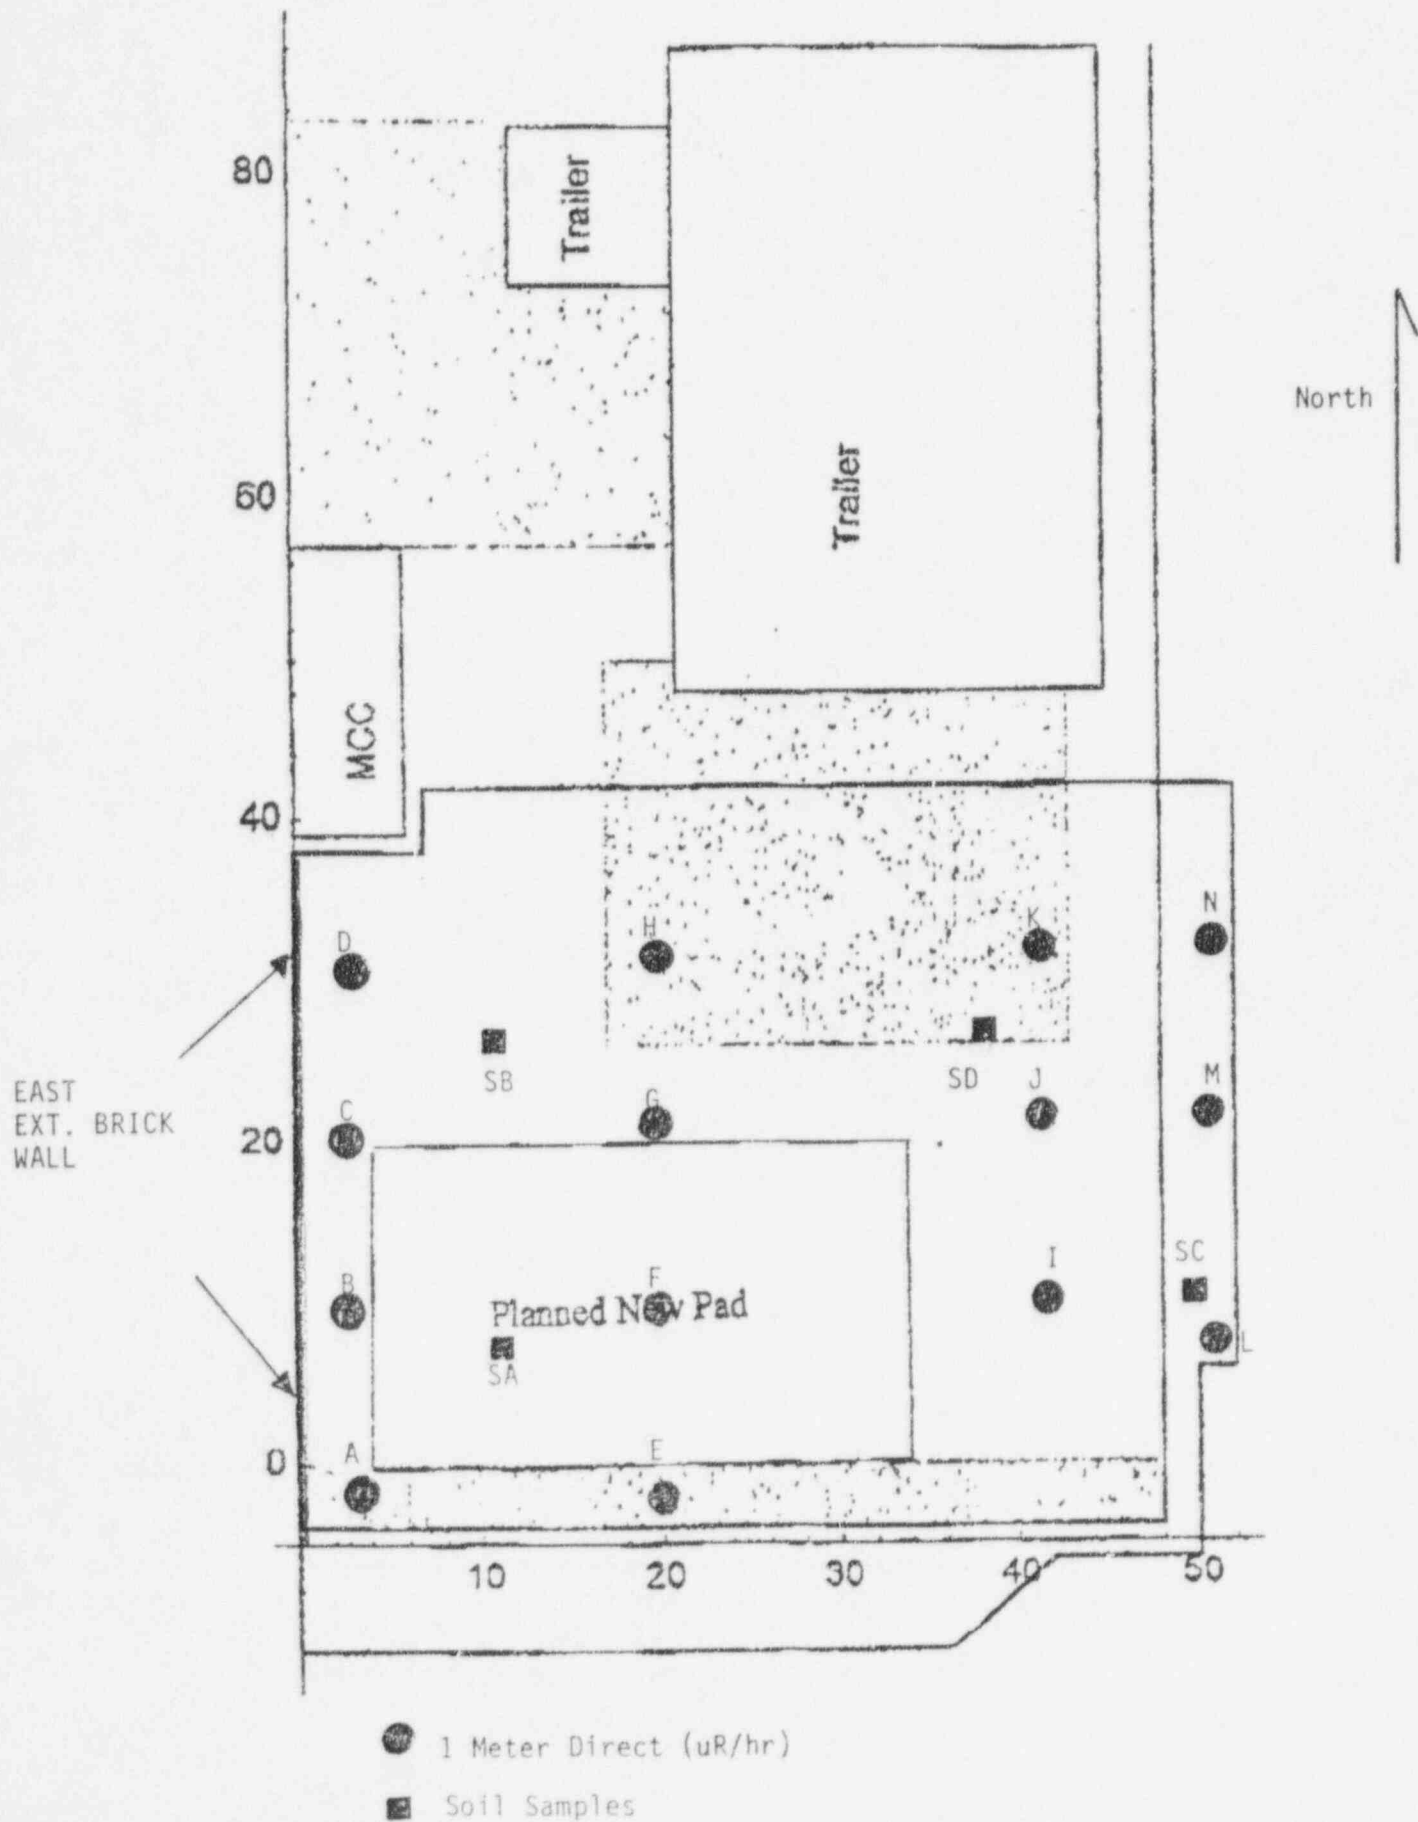
## Building 235 East Pad

Direct measurements performed one meter from the surface of the soil in the east pad area ranged from 8 to 30 microroentgens per hour (uR/hr) (0.08 to 0.30 microsieverts per hour (uSv/hr)). Background measurements varied considerably because of the presence of contamination throughout the Mallinckrodt facility.

Building 235 East Pad Direct Exposure Measurements (Attachment 2)

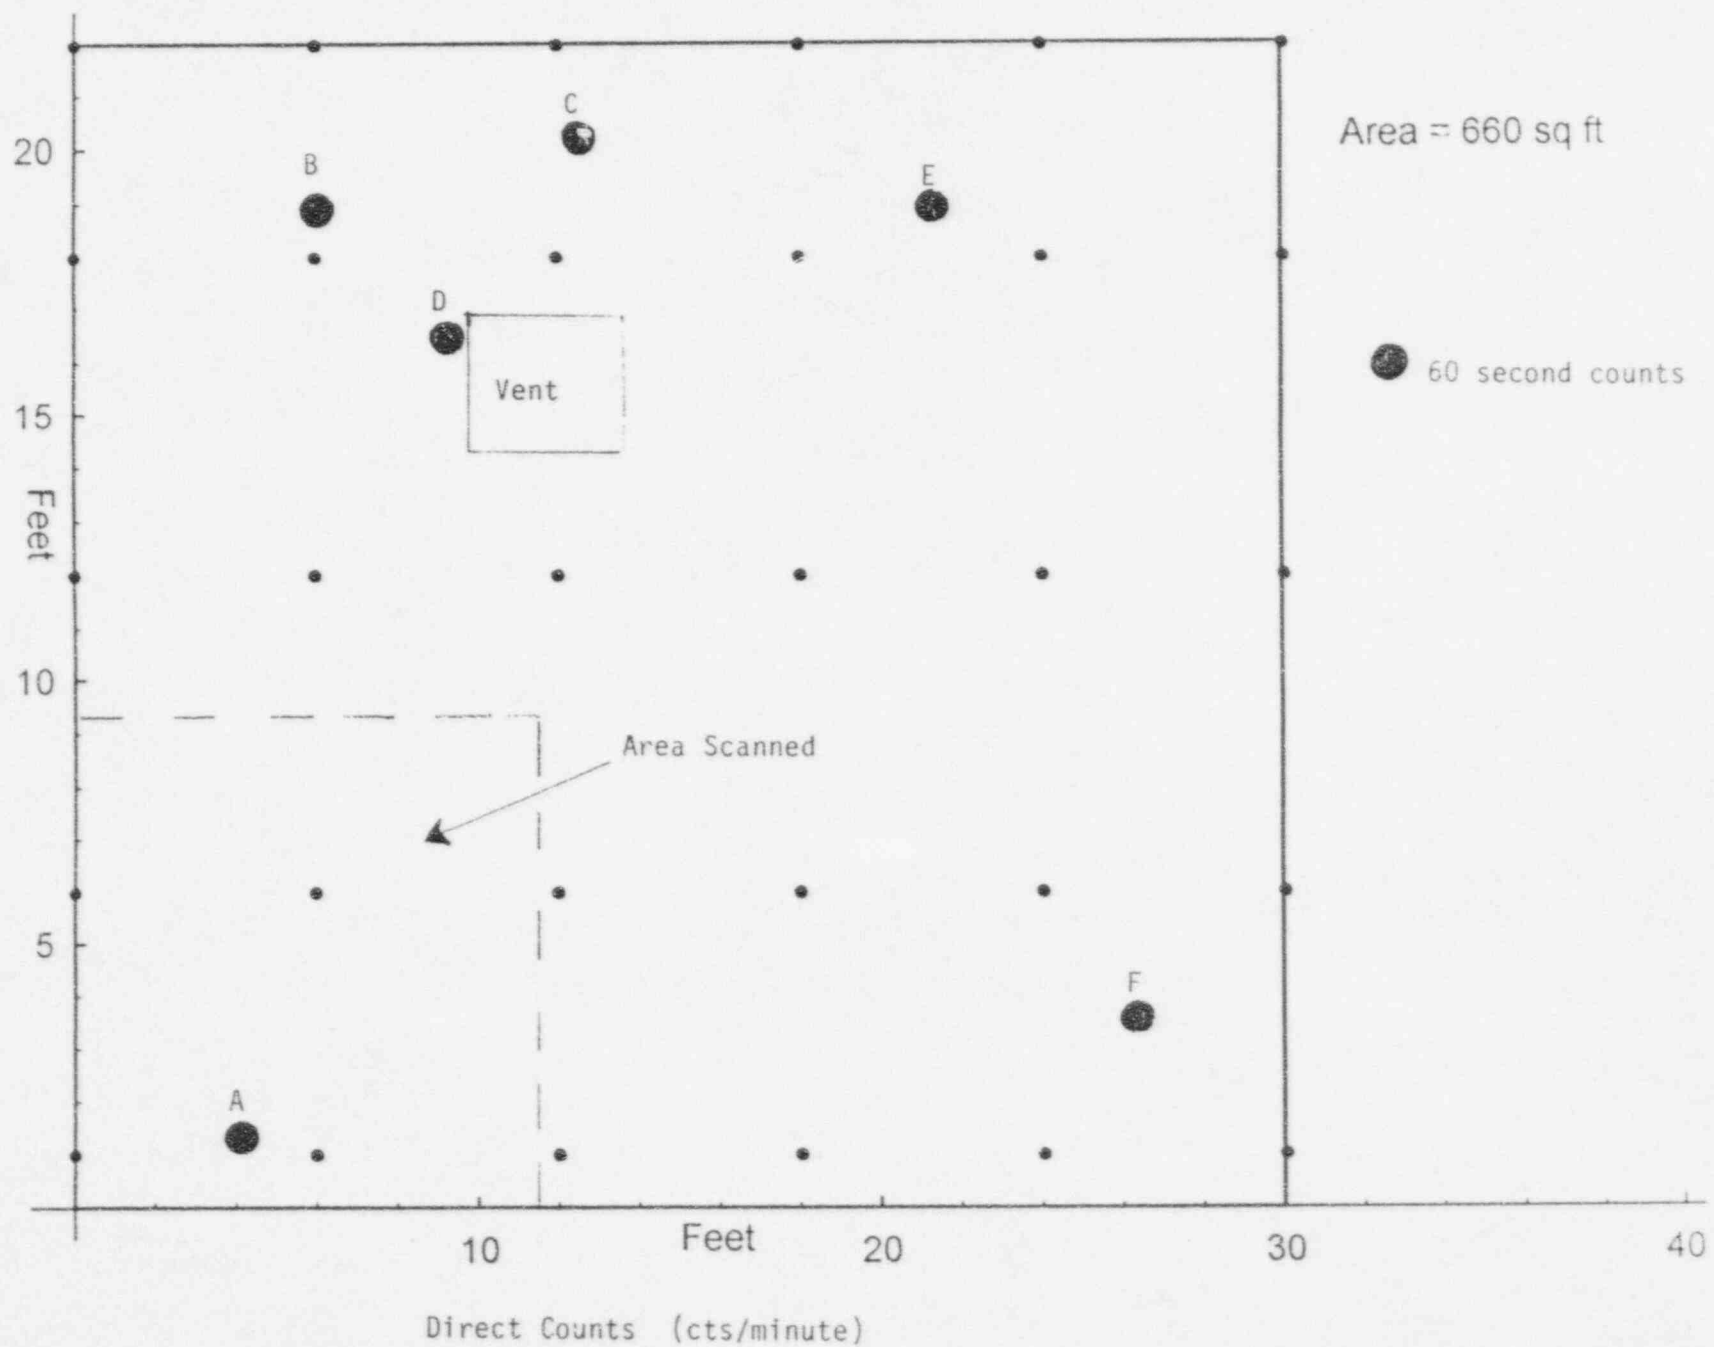
Building 235 East Exterior Brick Wall FC 83-23 Limit of 1100 Beta DPM/100 cm<sup>2</sup>

The scanning counts per minute measurements on the building 235 east exterior wall ranged from 60 to 70 cpm with a background measured to be approximately 60 cpm. Direct 60 minute counts on the wall ranged from 70 to 88 cpm.

Building 235 East Wall 60 minute Counts (Attachment 3)
