**Wolf Creek Incomplete Rod Insertions During Cycle 8  
Interim Report on Inspection Plan, Inspection Results and Root Cause**

Several activities were undertaken by Wolf Creek and Westinghouse to address the incomplete RCCA insertions that occurred at Wolf Creek near the end of cycle 8. These activities included the preparation, review and implementation of a test plan and the formation of a root cause team.

This report includes the test plan, a summary of the test results and a summary of the work and conclusions of the root cause team.

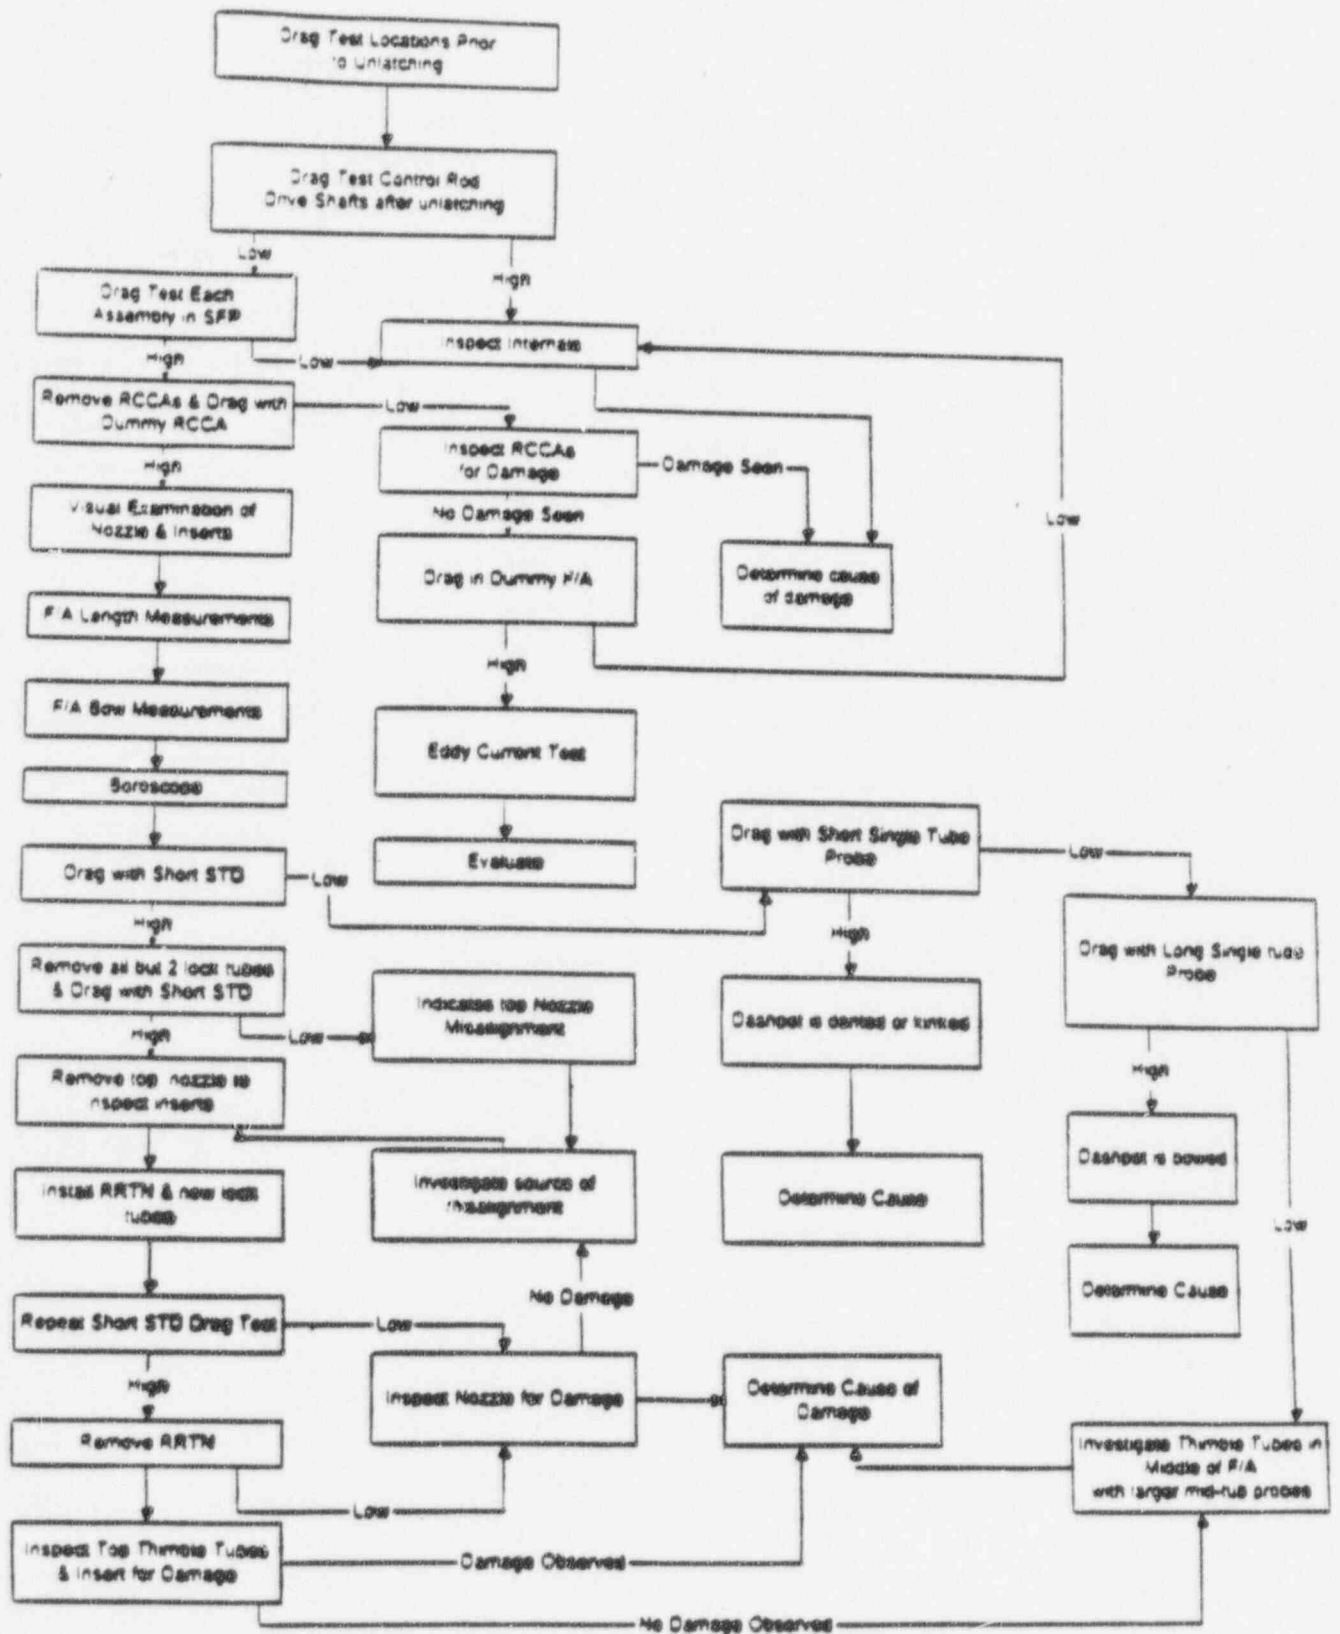
Figure 1-1 - Wolf Creek Decision Tree for RCCA Insertion Anomaly

The inspection plan logic tree is shown in Figure 1-1.

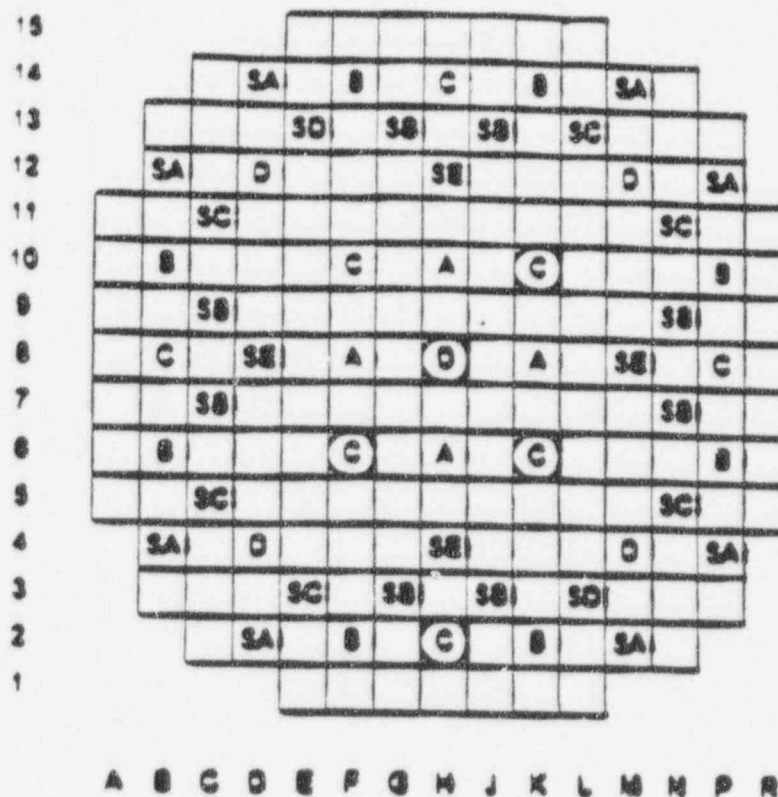
Figure 3-4 - Locations of RodDED Core Locations at Wolf Creek

# UT probe travel problem, 1103, 1154, 1143

Re-Loading Test P - Pass  
F - Fail  
N - No Test
