RE: Permit No. 522.

INSPECTION REPORT

TO FILE: Teton Exploration Drilling, Inc., Permit Number 522
FROM: Cathleen McCarty, ^{64m}District I Environmental Specialist
DATE: October 10, 1985
SUBJECT: NRC/DEQ Inspection Conducted on September 23 and 24, 1985.
PARTICIPANTS: Dick Appel, Teton
Roger Garling, Teton
George Pangburn, NRC
Randy Brich, NRC
Lisa Geesey, LQD District I
Cathy McCarty, LQD District I

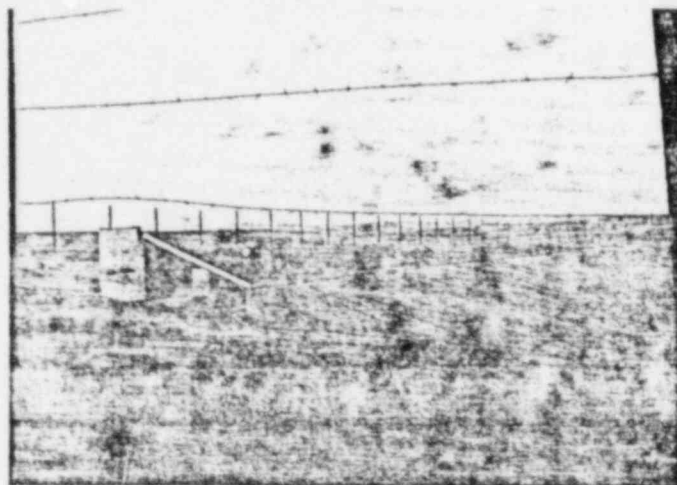
The south pond has water in it. Some of the water came from precipitation but most of it is from pumping well MR-1. The water coming from well MR-1 was treated with barium chloride before going into the pond. Photograph number 1 is looking at the barium chloride treatment tank for the well.

Photograph #1 is looking southwest at the barium chloride treatment tank for Well MR-1.

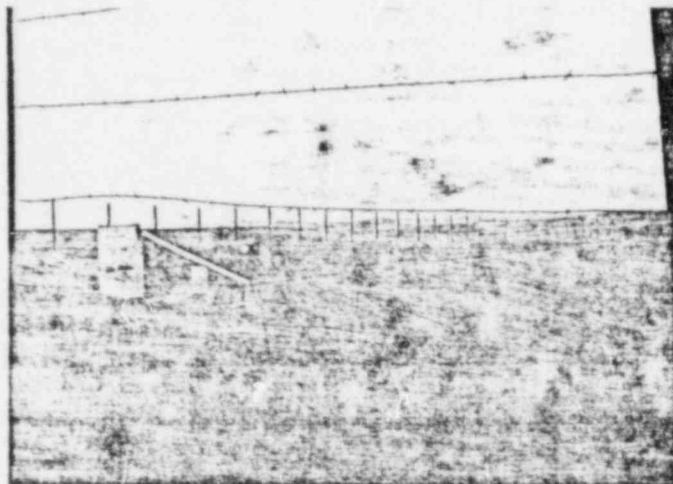
Photograph #1 is looking southwest at the barium chloride treatment tank for Well MR-1.
