RADIOLOGIC AND ENGINEERING ASSESSMENT

DOE ID NO.: GJ-05017-MR
ADDRESS: 735 NORTH 3RD STREET

JULY 1985

BENDIX FIELD ENGINEERING CORPORATION
P.O. Box 1569
Grand Junction, Colorado 81502

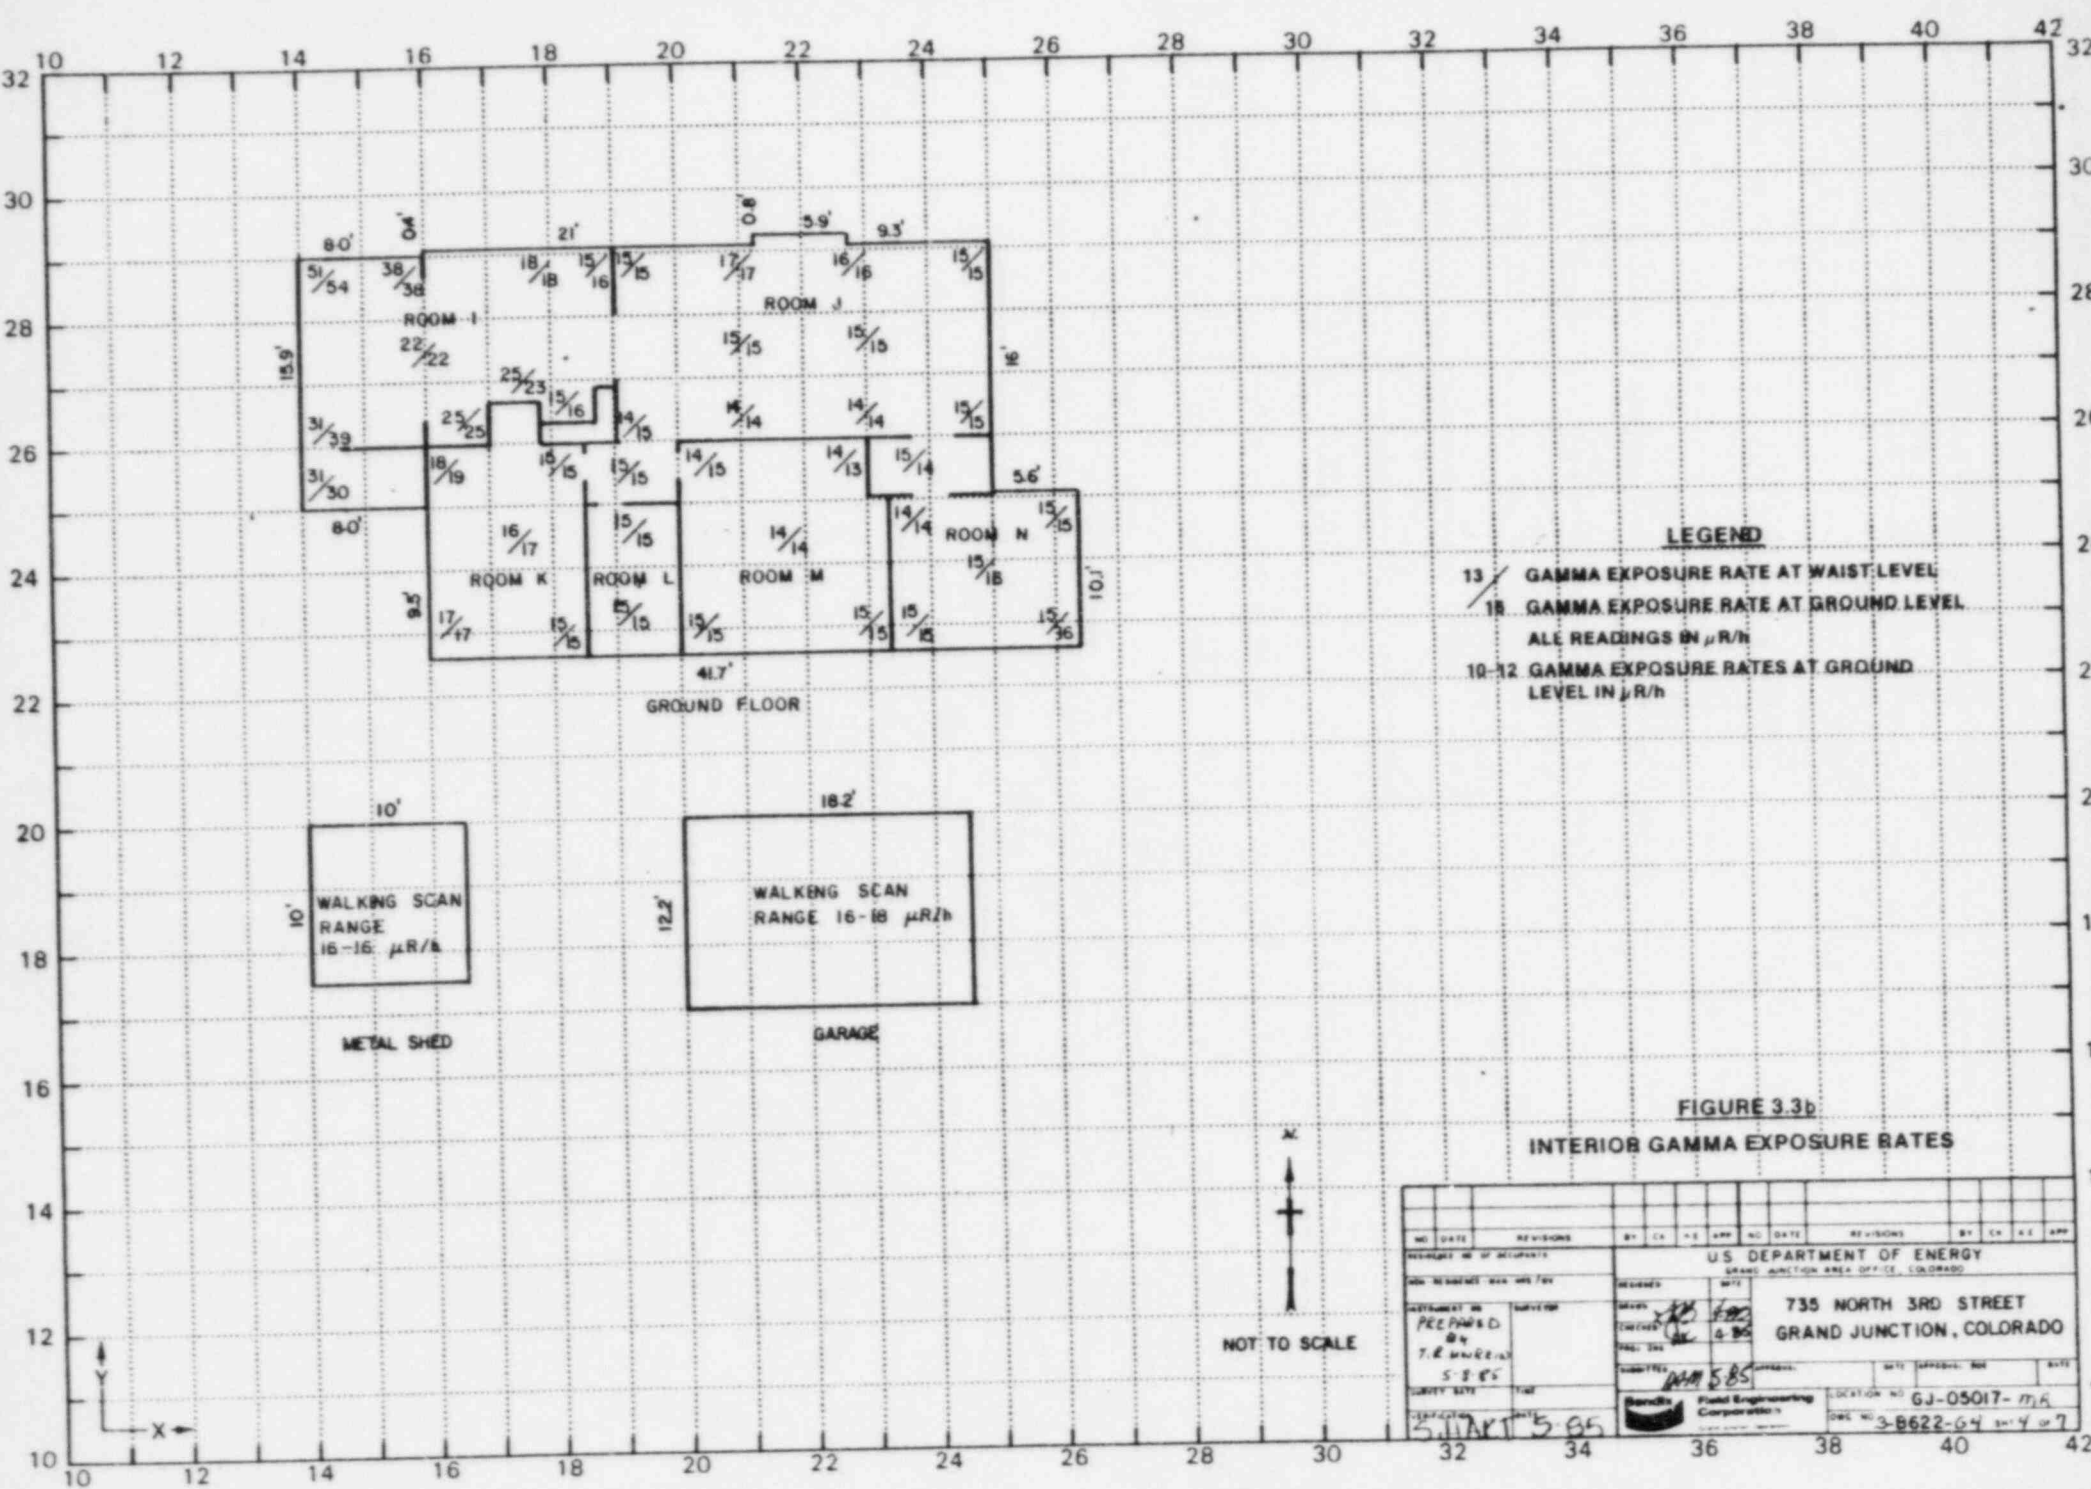
FIGURE 3.3b

*Exposure rates and room locations are shown in Appendix Figures 3.3a and 3.3b. Walking scans were performed in the garage and metal shed. These areas and the ranges of gamma measurements are shown in Appendix Figure 3.3b.

INTERIOR GAMMA EXPOSURE RATES

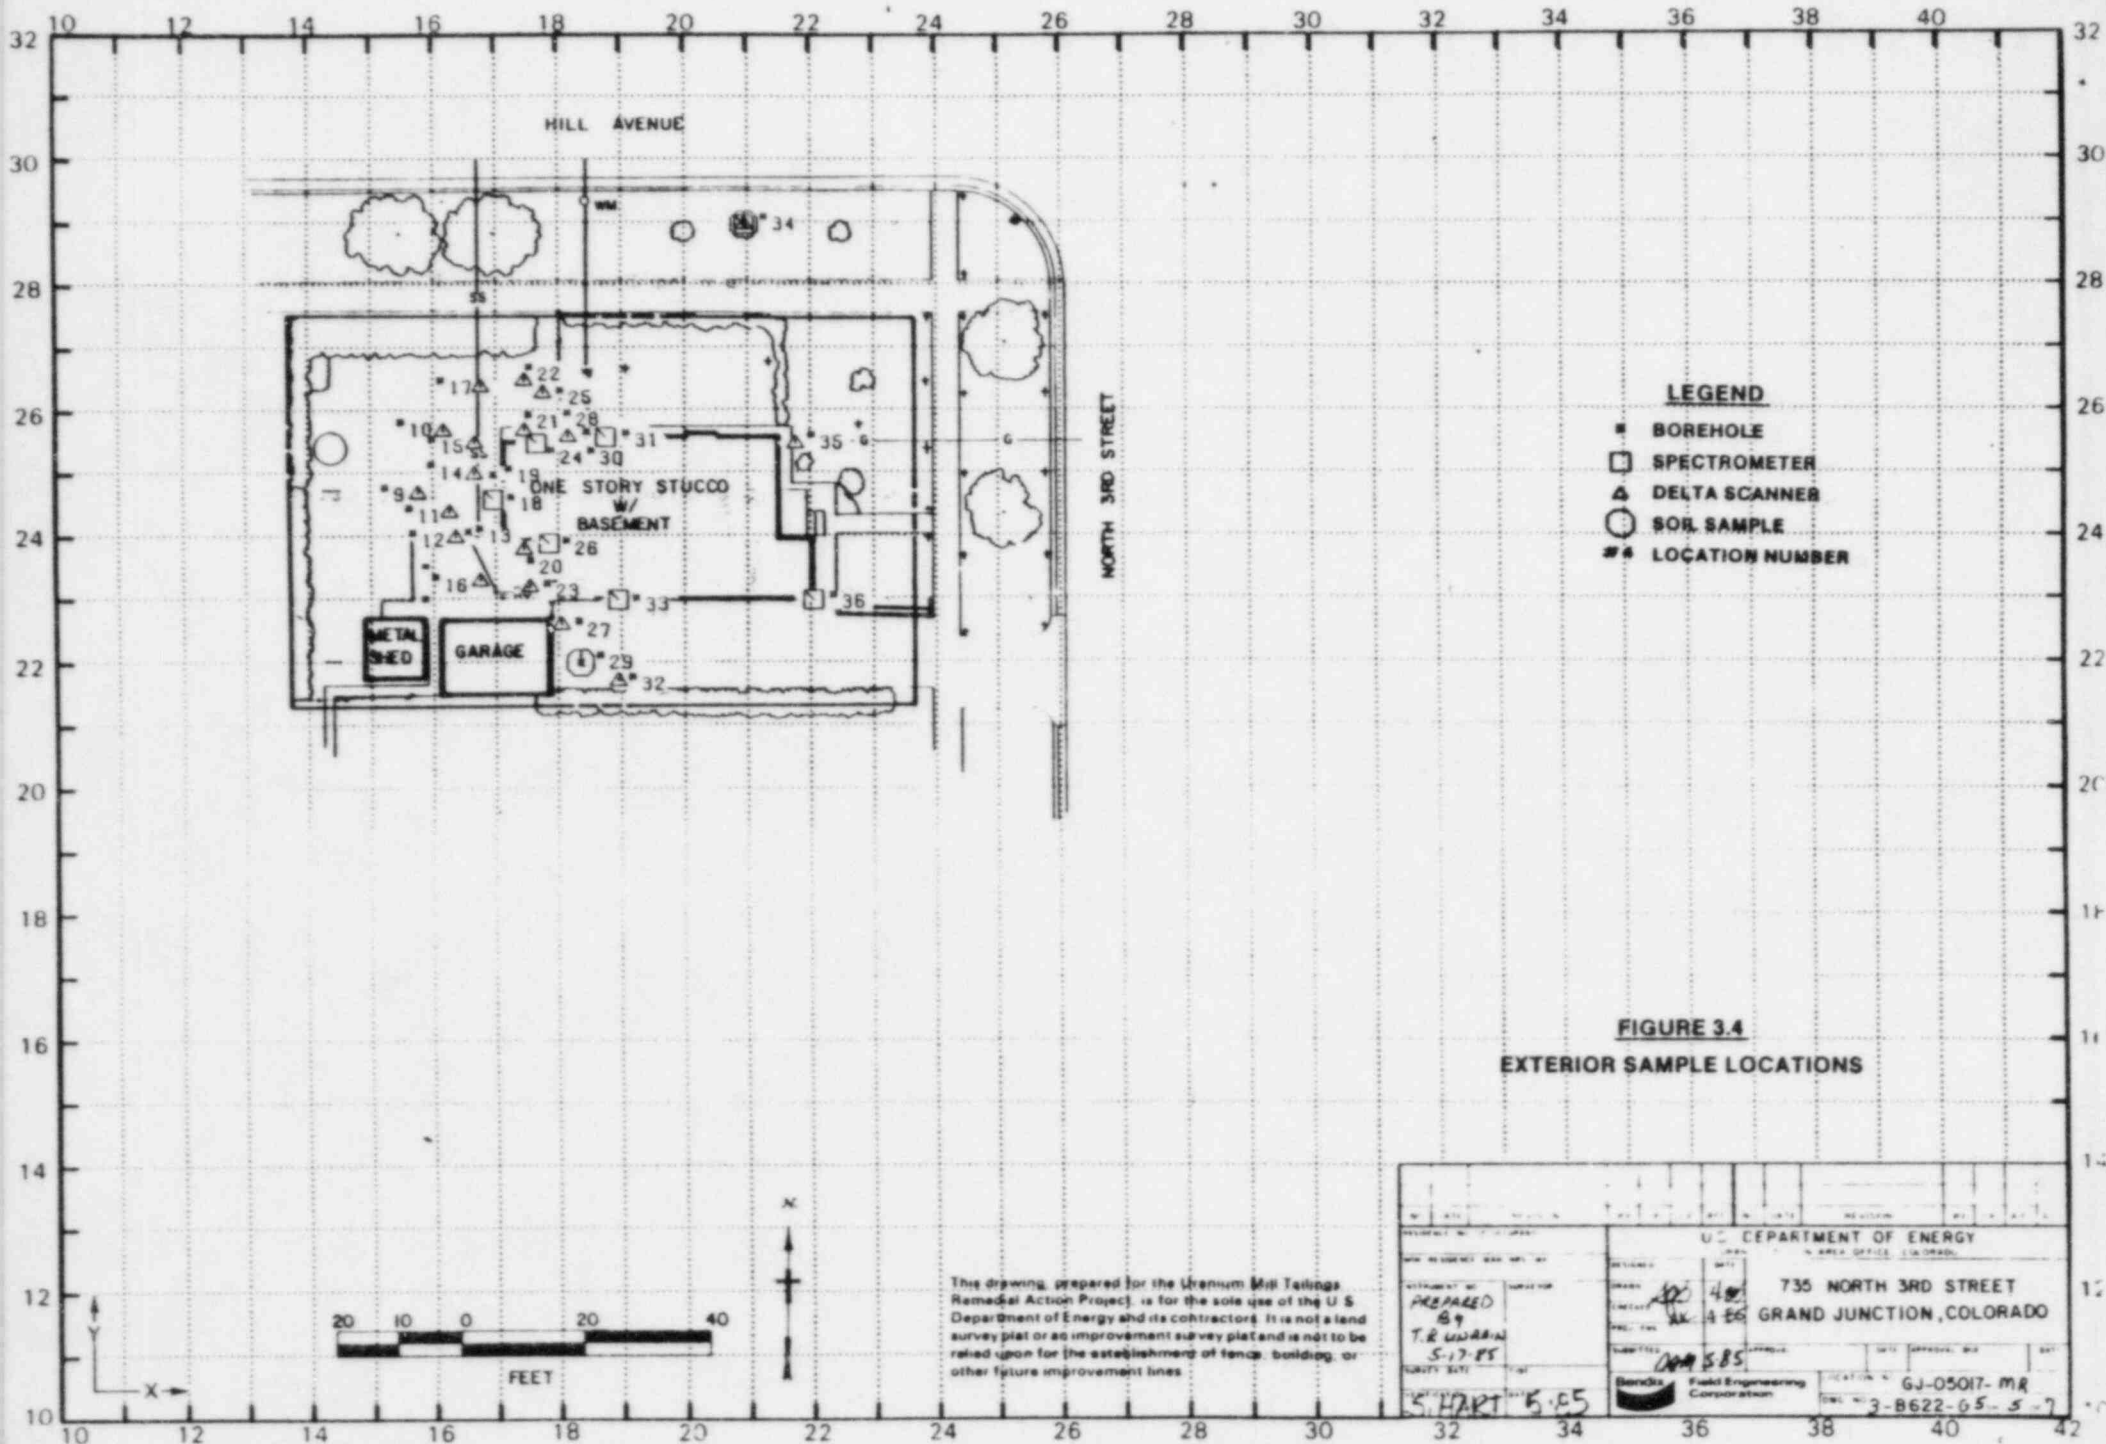
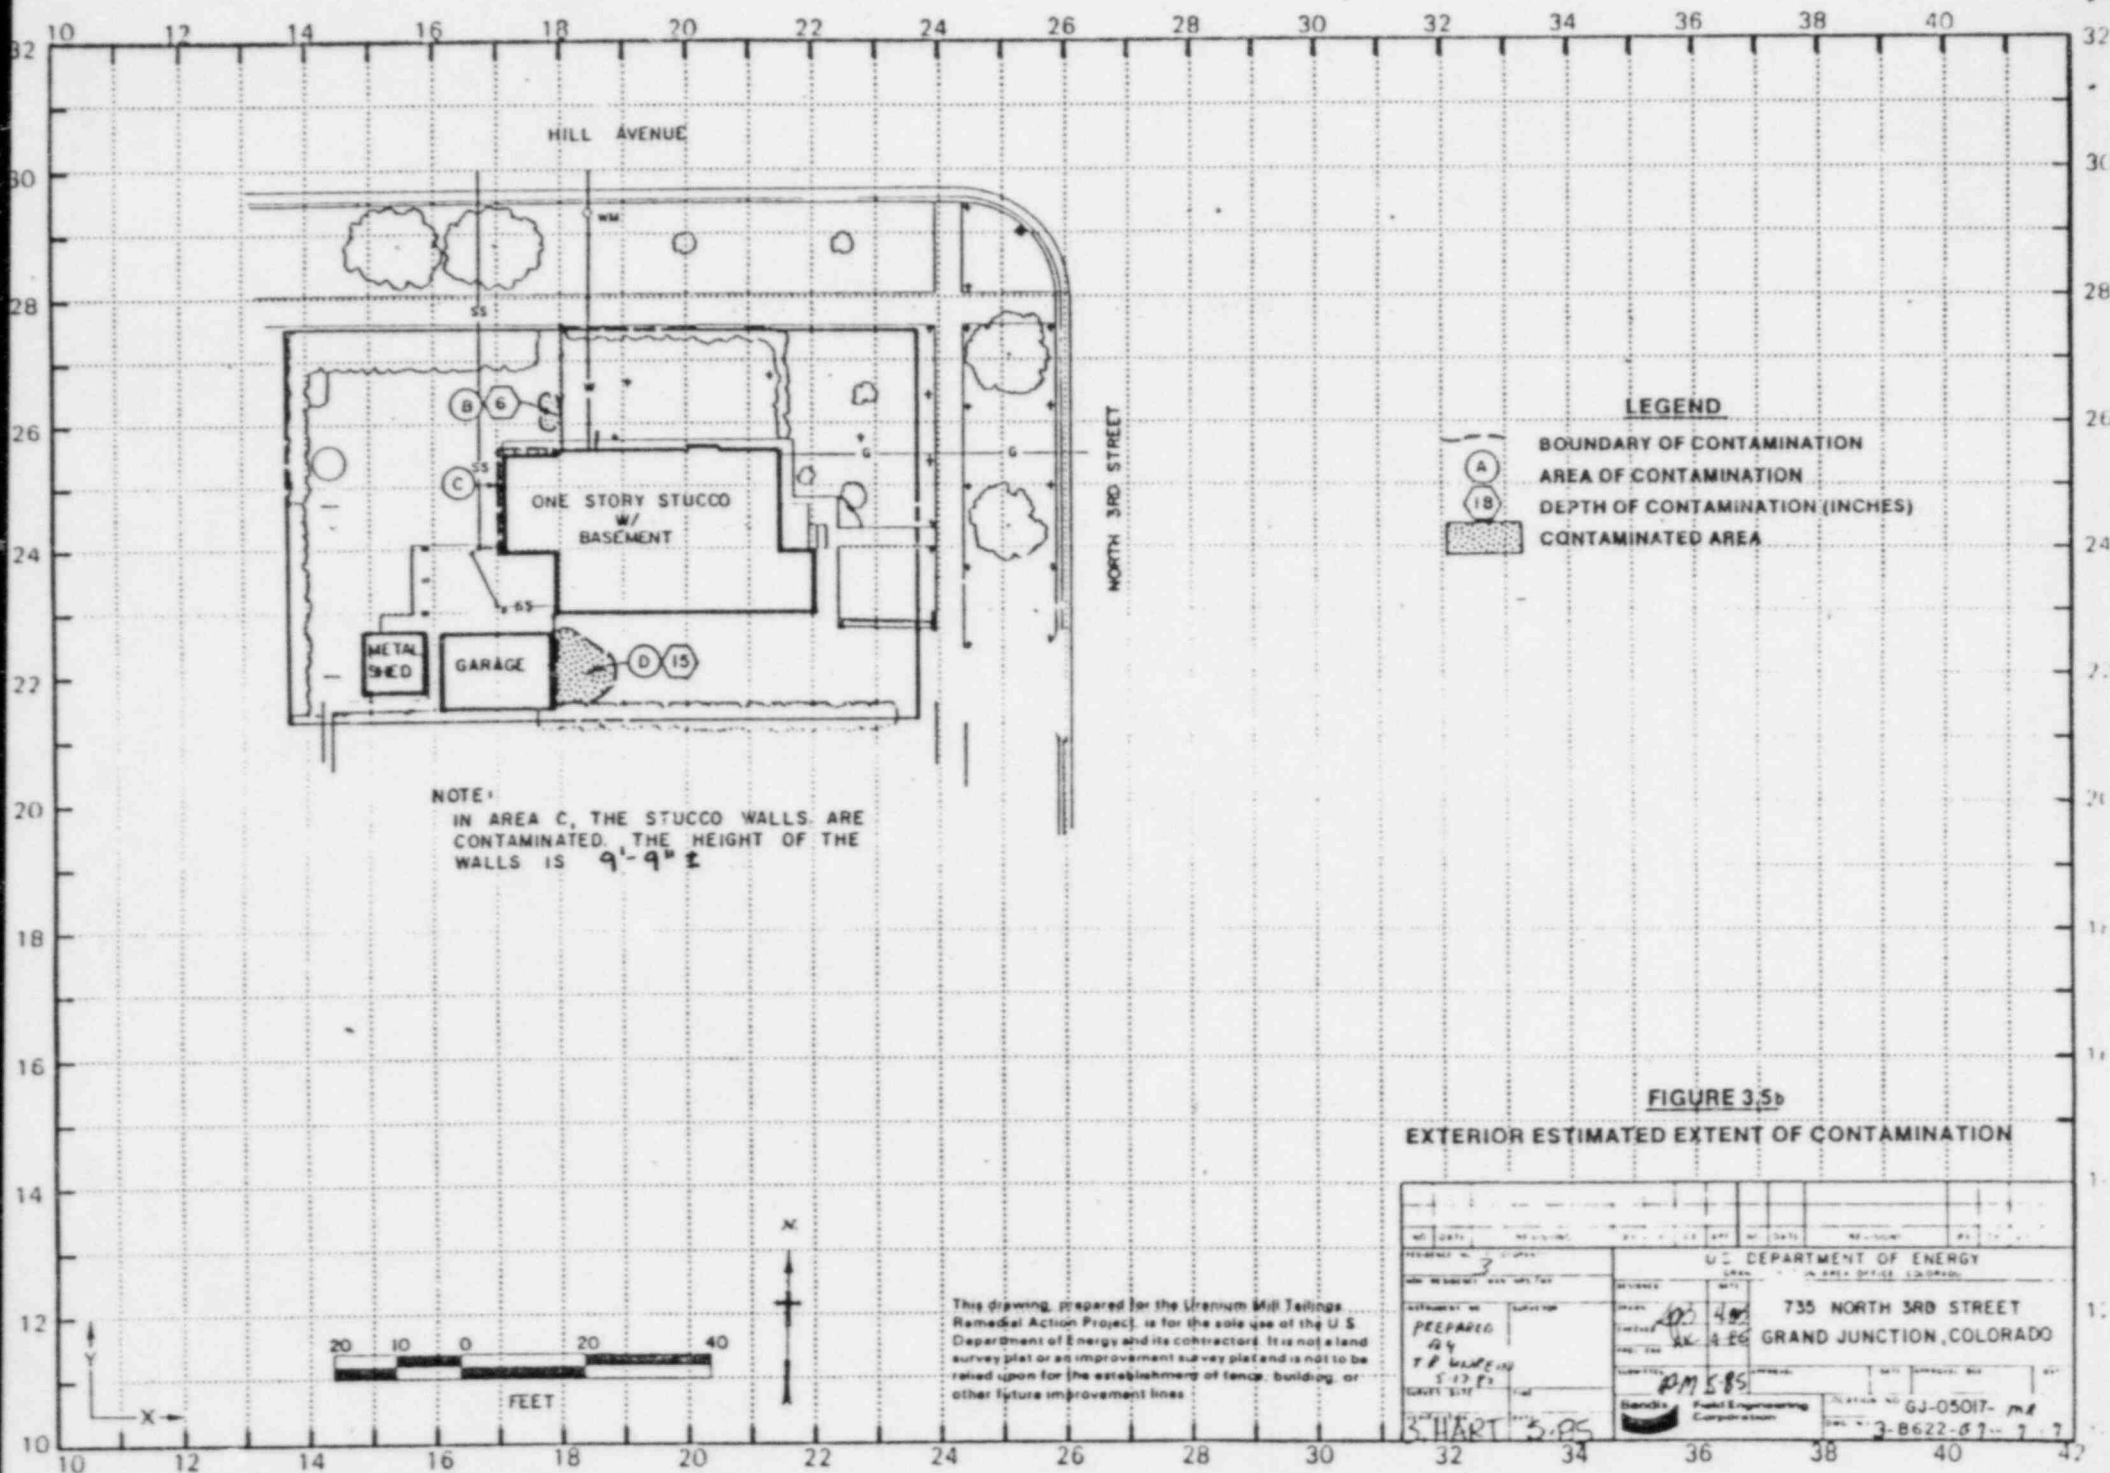
Appendix Figures 3.5a and 3.5b show identified areas and estimated depths of contamination on this property, based on assessments of all measurements taken. As noted in these figures, areas recommended for remedial action that contain identified residual radioactive materials are:

- (AREA A) The north and south walls of the basement stairwell are contaminated. The height of the walls from the basement floor is 48 inches (excluded).
- (AREA B) A small deposit north of the primary structure is contaminated to a depth of 6 inches (approximately 28 sf).
- (AREA C) Portions of the north and west exterior stucco walls of the primary structure are contaminated. The height of the walls is 111 inches (approximately 240 sf).
- (AREA D) The soil under the uncontaminated 3-inch-thick concrete driveway east of the garage is contaminated to a total depth of 15 inches (approximately 115 sf).

The recommended remedial action for this property, DOE ID No. GJ-05017-MR, includes select removal of areas identified as containing radioactive material, except for Area A, which is the basement stairwell walls (as discussed in Section 3.5 and shown in Appendix Figures 3.5a and 3.5b) and transport of removed material to the disposal site.

Area A, as discussed in Section 3.5 and shown on Appendix Figure 3.5a, will not be included in this remedial action because the interior RDC working level and the interior gamma do not exceed EPA Standards.

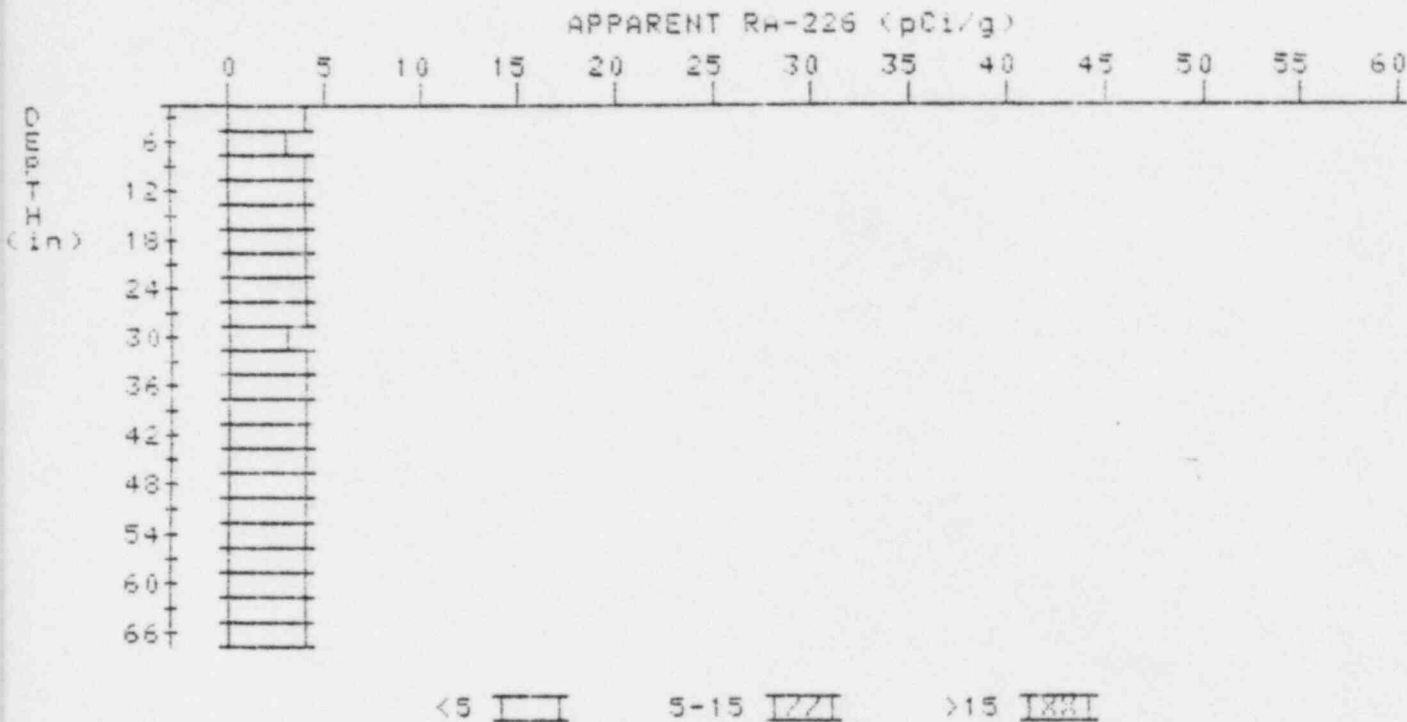
APPARENT RADIUM-226 CONCENTRATION 13

PROPERTY NUMBER: GJ-05017-MR
HOLE NUMBER: 13
LOCATION: 166241

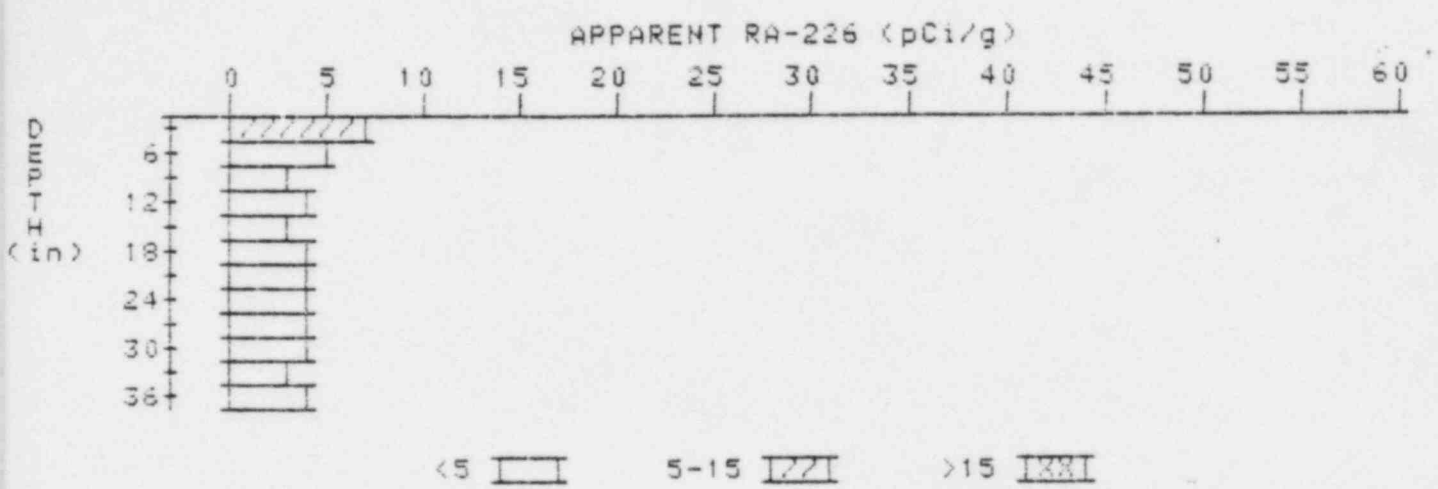
APPARENT RADIUM-226 CONCENTRATION 19

PROPERTY NUMBER: GJ-05017 - MR
HOLE NUMBER: 19
✓ LOCATION: 170250

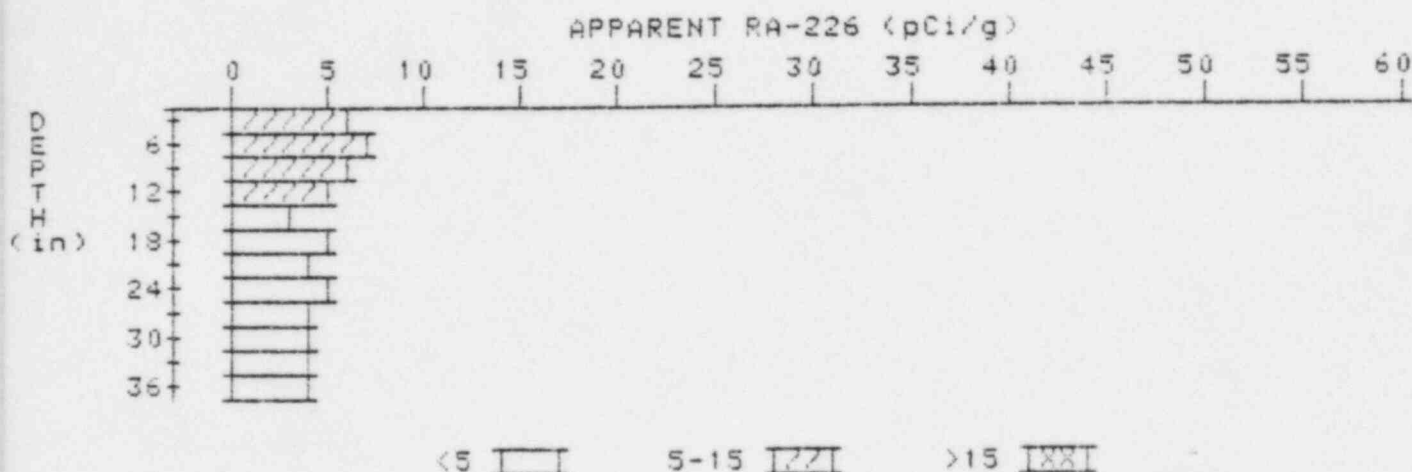
APPARENT RADIUM-226 CONCENTRATION 29 DECONVOLUTION GRAPH

HOLE NUMBER: 29

✓ LOCATION: 184220

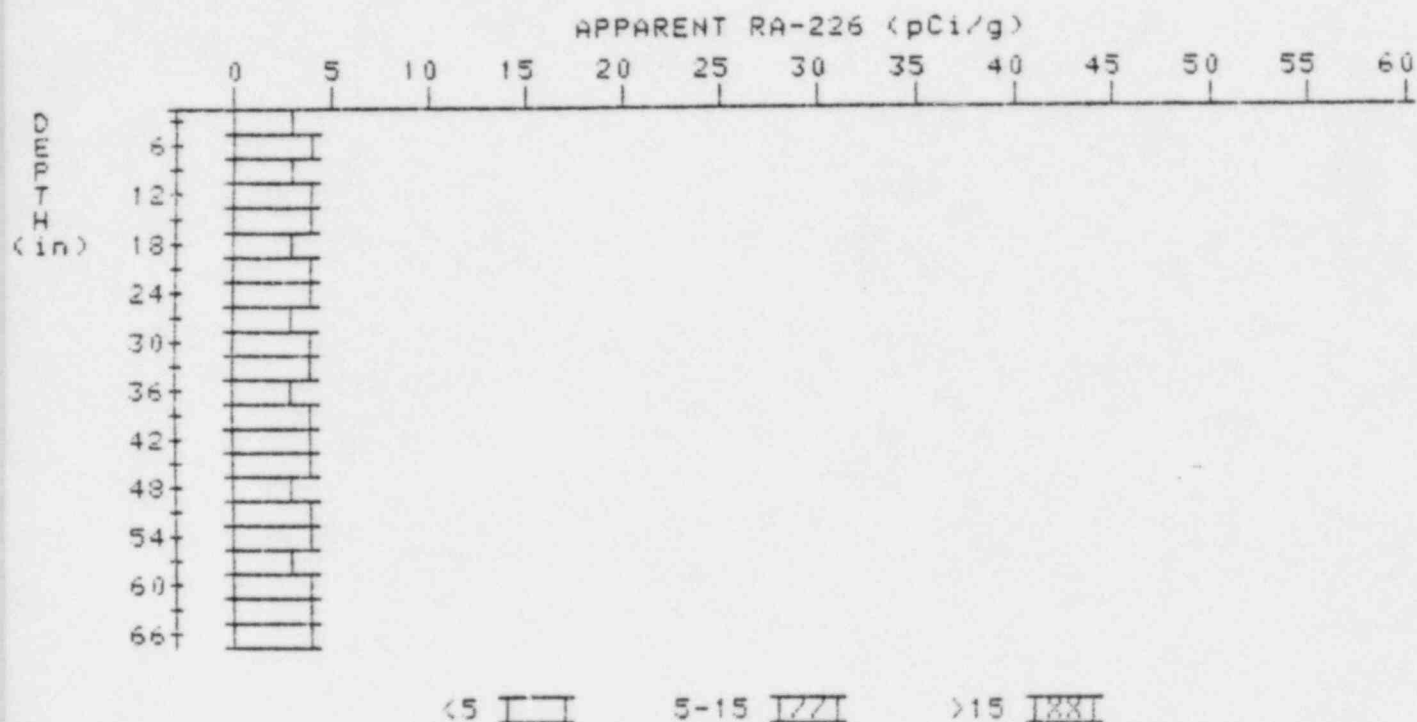
APPARENT RADIUM-226 CONCENTRATION 30 DECONVOLUTION GRAPH

PROPERTY NUMBER: GJ-05017 - MR
HOLE NUMBER: 30
✓ LOCATION: 185257

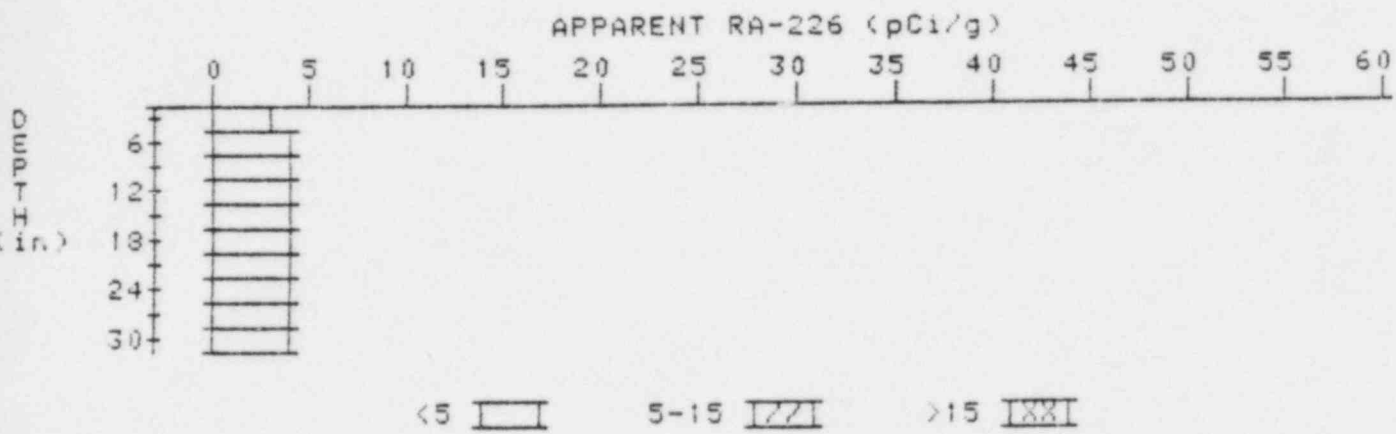
APPARENT RADIUM-226 CONCENTRATION

PROPERTY NUMBER: GJ-05017 - MR
HOLE NUMBER: 34
✓ LOCATION: 210290
