U.S. NUCLEAR REGULATORY COMMISSION
REGION I

Report No. 85-01

Licensee: Brigham and Women's Hospital
75 Francis Stret
Boston, Massachusetts 02115

Inspection Summary: Inspection Conducted on August 20, 1985, and August 21, 1985,
Combined Report No. 030-12239/85-01, 030-15070/85-01, and
030-22102/85-01

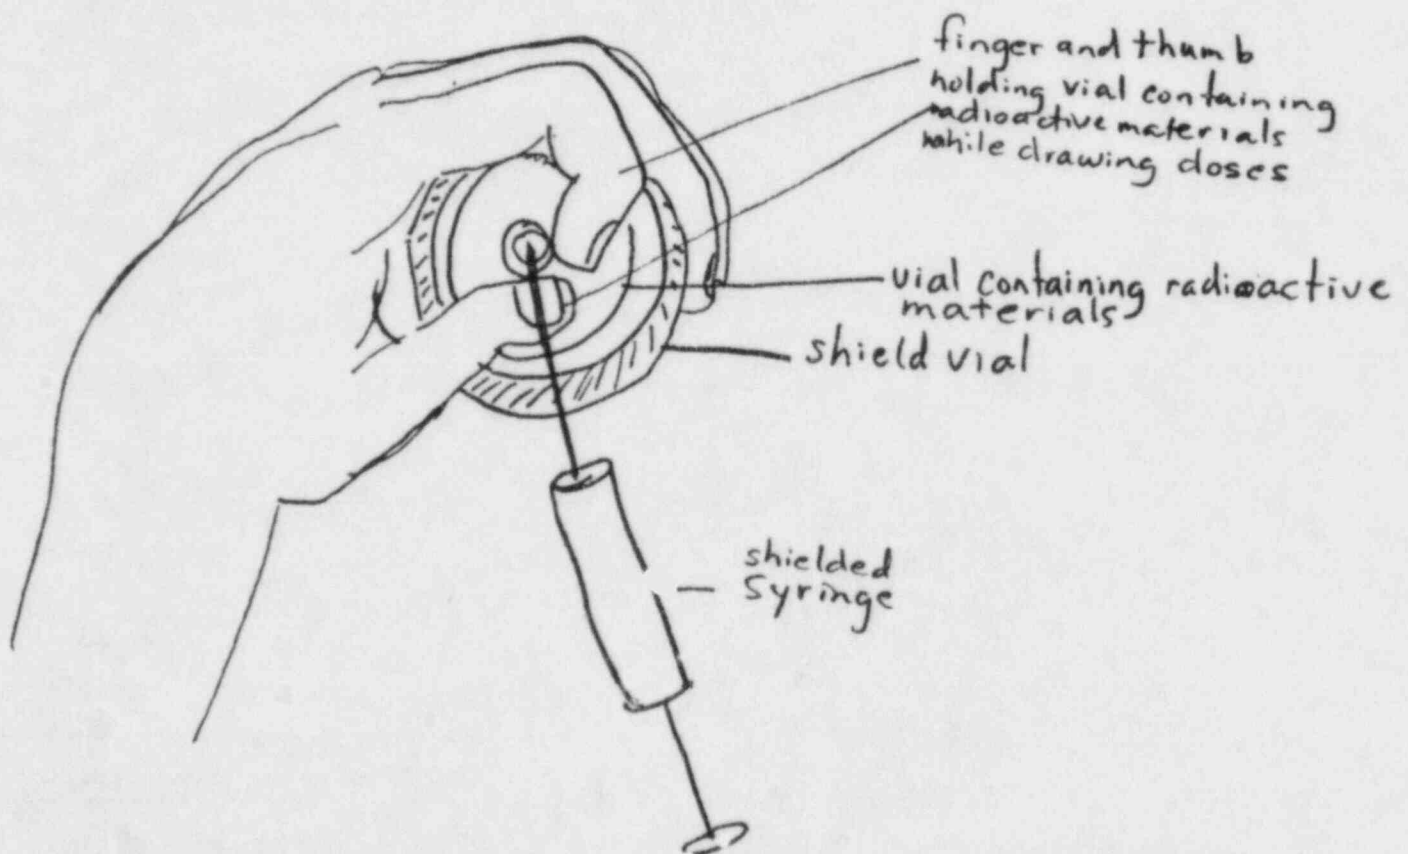
EXHIBIT 1

The inspector observed the drawing up of doses of thallium-201 in the Nuclear Pharmacy and technetium-99m MDP in Nuclear Medicine. In both cases, the individual had to hold the vial containing the radioactive material in the vial shield by use of the tips of the gloved index finger and thumb. (See drawing Exhibit 1). The inspector stated that the use of screw-top shielded vial containers for the vials would eliminate the majority of this unnecessary exposure and discussed this need with the RPO (See commitment in Section 21).

The inspector met with the individuals identified in Section 1 and discussed the results of the inspection. The inspector requested and obtained commitments from the licensee's representatives to (1) provide lead shields with screw-on shield tops for Nuclear Medicine and the Radiopharmacy in order to reduce the exposure to fingertips (See Section 13); (2) identify the users of the J. L. Shepherd irradiator by either last name in the log book or provide a key which will identify the initials of the user (See Section 3); and (3) place either on the radiation survey record or medical record of iodine-131 therapy patients a verification that the residual activity of iodine-131 was 30 millicuries or less upon the patients release from the hospital (see Section 13).
