Loss of Main and Auxiliary Feedwater Event at the Davis-Besse Plant on June 9, 1985

U.S. Nuclear Regulatory
Commission

Manuscript Completed: July 1985
Date Published: July 1985

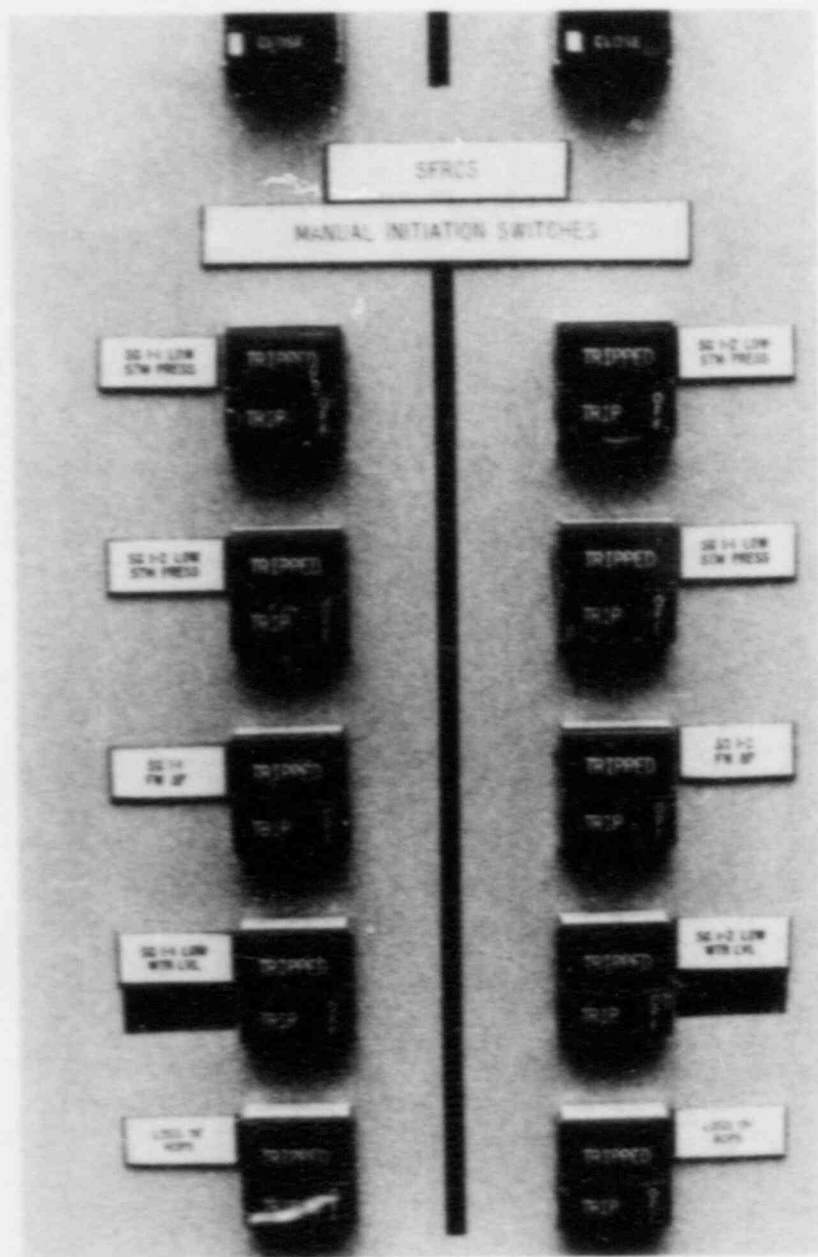
Figure 3.6 Manual Initiation Switches for SFRCS

He went to the manual initiation switches at the back panel and pushed two buttons to trip the SFRCS. (The SFRCS control panel is shown in Figure 3.6.) He inadvertently pushed the wrong two buttons and, as a result, both steam generators were isolated from the emergency feedwater supply. He had activated the SFRCS on low pressure (the top pair of buttons in Figure 3.6) for each steam generator instead of on low level (the fourth pair of buttons from the top). By manually actuating the SFRCS on low pressure, the SFRCS was signalled that both generators had experienced a steamline break or leak and the system responded, as designed, to isolate both steam generators. The operator's anticipatory action defeated the safety function of the auxiliary feedwater system--a common-mode failure and the third abnormality to occur within 6 minutes after the reactor trip.

The operator returned to the auxiliary feedwater station expecting the AFWS to actuate and provide the much-needed feedwater to the steam generators that were boiling dry. Instead, he first saw the No. 1 AFW pump, followed by the No. 2 AFW pump trip on overspeed--a second common-mode failure of the auxiliary feedwater system and abnormalities four and five. He returned to the SFRCS panel to find that he had pushed the wrong two buttons.
