**SEISMIC AND STRUCTURAL REVIEW OF ADVANCED MEDICAL SYSTEMS
LABORATORY FACILITIES**

by
James E. Beavers, Ph.D., P.E.
Vice President

June 6, 1996

AN ASSESSMENT

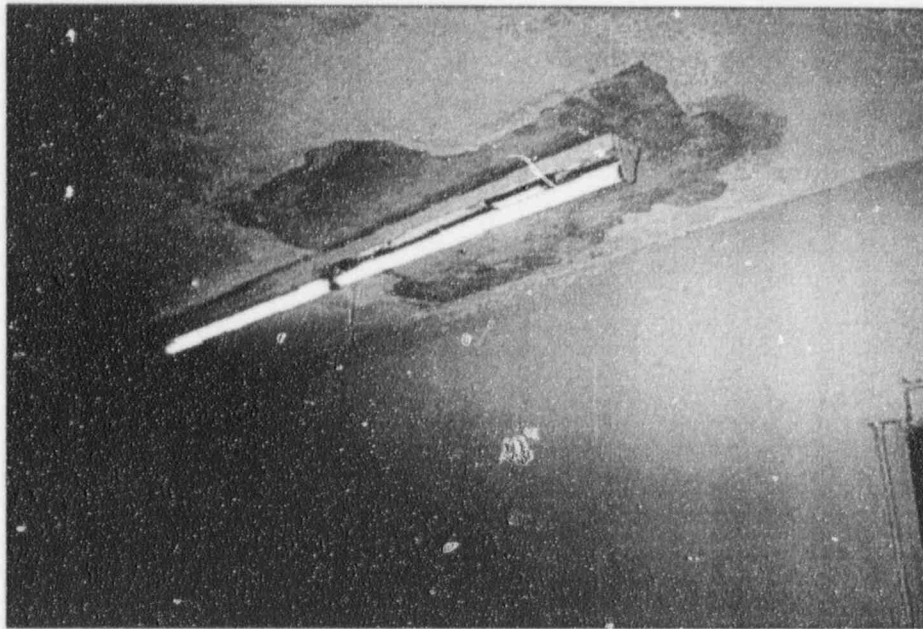
Figure A-2. Ceiling water damage.

outside the area to occur. This may have been the original intent; however, at both the conduit and ventilation chases, the risers are only two inches. In addition, at the ventilation chase, the riser has a 1½-inch notch in it. Thus, the maximum fluid that can be contained within the equipment is about 40 gallons. Therefore, the fluid runs over the ½-inch riser, down the chase onto the false ceiling. The first time a leak of significance occurred, the fluid collected in the false ceiling and was held there until the plaster of the false ceiling gave way as shown in Figure A-2.

This leakage caused no deterioration of the second floor slab's structural strength, and the fluids did not penetrate the concrete floor slab. There is no visible degradation of the floor slab, and it is highly unlikely there has been any degradation. In addition, the main part of the equipment room is over the radiography room where the floor slab is 2-feet thick.

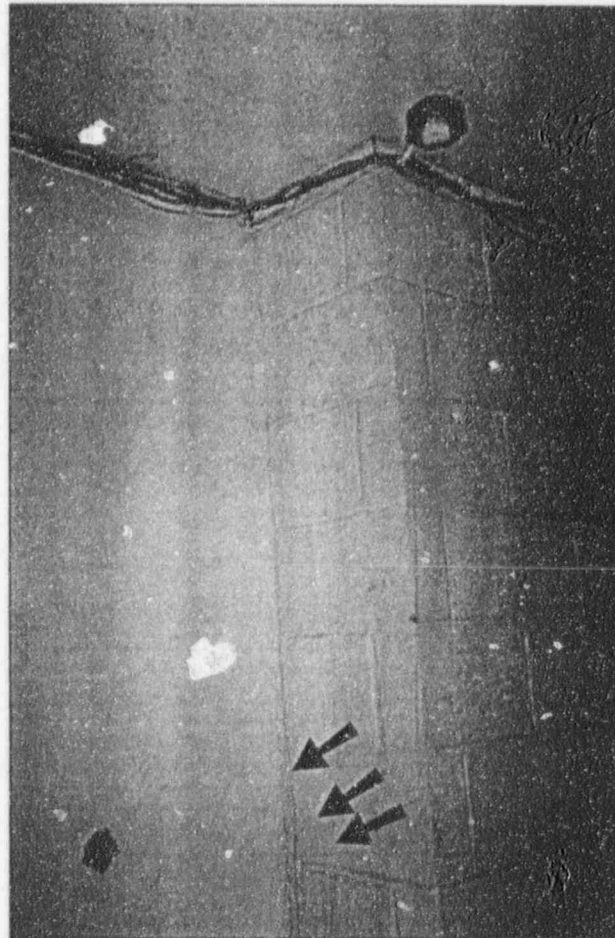
Figure A-3. No ceiling tile water damage but evidence of fluid on the wall

A second inspection was conducted on June 3 to determine the discrepancy. While no water damage was noted in the false ceiling, it was quite apparent that fluid had run down the wall as shown in Figure A-3.

5.3 RESPONSE: After discussing the potential source of the fluid with the operations manager and other staff, it became clear that most of the leaks had occurred as a result of equipment failures. For example, in the fall of 1995, a massive heat exchanger failed resulting in approximately 50 gallons of water being spilled into the equipment room which leaked

through to the first floor, as had previous leaks. In January 1995, a boiler leak occurred that caused leakage at the same location. Previous leaks caused the ~2 ft-by-2 ft ceiling plaster to fall from the false ceiling in this area. No one at the AMSLF knows the origin of the original leaks; however, most likely the leaks were caused by similar mechanical failures in the equipment room and possible roof leakage, especially since two major ventilation penetrations through the roof exist. However, it would take a serious roof leak to accumulate over 40 gallons of water.

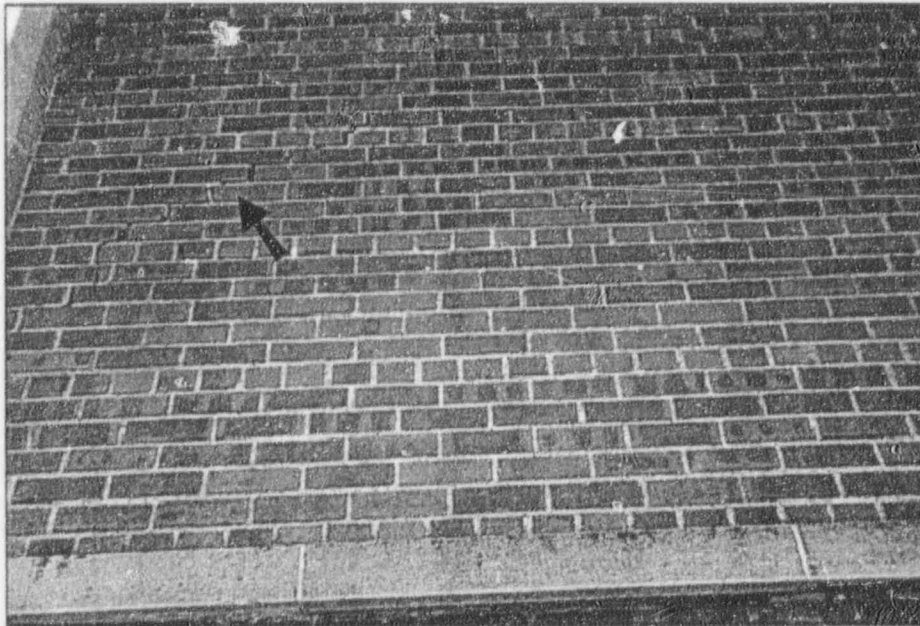
Figure A-4. Cracked southeast corner wall.

5.7 RESPONSE: As described in the NRC report, cracking does exist and is shown in Figure A-4. From the outside, the cracking appears to stop just short of the area where the second floor slab ties into the common wall brick. From inside the building below the second floor, it is evident that cracking does extend through the wall; however, it is not continuous, i.e., the cracking on the inside of the wall is almost an opposite pattern, as shown in Figure A-5.

Unfortunately, it is difficult to tell what actually caused cracking at the southeast corner of the building. As noted in the NRC report, the structural support of the 1958 building is a mix of load and non-load bearing masonry and concrete block, reinforced concrete, and steel framing. These materials are not compatible from an aging and expansion standpoint. In addition, the stiffness properties of the structure vary from extremely stiff (the test cell and radiography room) to very flexible (the lobby area). Thus, in a building over 30 years old with these types of similarities, one should expect to see cracking of this type; however, this cracking appears to have a unique cause. As noted in the NRC report,

MMI VI was only recorded in a radius of 10 miles of the epicenter. In addition, the directional motion of the seismic wave should have been in a southwest direction. The southeast corner of the building has moved perpendicular to that motion. Thus, this reviewer believes this damage is the result of a different loading mechanism.

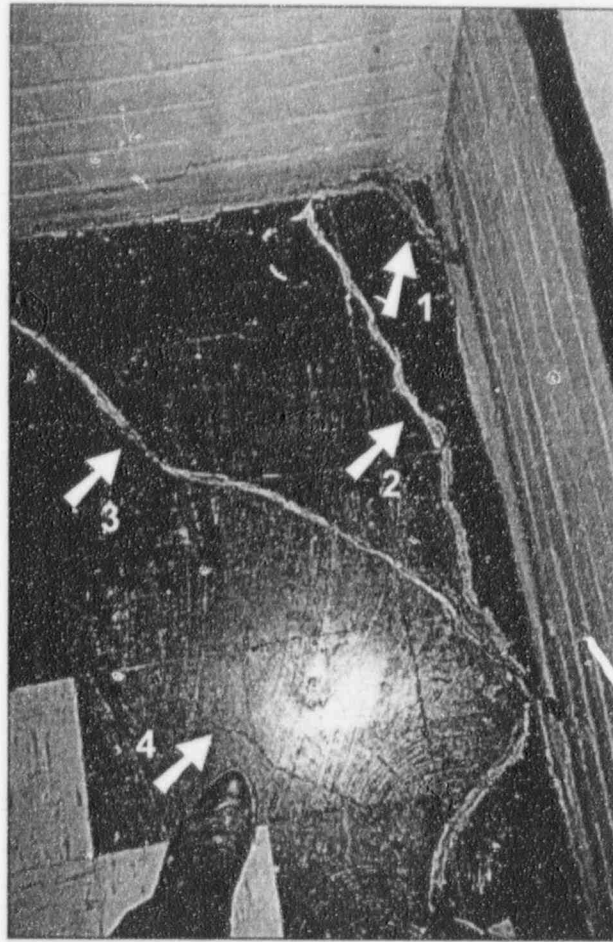
Figure A-6. Cracked second floor slab at southeast corner wall.

From inside the building above the second floor, the east and south walls in the corner show no cracking; however, as shown in Figure A-6, there are four cracks in the second floor slab that are visible to the human eye. One very large crack is nearest the corner, is at an approximate 45° angle to each wall, has a width of one-half inch, and has a length from wall to wall of about six inches. Based on the width of this crack, it must be assumed that the crack continues through to the slab edges underneath both the east and south walls. No reinforcing steel was found in this crack. A second crack runs almost parallel to the south wall, appears to cross the third crack, and then merges into the fourth crack. The third and fourth cracks are also at about a 45° angle to each wall. Based on the width of the crack nearest the corner, it appears that the southeast corner has moved southeast a distance of as much as $\frac{1}{2}$ to $\frac{3}{4}$ -inch. These floor cracks seem to indicate excessive bending moment in the floor slab at this corner, which would be indicative of significant settlement at the corner. Underneath the second floor slab, matching crack patterns were found. It was determined that the as-built dimension of the floor slab was six inches.

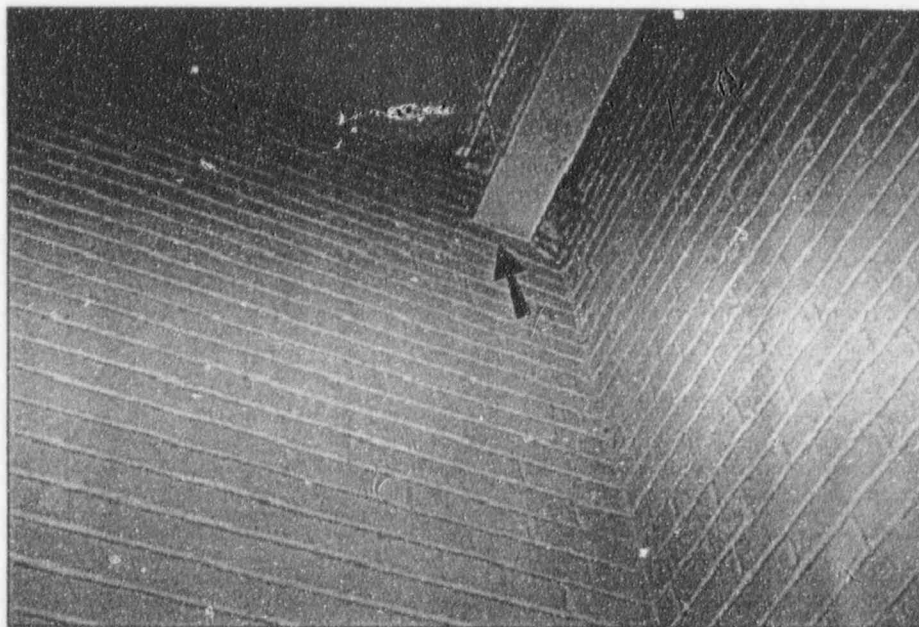
Figure A-7. Wall movement at purlin in corner.

5.13 RESPONSE: This movement appears to be approximately 1/4-inch as shown in Figure A-7. Although such movement may occur for a building having a mix of materials involving steel, concrete, and masonry as main structural elements, this movement must be attributed to the corner moving to the southeast at the second floor. According to Dwg. S-1, all beams bearing on the masonry wall have wall anchors. These anchors are two angles, 6 inches by 4 inches by 3/8 inch. Thus, the wall anchor should be holding the common masonry wall from moving further eastward at the top. No sign of distress in the veneer

wall was noted from the outside, however, some cracking was noted in the load bearing wall beneath the purlin.

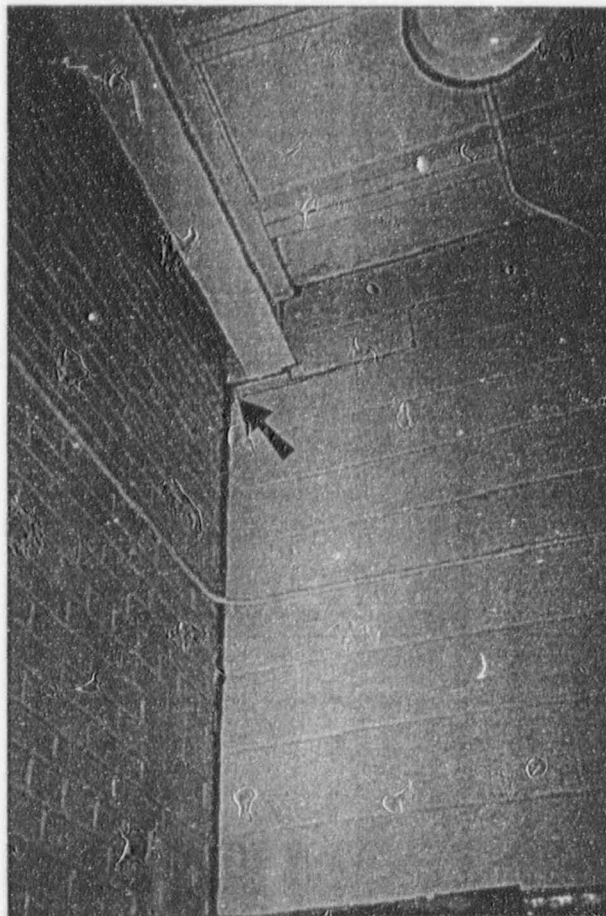
Figure A-8. Purlin and Wall Movement.

5.14 RESPONSE: It is the opinion of the reviewer that this movement has nothing to do with what has happened at the southeast corner of the building. The biggest problem with the construction of this building is that none of the interior non-load bearing walls were interlocked or tied in with any of the structural members, and most of the non-load bearing walls have separated leaving visible cracks from adjoining walls. The location of the cracking in question is shown in Figure A-8 and, as indicated in the NRC report, the crack opening is approximately one inch. This wall is the west side of a right angle interior wall forming a small room in the southeast corner. If the north side of the interior wall is compared to the paint lines on the roof decking, it is evident that the entire top of the non-load bearing wall has moved northward about one inch. There is no evidence that the purlin has moved southward at this location.

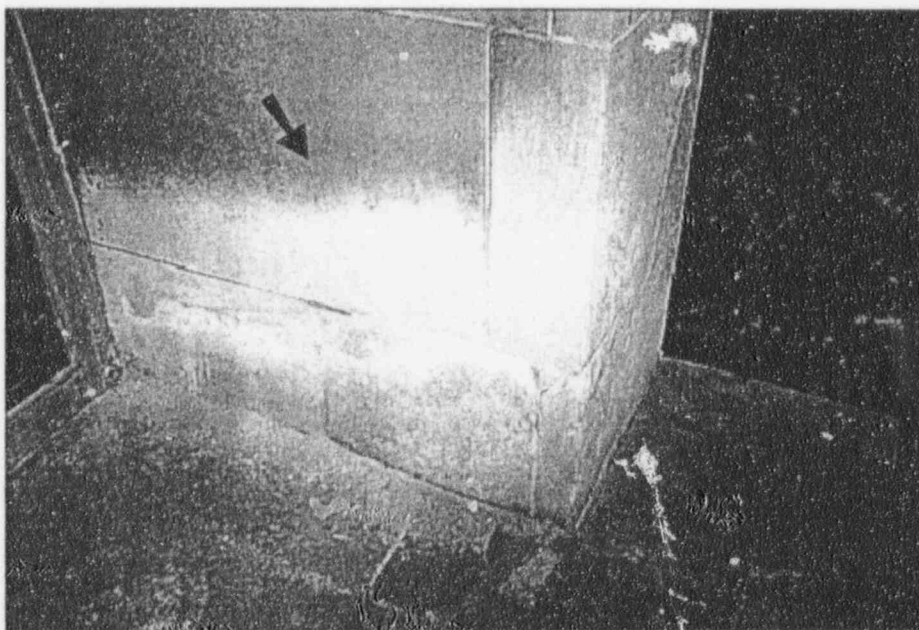
Figure A-9. Lobby stone showing salting.

5.16 RESPONSE: It is believed that the failure of the stone corner at the bottom of the wall has resulted from a totally different cause, but may have something to do with the in-filled wall movement at the second floor. This stone corner is located next to the lobby entrance of the 1958 building. Upon inspection of the site, it is very apparent that the joint failure of the mortar has been caused by salting the lobby entrance to remove snow and ice. The stone facing is discolored where the salt was thrown as shown in Figure A-9, and where discoloration has occurred, mortar in the joint was attacked. At a distance of approximately one foot north of the south corner of the stone, there is no stone discoloration and the joint is intact. As a result of joint failure, the stone has fractured. Again this is a life-safety issue and has no bearing on the structural stability of the 1958 building.

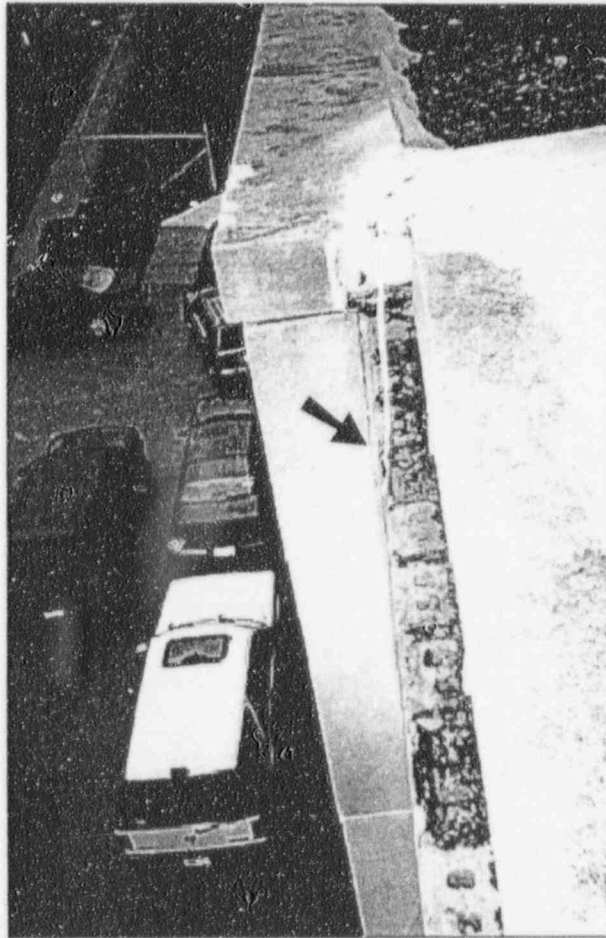
Figure A-10. 1963 building parapet.

5.17 RESPONSE: While there is significant distortion of the stone coping on the parapet of the 1963 building as shown in Figure A-10, with the 1958 building parapet being in the background, this distortion is not believed to be associated with Concerns 5.15 or 5.16 discussed above. Rather, it is believed to have been caused possibly by a crane or crane-like piece of equipment placing workers or equipment on the roof. The movements of the stone coping of the 1963 building do not relate to the movements that have occurred at the northeast corner of the 1958 building.
