U.S. NUCLEAR REGULATORY COMMISSION
REGION I

Report No. 30-16028/85-01
Docket No. 30-16028
License No. 18-19078-01 Priority I Category CI
Licensee: Quality Assurance Laboratories, Inc.
80 Pleasant Avenue
South Portland Maine 04106
Facility Name: Quality Assurance Laboratories, Inc.
Inspection At: South Portland, Maine
Inspection Conducted: October 4 and 7, 1985
Inspector: Thomas K. Thompson 11/4/85
Thomas K. Thompson, Health Physicist date
Approved by: John E. Glenn 11/4/85
John E. Glenn, Chief date
Nuclear Materials Safety Section B

Inspection Summary: Routine, unannounced inspection of the radiation safety program on October 4 and 7, 1985 (Report No. 30-16028/85-01)

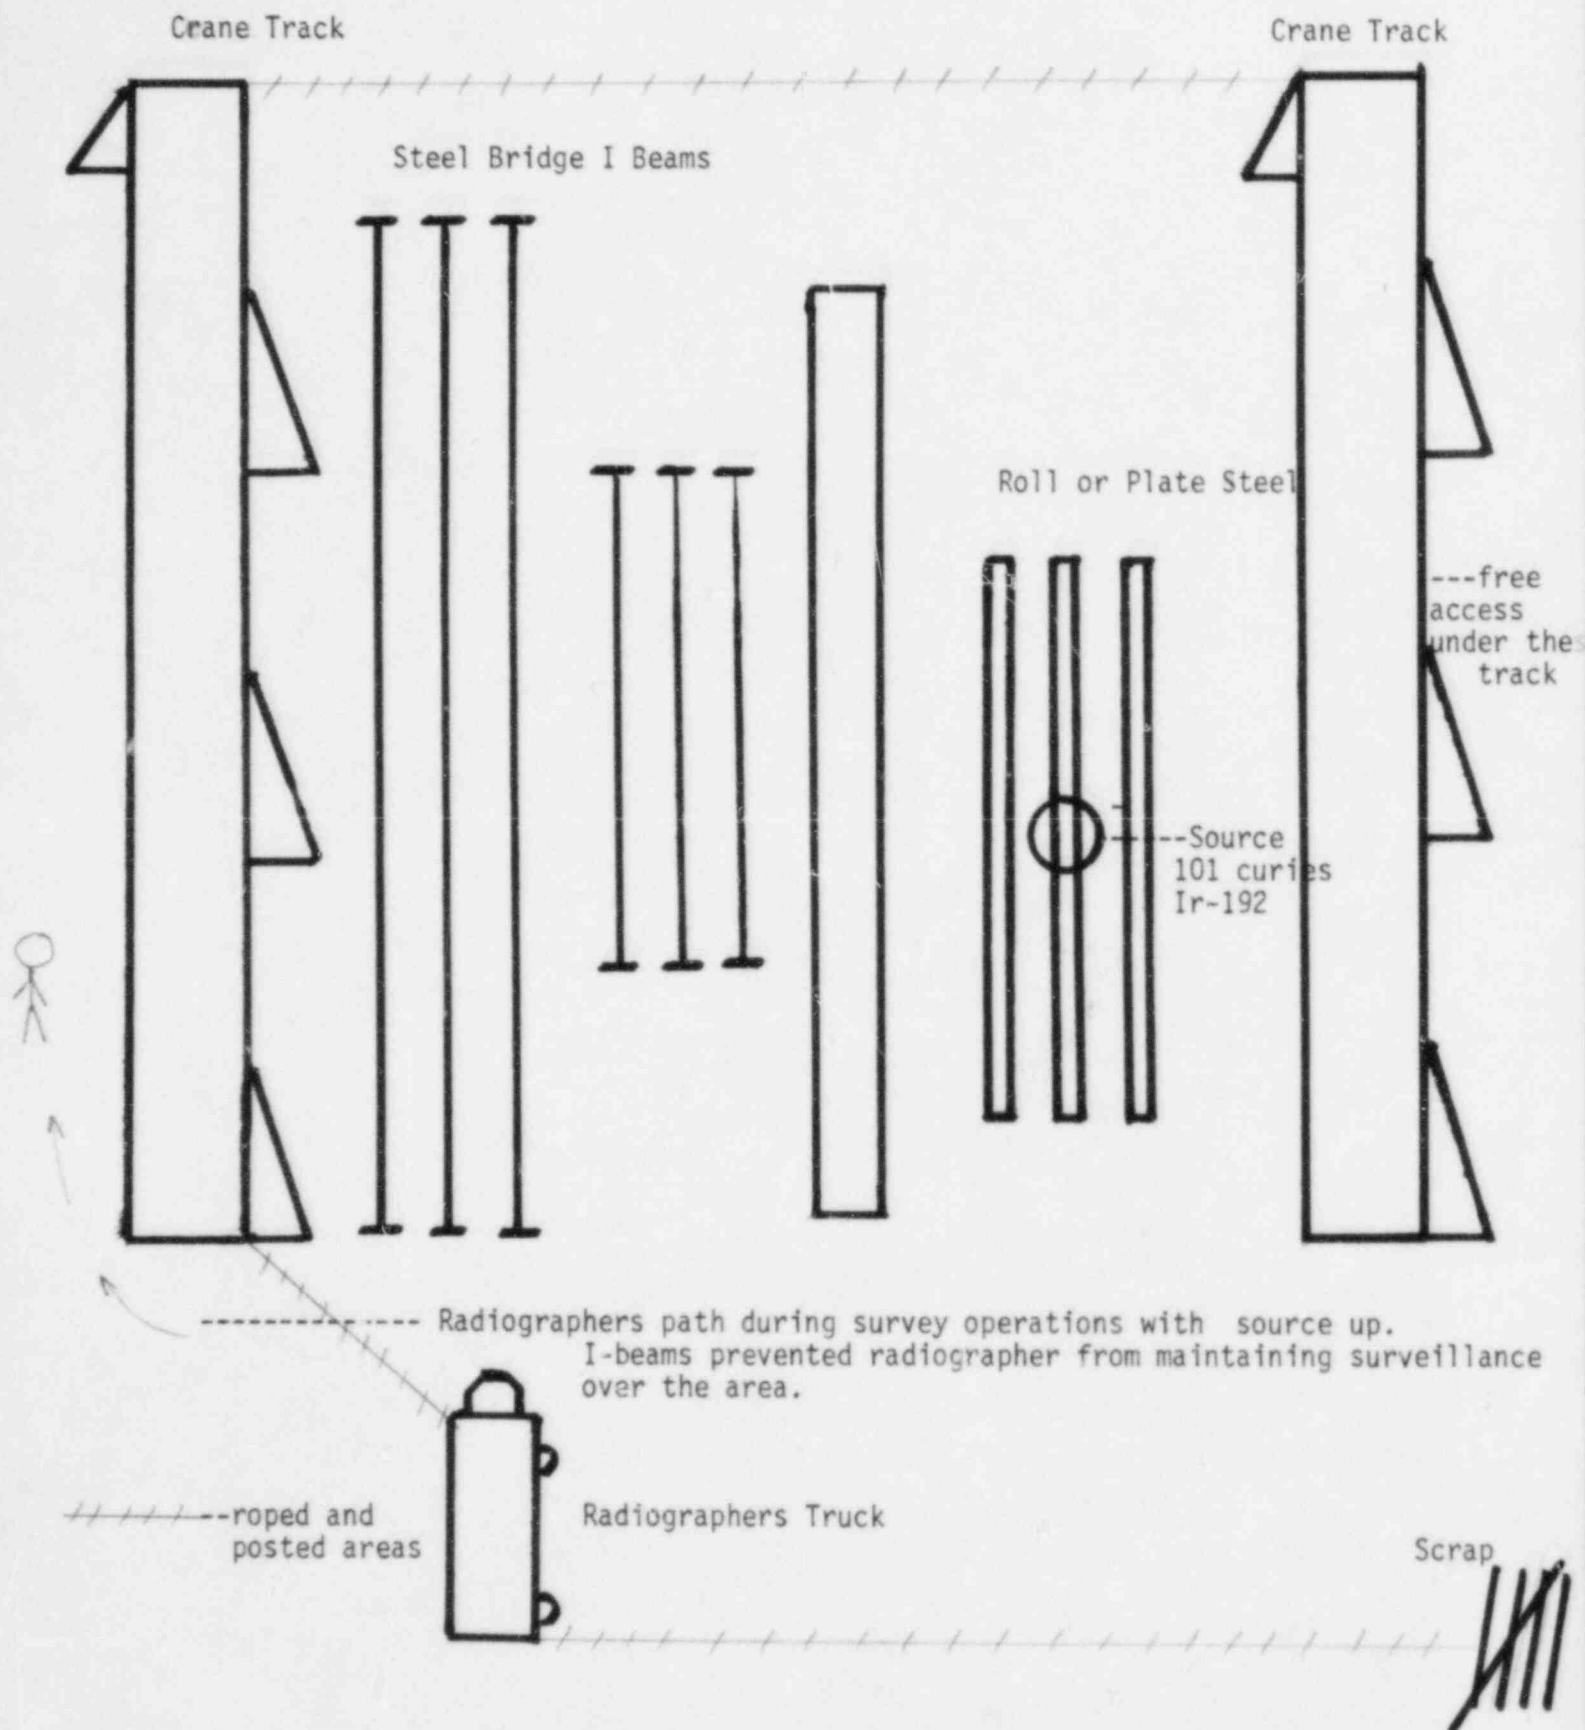
Field Site (Bancroft-Martin Yard) on 10/4/85

- a. The radiographer failed to rope off or otherwise provide a continuous barrier with conspicuous postings on one side of the restricted area (leaving an opening of approximately 50 feet or more).

The inspector noted that during radiographic operations a non-licensee employee walked toward the open, unroped area. The radiographer returned the source to the shielded position prior to the employee gaining access to the radiation area. The inspector discussed with the radiographer the inadequacy of the barriers and postings as evidenced by the individual who walked toward the radiation area with little hesitation. The radiographer stated that he did not have sufficient rope to place around the entire restricted area.

The failure to conspicuously post a high radiation area is an apparent violation of 10 CFR 20.203(c).

The inspector observed that a radiographer did not maintain continuous surveillance over the high radiation area at the Bancroft-Martin field site. The radiographer walked behind a set of crane tracks adjacent to several large I-beams during the process of performing a survey of the area with the source exposed. (See attached Enclosure 1.) He was out of view of the exposed source for several seconds and, therefore, unable to maintain direct visual surveillance of the high radiation area.

The failure to maintain direct surveillance of the radiographic operation to protect against unauthorized entry into a high radiation area is an apparent violation of 10 CFR 34.41.

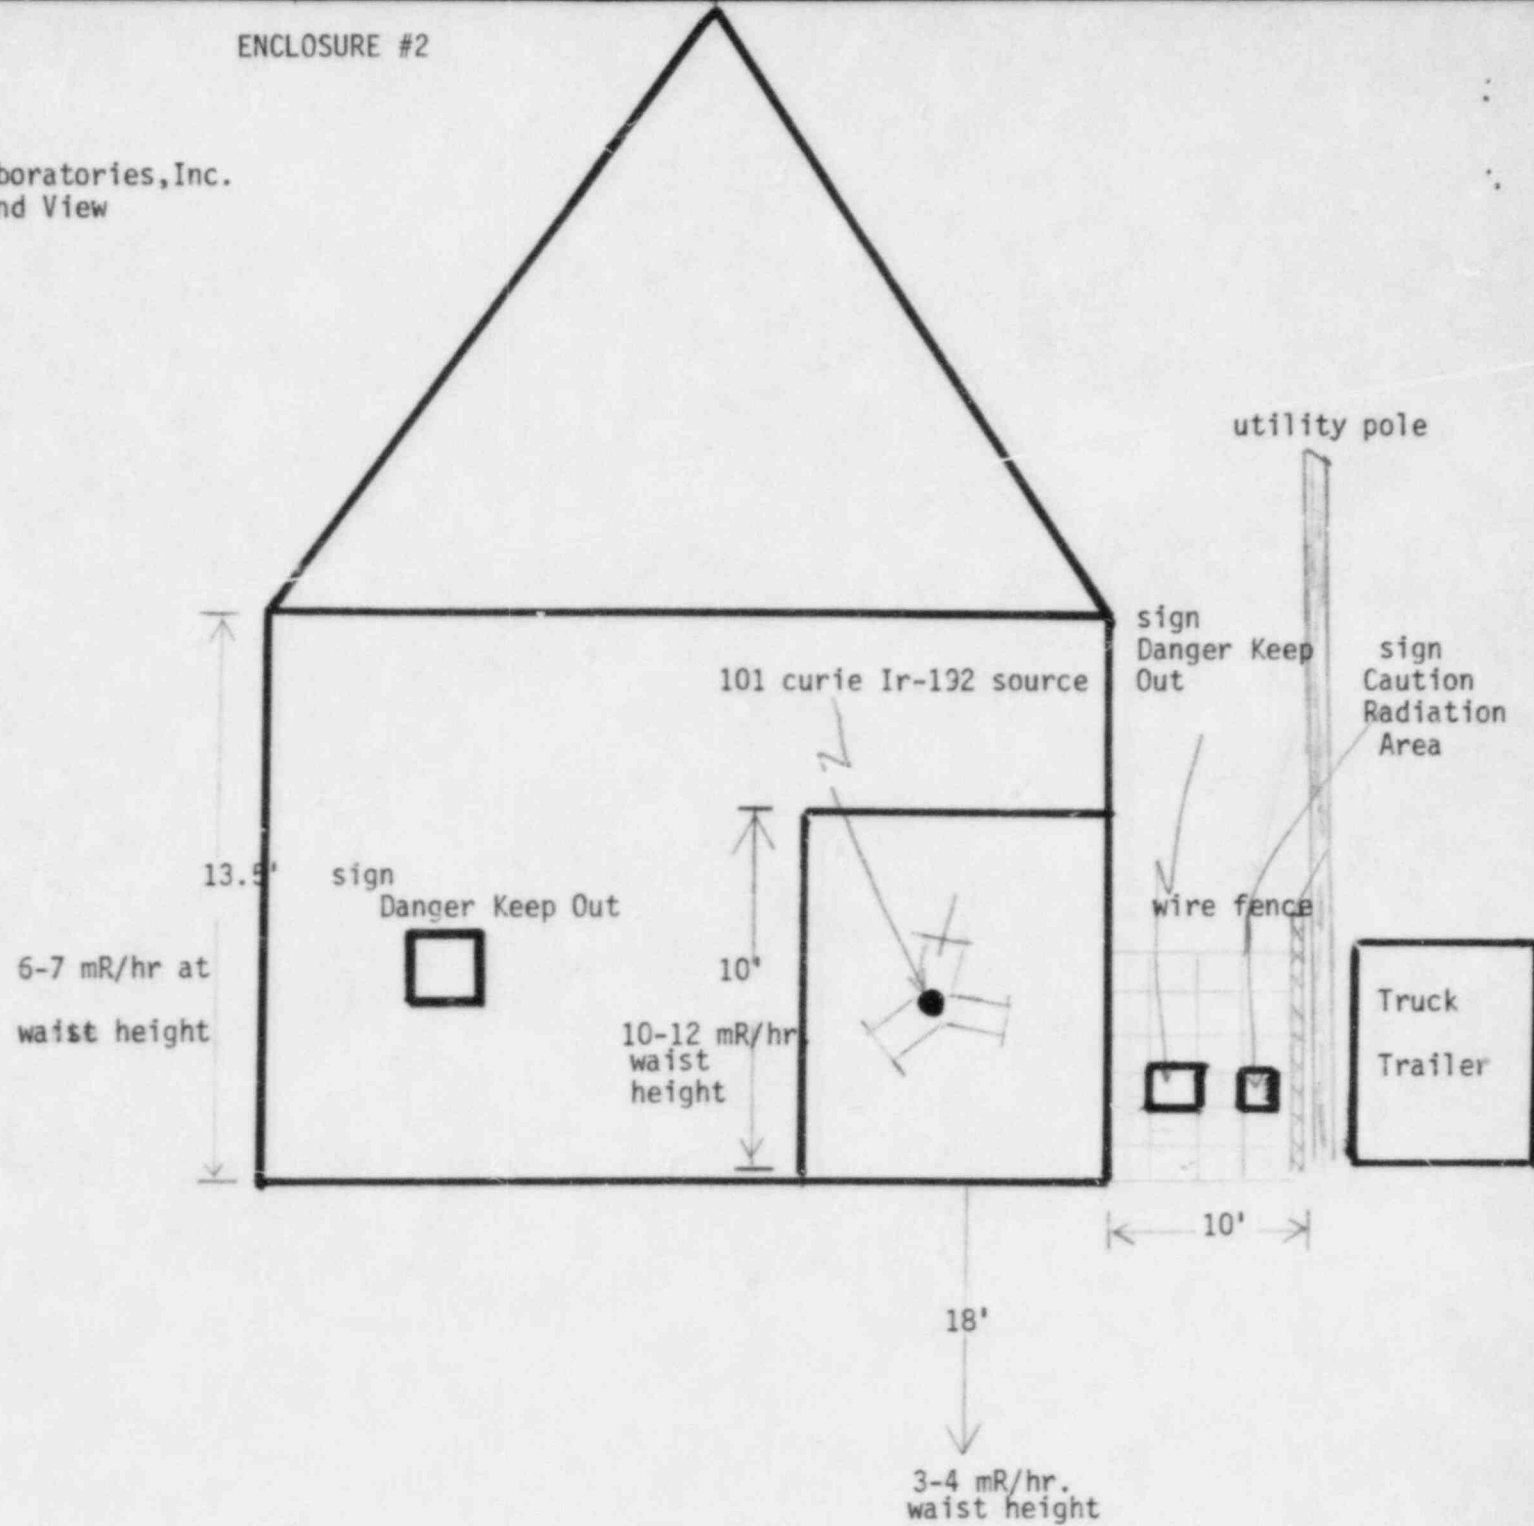
ENCLOSURE #2

The Radiation Safety Officer stated that panoramic, uncollimated radiography operations were performed weekly. The inspector asked the licensee's President what the radiation levels were outside the facility, on the roof, adjacent utility pole and on top of a nearby truck trailer. The President stated that he was unaware of the radiation levels at these locations. The roof of this facility is unshielded, approximately 13'6" high. There is a utility pole 10' from the radiography cell wall which extends approximately 6' above the roof line (see Enclosure 2). There is also a truck trailer approximately 11' from the cell wall with several piles of ladders nearby.

The failure to perform an adequate survey to demonstrate compliance with 10 CFR 20.105(b) is an apparent violation of 10 CFR 20.201.

The inspector made measurements of radiation levels around the permanent facility on October 7, 1985, during the use of an uncollimated 101-curie Ir-192 source placed inside a large steel casting, a similar configuration to that utilized the week before during normal cell use. Enclosure 2 indicates the NRC values measured with an Eberline E-120 instrument described in Section 9 of this report. The licensee's radiographer stated that the exposure time for this particular shot was short enough that 2 mR in any one hour would not be exceeded outside the facility walls. The NRC measurements confirmed this premise.
