Re: Reportable Occurrence: Tech Spec Violation
License R-2, Docket No. 50-005, letter of December 20, 1996

Addendum to Reportable Event Letter of December 20, 1996

On December 16, 1996 the Penn State Breazeale Reactor operated in violation of a Technical Specification (TS) requirement. The reactor was operated at 100 watts steady state and subsequently pulsed (\$2.75). It was discovered after the pulse that the fuel temperature safety channel was inoperative during the steady state condition and during the pulse. The other safety channels, linear power, and percent power, were operational during the steady state operation. The reactor's negative temperature coefficient and the TS limit for pulse magnitude are the dominate safety features during a pulse. Even though the fuel temperature safety channel trip is ineffective at protecting the core during a pulse, it is required by TS. It is also a TS requirement that the peak fuel temperature be recorded during a pulse. During the operation prior to the pulse #6659, TS Sections 3.2.3 and 3.2.4 were violated. During pulse #6659, sections 3.2.3, 3.2.4 and 4.2.3e were violated.

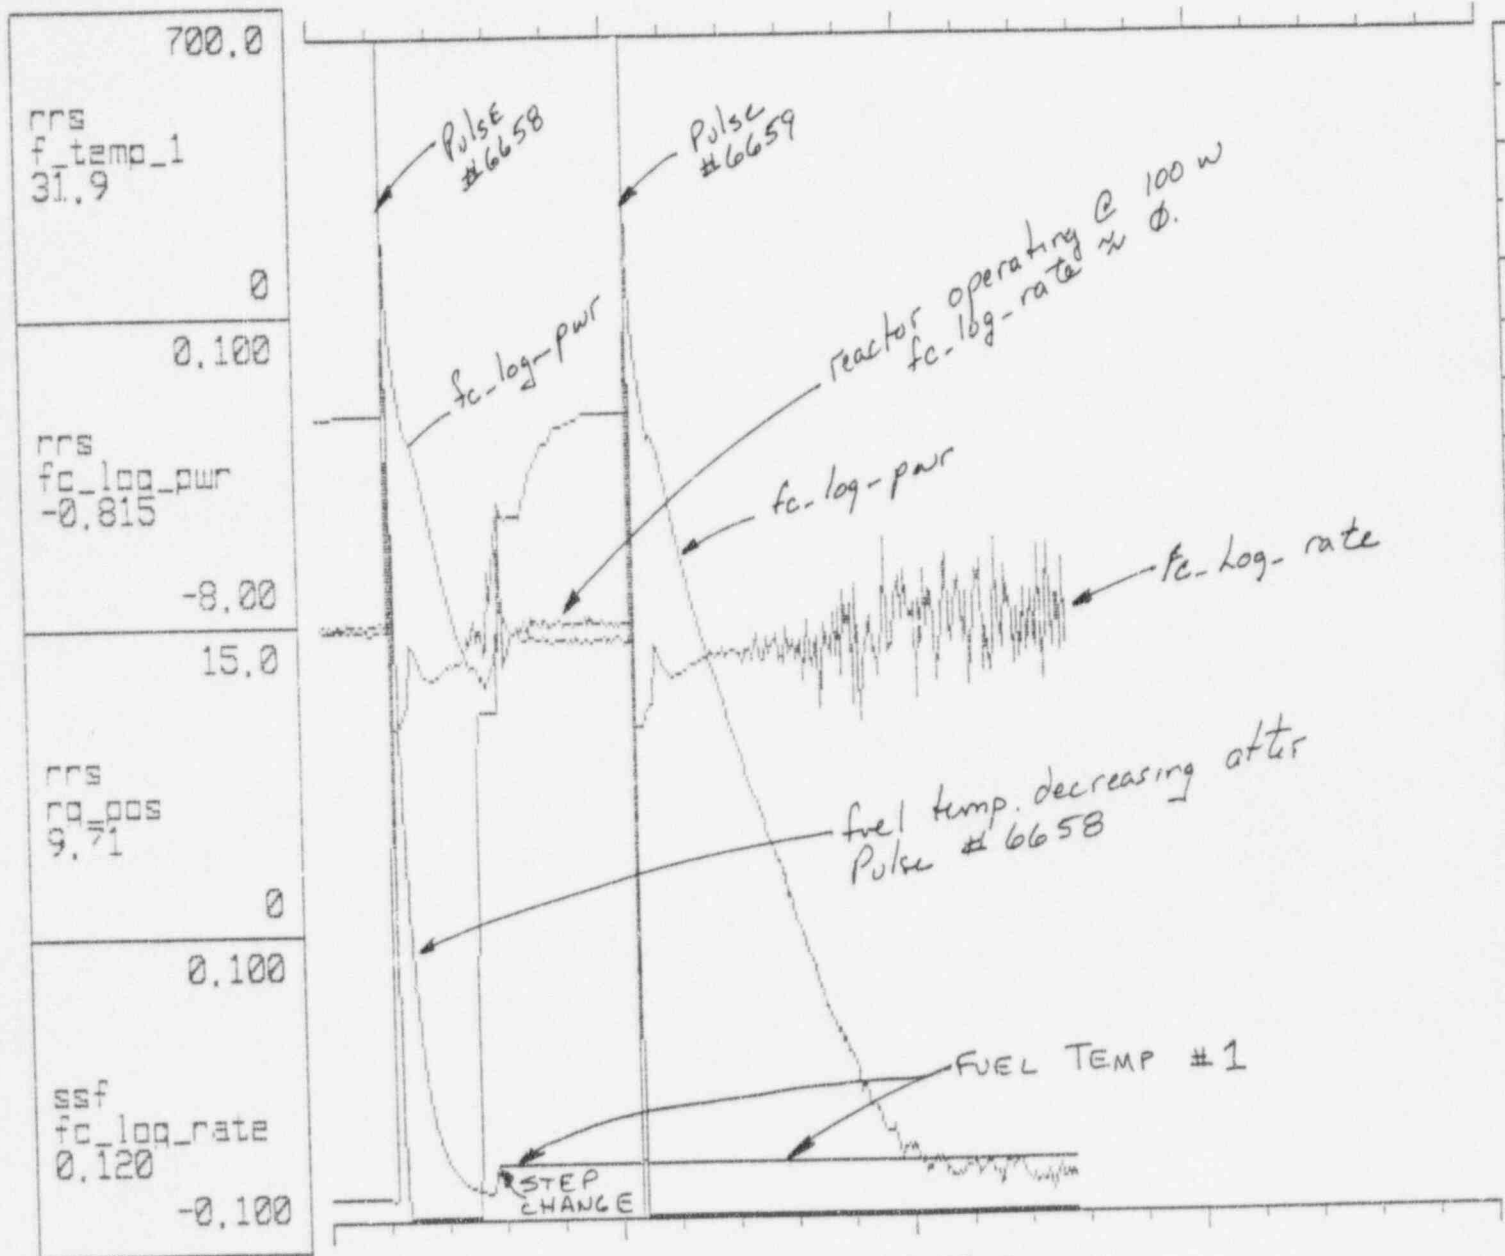
Data 96 Dec 16 19:57:29.13 Set name =neg_temp Update Period = 9.64 sec

Immediately a comprehensive evaluation of this event was undertaken. Attachment 1 documents the fuel temperature before, during and after pulse #6659. This trend clearly shows the fuel temperature step change just prior to operating the reactor at 100 watts and returning to normal some 53 minutes later. Attachment's 2 and 3 show the data acquired during pulses #6658 and #6659. After reviewing data from the Local Area Network (LAN) system, the DCC-Z message log, the trends printed by the staff immediately after the event, and reviewing the event with the experimenter, we were able to reconstruct the timetable above. Between pulses #6658 and #6659 the experimenter increased the experimental probe excitation from +15 volts to +20 volts, this caused the initial step change in the fuel temperatures. After the event had taken place and the reactor was secured, the experimenter turned his equipment off for the night. This resulted in the fuel temperatures returning to their normal readings. During the investigation the following key steps were completed:

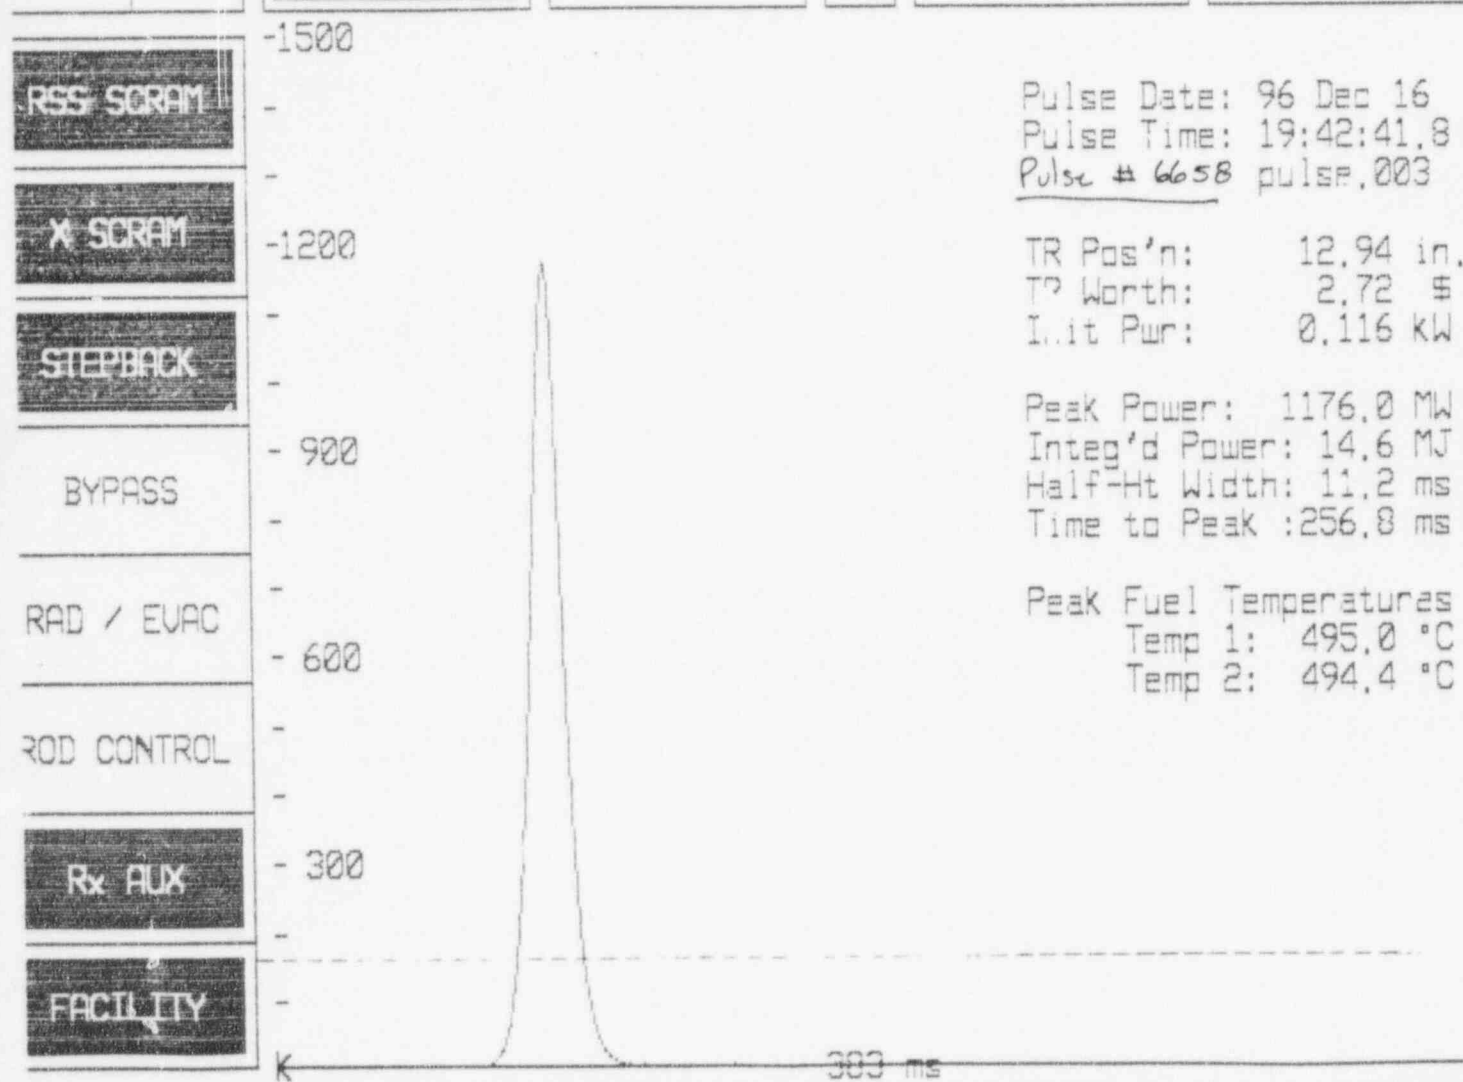
Attached are trends of pulse #6658, pulse #6659 and a time trend showing reactor power, and reactor fuel temperature during pulses #6658 and #6659.

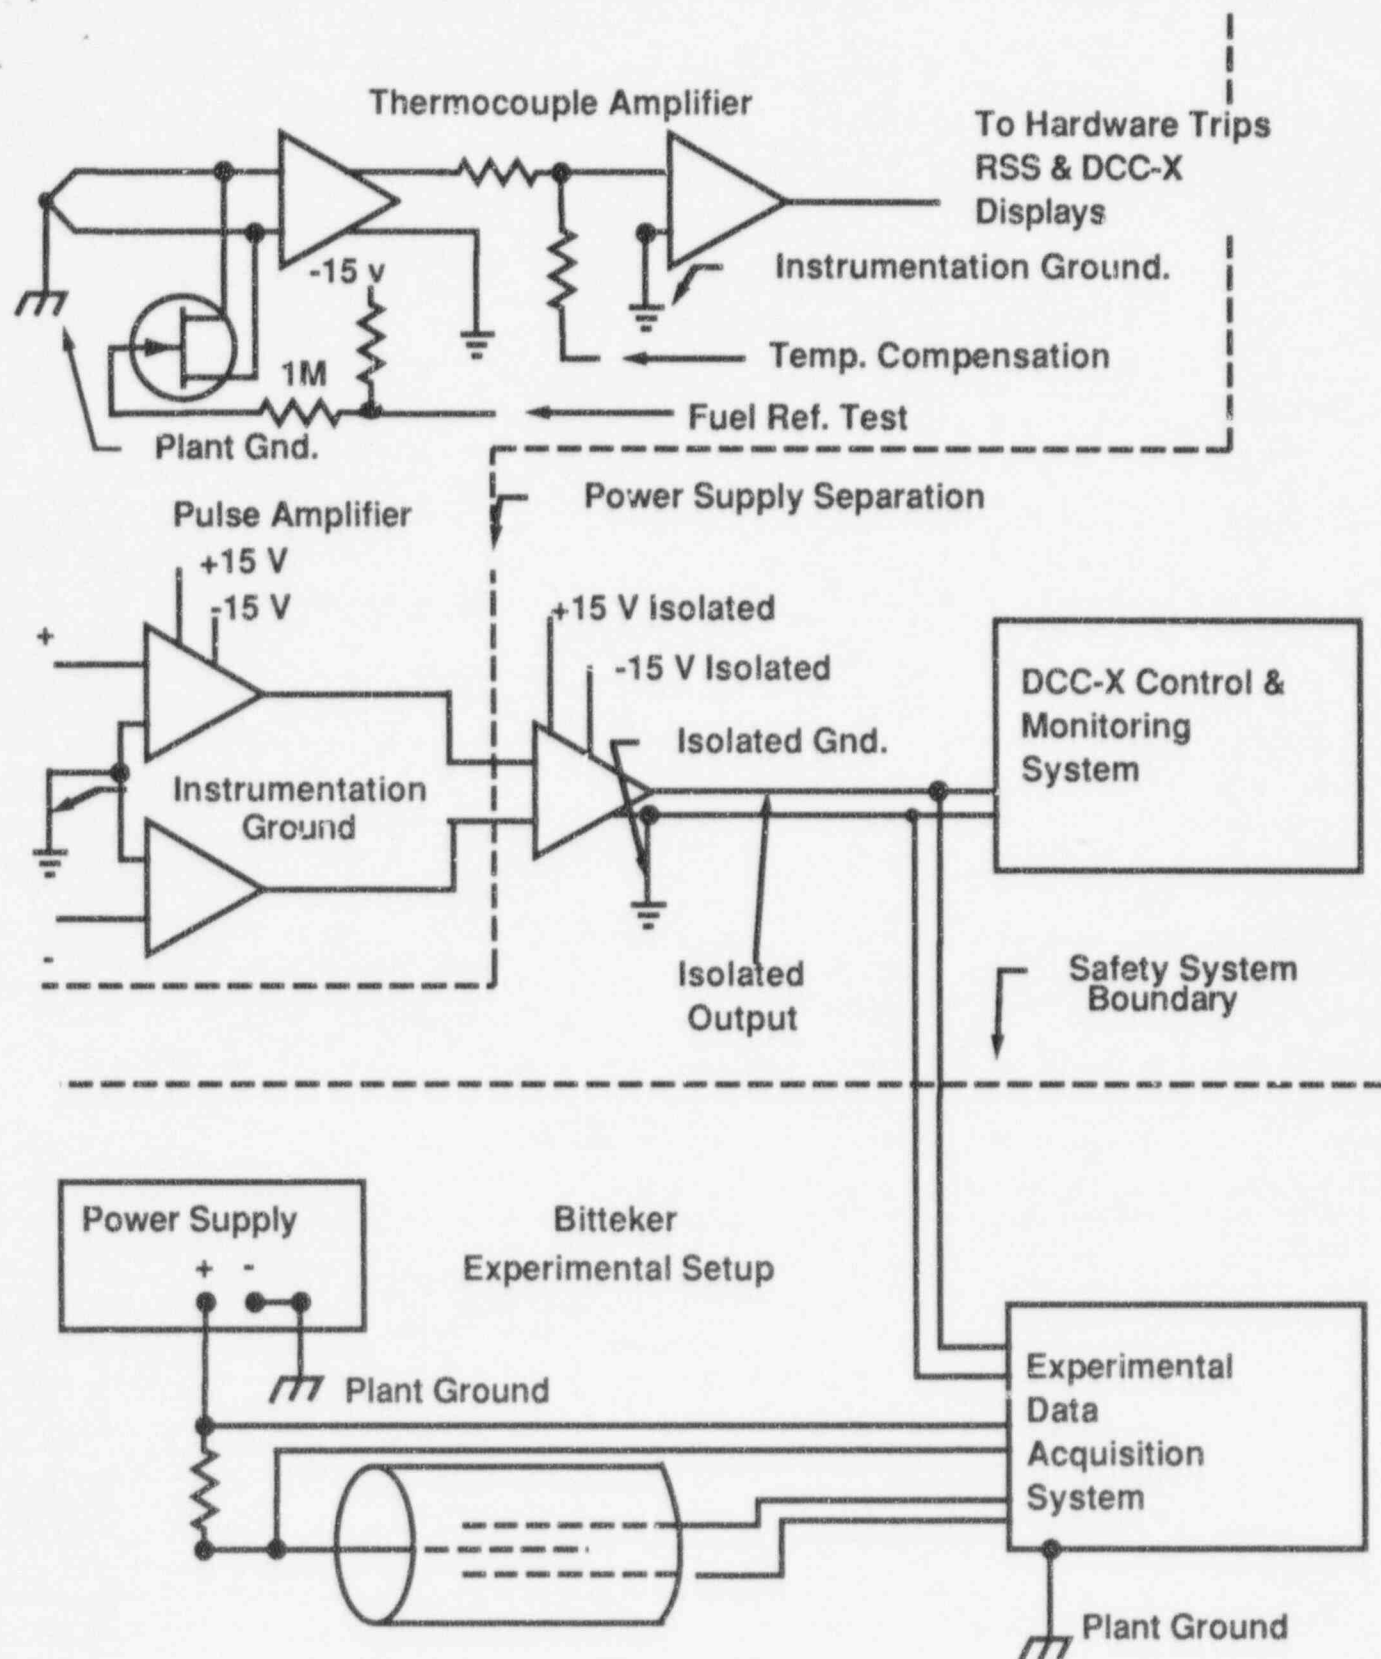
Figure 1

The -10 volt potential measured on both sides of the thermocouples with respect to instrument ground is key to the analysis of why the thermocouples were non-operative during the steady state operation and did not respond to the pulse. Referring to Figure 1, the main components of the thermocouple amplifier circuit are the thermocouple, diode protection, JFET, instrumentation amplifier and the temperature compensation. The thermocouple input is connected between R1 and R2 and R6 and R7 which provides bias current for the amplifier and a substitute voltage if the thermocouple opens or is disconnected. This substitute voltage provides an input to the amplifier that generates an output indication of greater than 1200° C. Zener diodes CR1- CR4, provide over voltage protection for the input of the amplifier. The JFET is normally held off by holding the gate to source differential voltage to approximately -13 volts. When the gate is pulled to ground by a test switch, the differential gate to source voltage becomes approximately 0 volts turning the JFET on. This shorts the thermocouple inputs together; activating the test switch Fuel 1 Ref. or Fuel 2 Ref. also generates a non-operate condition which causes a reactor trip. When the thermocouple inputs are shorted the output of the thermocouple amplifier indicates the temperature of the compensation circuit. Due to the -10 volt potential being applied to the thermocouple junction the JFET was turned on. It was turned on by decreasing the gate to source voltage to approximately -3 volts. Turning on the JFET shorted the thermocouple inputs together. This does not generate a non-operate condition because the test switch was not activated and therefore did not trip the reactor. Shorting the inputs together forced the output of the amplifier to approximately 30 °C, which was the temperature indication of the temperature compensation circuit. Additionally when these inputs are shorted, they cannot respond to any temperature change in the fuel. This resulted in a non-operative thermocouple during the steady state operation and pulse #6659 since the circuit could not respond to the temperature of the instrumented element. Therefore the fuel temperature safety circuit was inoperative.
