**RESPONSE TO FREEDOM OF
INFORMATION ACT (FOIA) REQUEST****JIA - 96-351**

**NRC Question/Response ton/Response Tracking Form 93-81
Request for Failed Parts Listing for Relay Driver Board WSN-0133**

ROD CONTROL SYSTEM - FAILED COMPONENTS STATUS

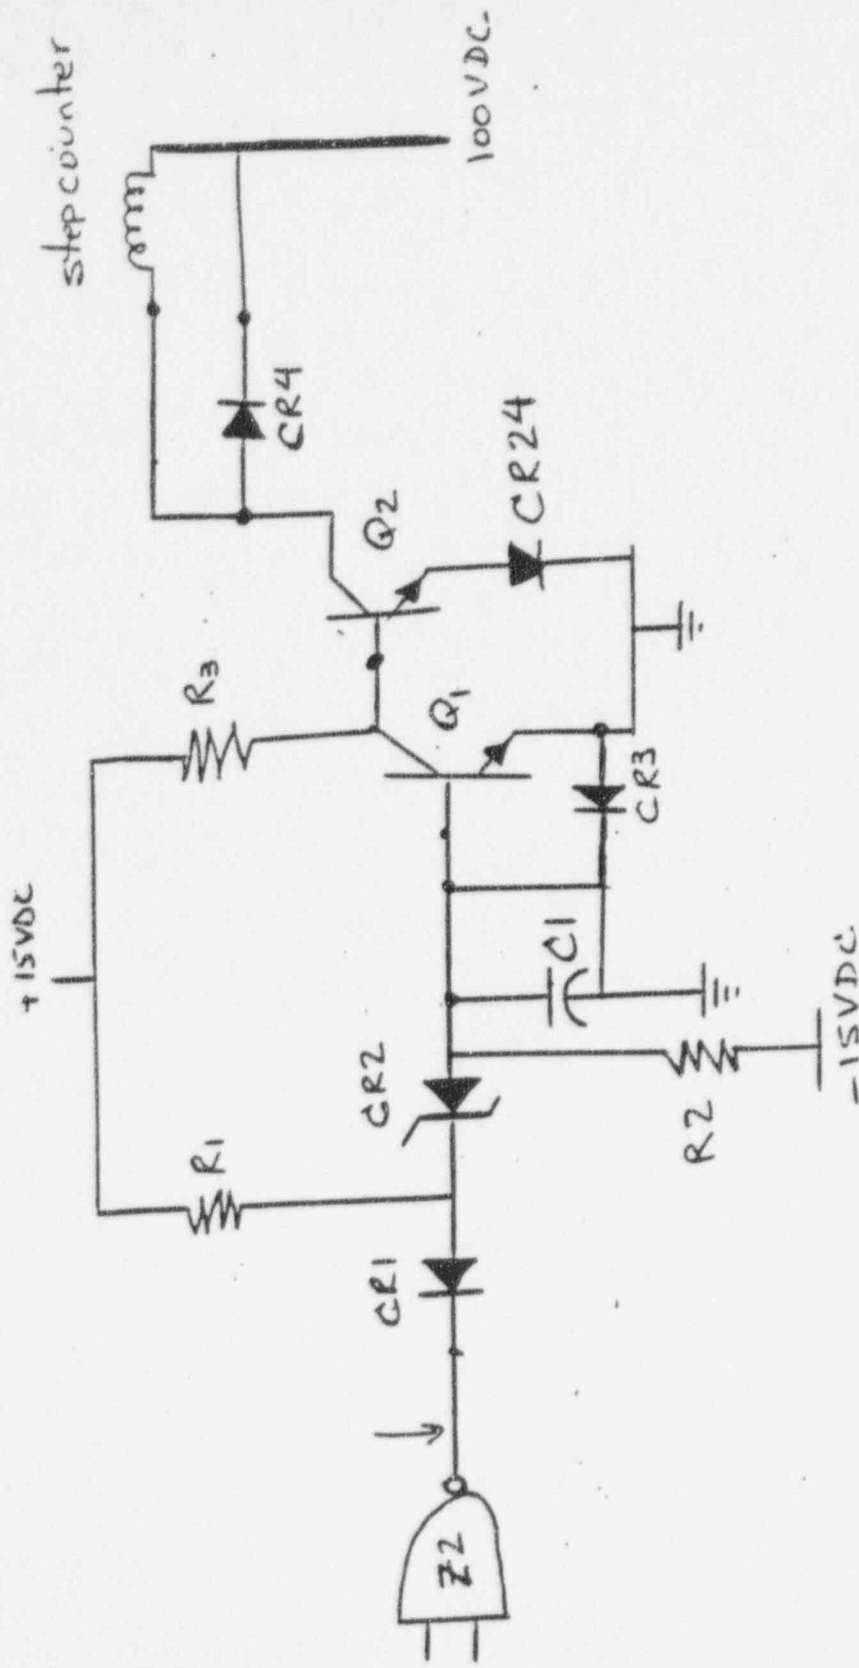
Fig 1

100VDC was shorted to -15VDC through
circuit components failures (Fig 1)

In order for 100VDC short to -15VDC through compo-
nents on relay driver cards be a valid assumption
the following components need to be failed as short:
 Q_2 transistor having collector to base shorted
and Q_1 transistor - at the same time must have
collector to base shorted too. When such event
takes place, the R2 resistor at the -15VDC will
limit the current flow to -15VDC from 100VDC.

Based on event scenario and recorded information, possibility of 100VDC & -15VDC short circuited through any parts of the circuits is extremely low and indications are hard to miss. Therefore there must be an external element to 100VDC and -15VDC short circuit theory.

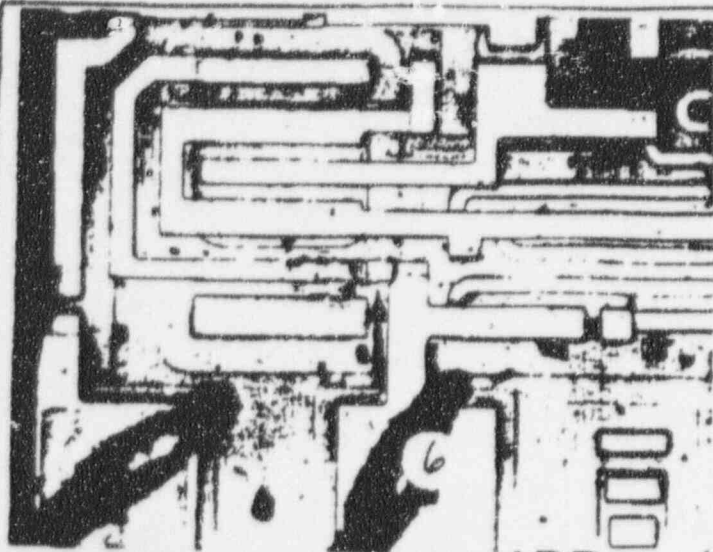
FIG. 1
S/N 12 PAD 6
ELECTRICAL OVERSTRESS

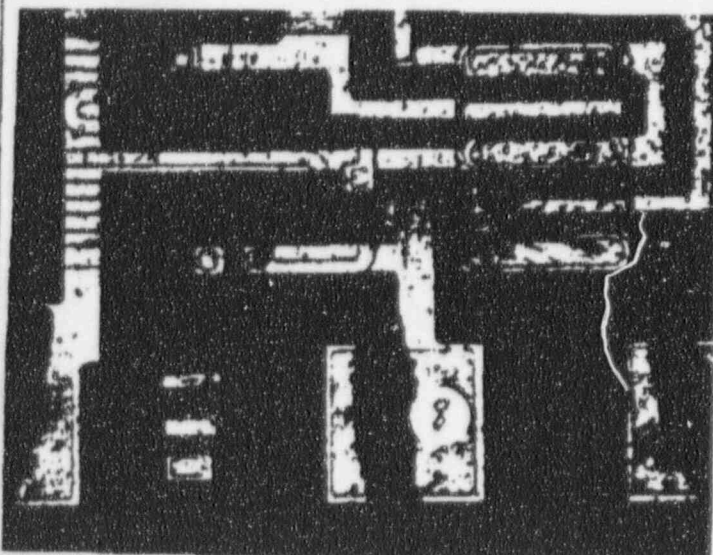
FIG. 2
S/N 12 Pad 8
ELECTRICAL OVERSTRESS

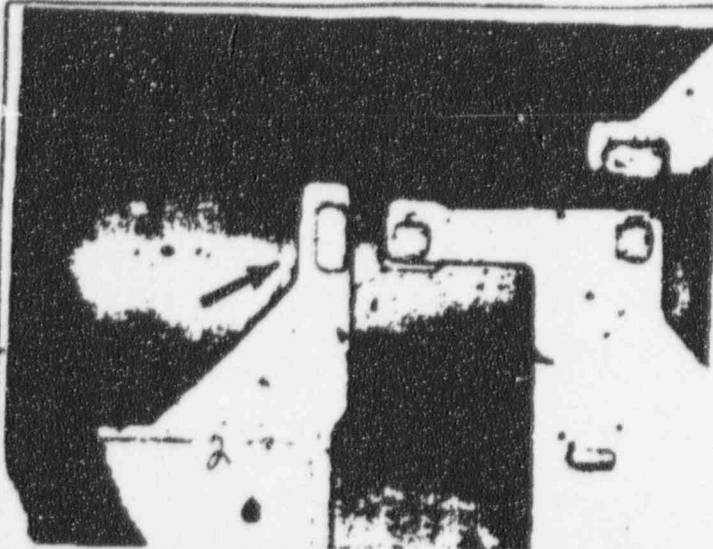
FIG. 4
S/N 11 PAD 2

INDICATIONS OF ELECTRICAL
OVERSTRESS DUE TO ESD

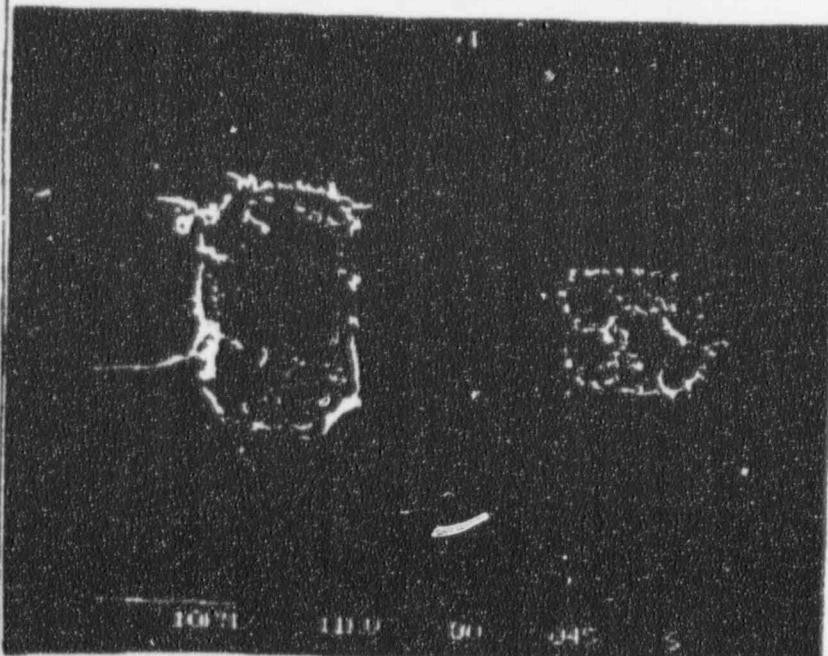
FIG. 6
S/N 11

AFTER DEPROCESSING
TO SILICON, SEM
EXAMINATION SHOWS
THE OVERSTRESS.

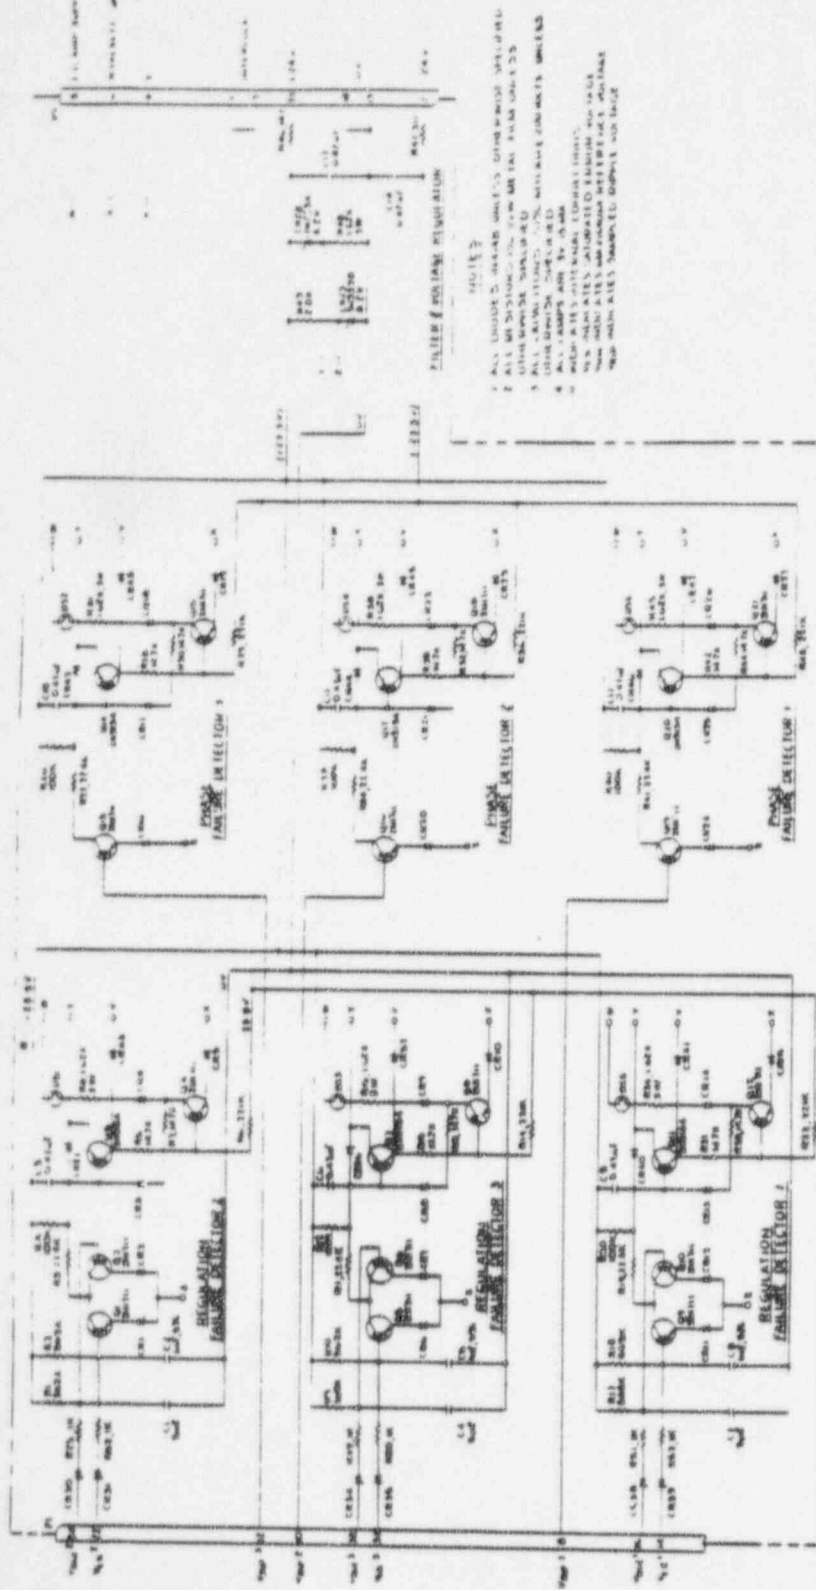
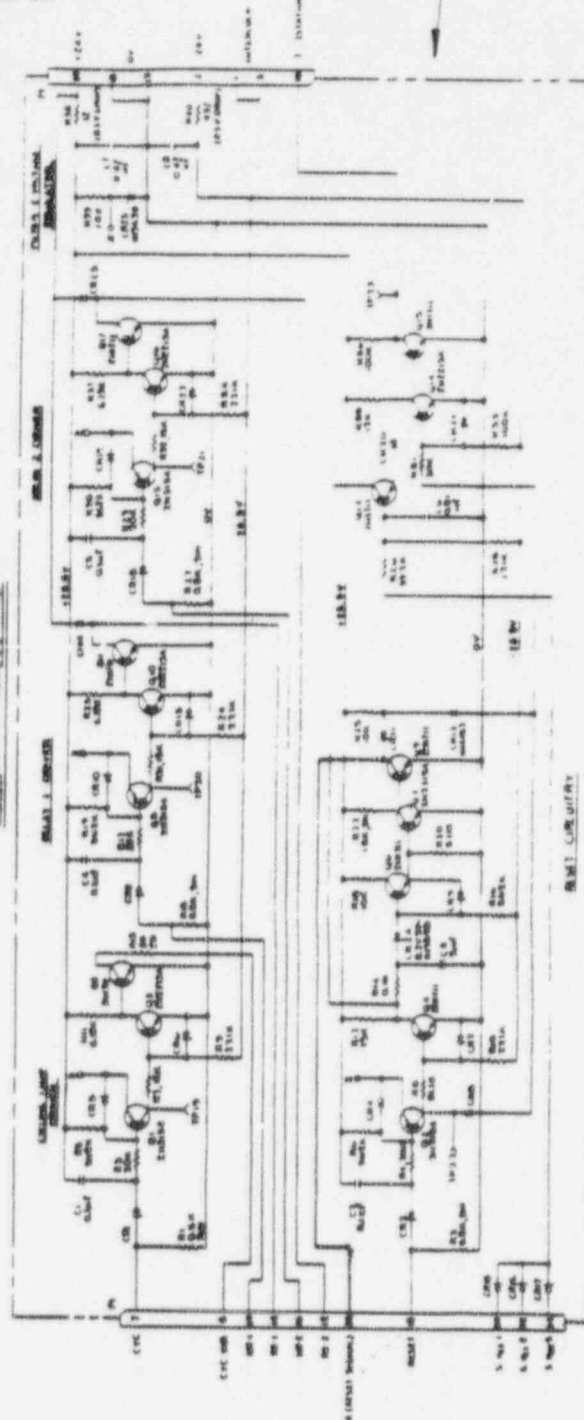
2. PIN 6 OF
MATING FELD
CONNECTOR IS
WIRED TO
PIN 26 OF
SIGNALING
PROCESS CARD
SHOWN BELOW.
JUMPERING OF PIN:
5 AND 6 ON
FAILURE DETECT
CARD APPLIES
+24VDC DIRECTLY
TO THE COLLECTOR
OF Q9 ON THE
SIGNALING PROCESS
CARD.

FAILED Qq LOCATED
ON THIS CARD

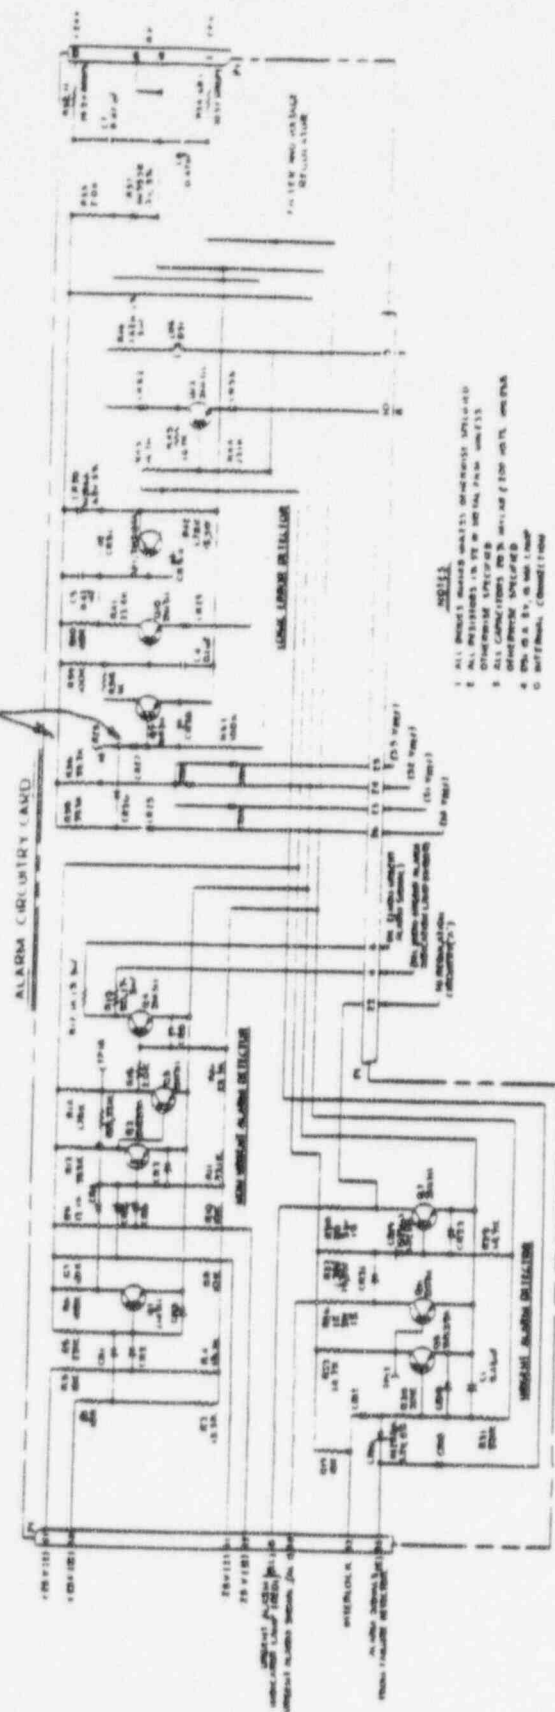
SHORTING OF TWO TRACES
DESCRIBED IN TEXT JUMPERS
+24VDC TO THE ANODE OF CR27
(WHICH IS THE JUNCTION OF CR25, CR26, & CR27)
