**Oyster Creek Core Spray System  
Inspection Program - 16R**

**Topical Report No. TR-110  
Project No. 328382**

OYSTER CREEK CORE SPRAY SPARGER SYSTEM  
INSPECTION PROGRAM

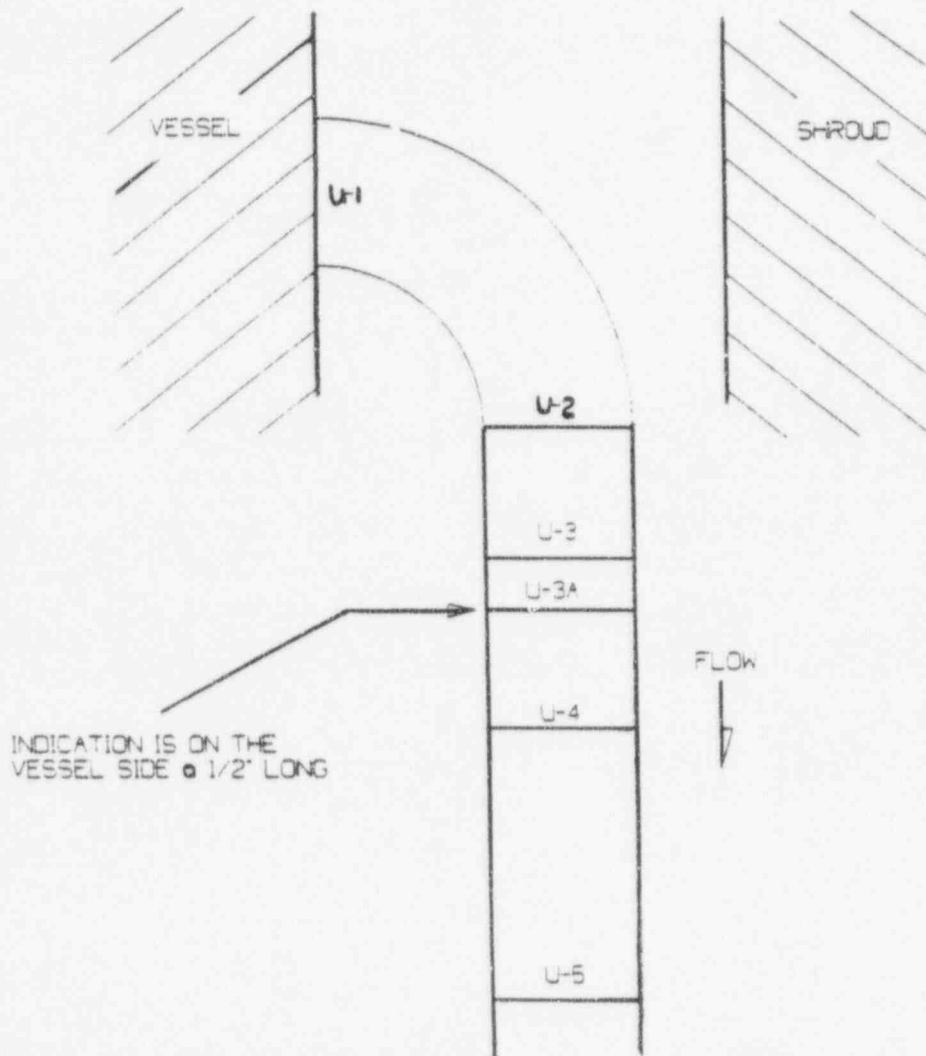
FIGURE 6

- ☐ Two linear indications originally observed during outage 14R in the annulus piping in system II, weld U-3A appear to be a weld past between 2 beads, as determined after cleaning. No changes and no air bubbles were observed emanating from this location during the air test.

CORE SPRAY PIPING WELD IDS  
LEAKER AT WELD L-3A

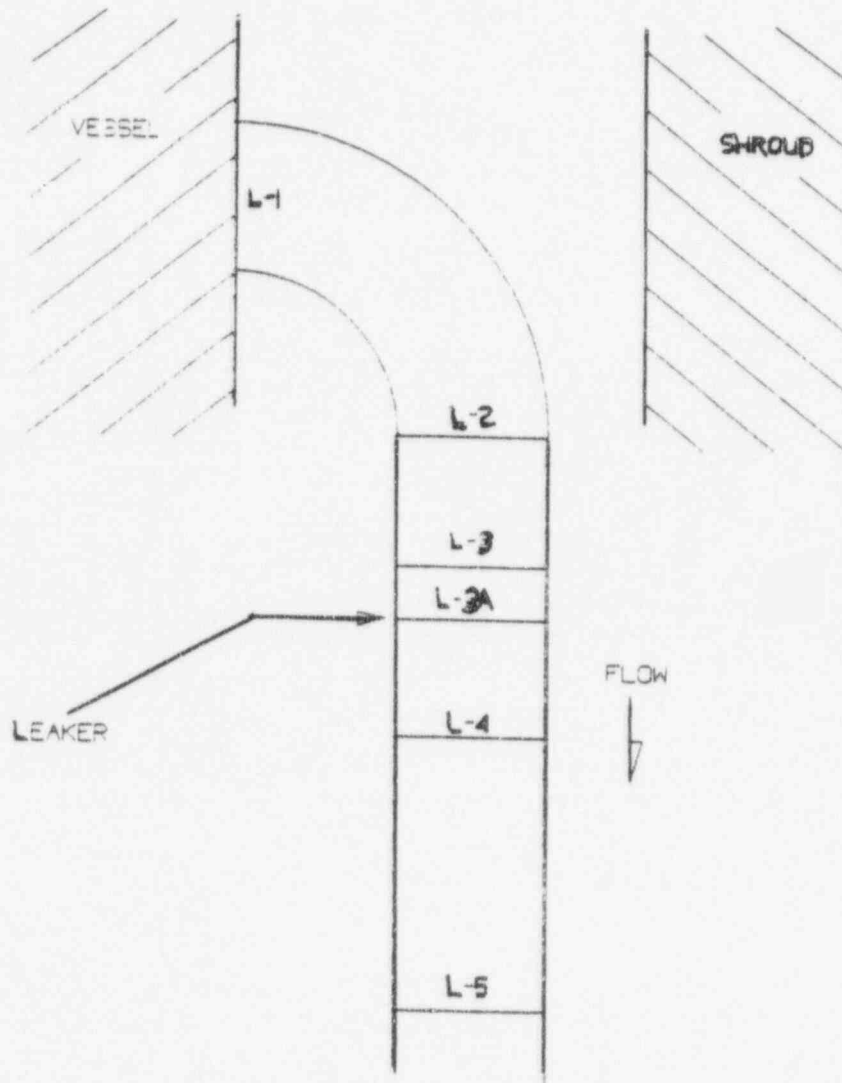
FIGURE 7

- ☐ One rounded, through wall, indication was observed in the toe of weld designated as L-3A. This weld is in System I of the annulus piping. Visual examination during 16R and previous air test during 15R revealed no change in this indication since its discovery in 14R. This indication was determined to be a fabrication flaw.
