LICENSEE EVENT REPORT (LER)

LaSalle County Station Unit Two

TITLE (4) Failure to Follow Procedures Results in Technical Specification Violation of the Core Standby Cooling System Pond Surveillance

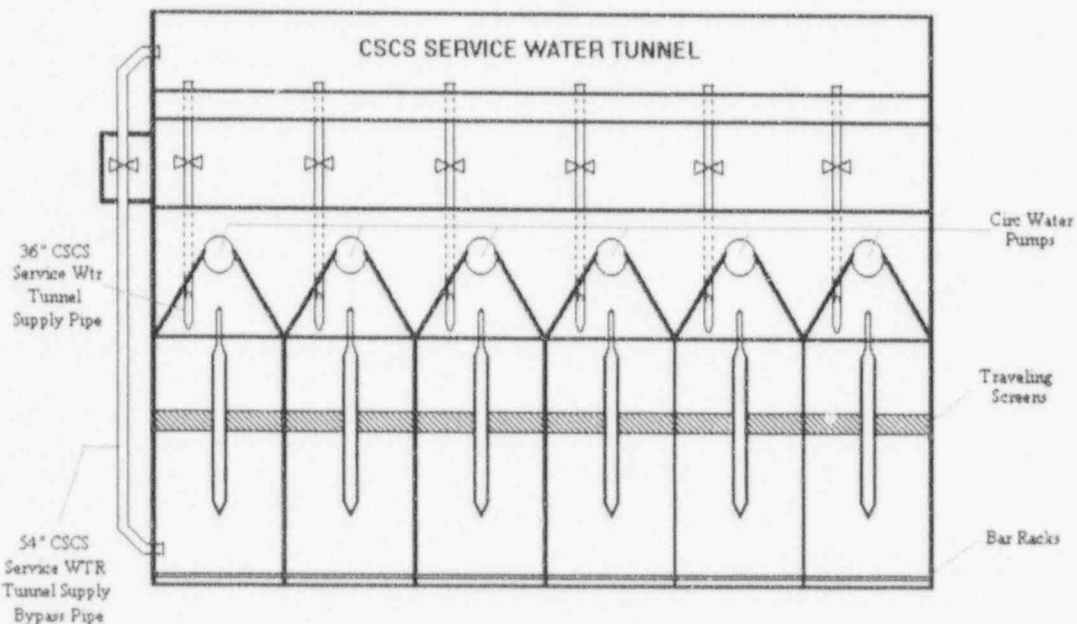
**LAKE SCREEN HOUSE**

There are 6 36-inch pipes supplying the Core Standby Cooling System (CSCS) [VF] tunnel, one from each of the 6 Circulating Water (CW) [KE] pump bays, located inside the bar grills and Traveling Screens. There is also a 54 inch CSCS inlet bypass pipe that can supply the CSCS tunnel from the Unit 1 CW Pump bay area located inside the bar grills and outside the Traveling Screens to provide a suction for the CSCS pumps in the unlikely event that the Traveling Screens would become completely blocked. (See Attachments A and B). Technical Specification 3.7.1.3 states the surveillance requirement that the sediment deposition anywhere within the Lake Screen House behind the bar racks is not greater than one foot in thickness. The basis of the one foot limit is to ensure that any sediment buildup would be below the bottom of the 7 CSCS tunnel inlet pipes. These pipes are 18 inches above the CW pump bay floor.

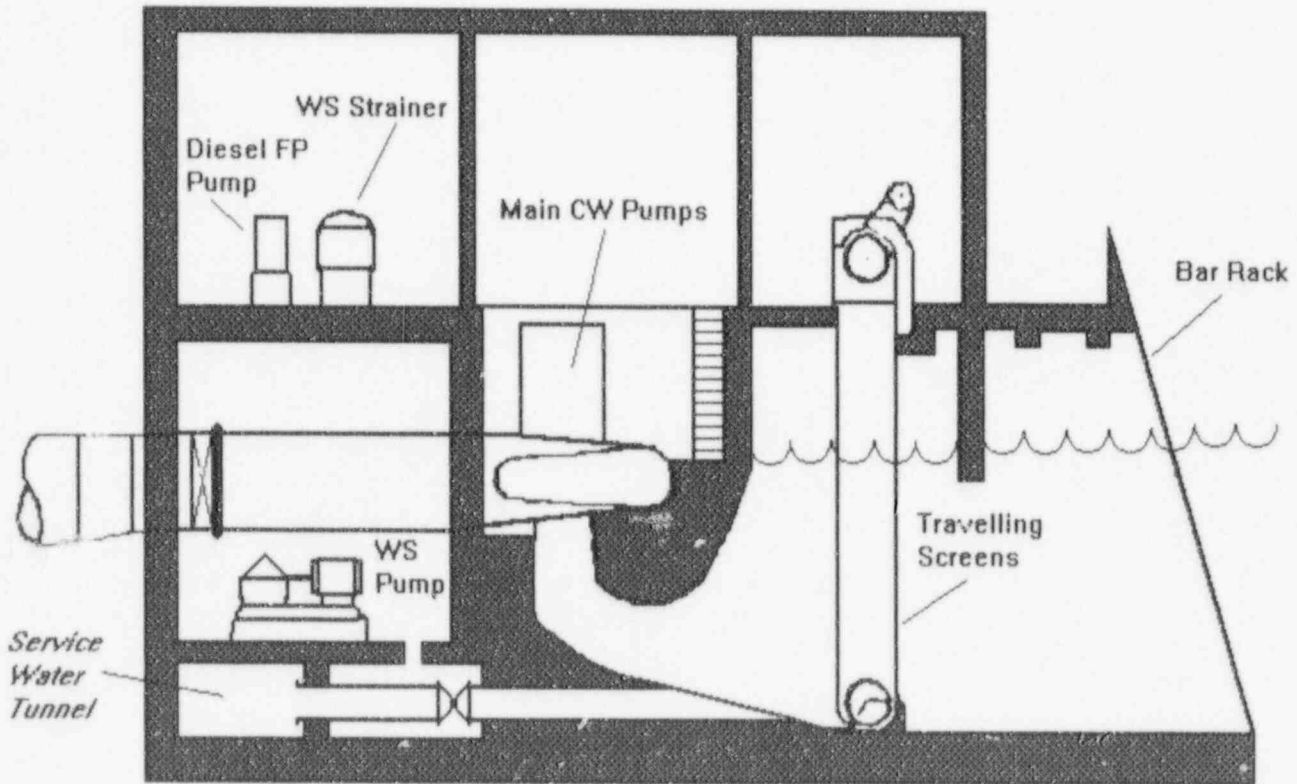
LAKE SCREEN HOUSE (Section)

The operability of the Ultimate Heat Sink ensures that sufficient cooling capacity is available for continued operation of the safety-related equipment during normal and accident conditions. There are 6 36-inch pipes supplying the Core Standby Cooling System (CSCS) tunnel, one from each of the 6 Circulating Water pump bays, which are inside the bar grills and the Traveling Screens. There is also a 54 inch CSCS inlet bypass pipe that can supply the CSCS tunnel from the Unit 1 CW Pump bay area located inside the bar grills and outside the Traveling Screens to provide a suction for the CSCS pumps in the unlikely event that the Traveling Screens would become completely blocked. The basis of the one foot maximum limit on sediment anywhere in the Lake Screen House inside the Bar Racks is to ensure that any sediment buildup would be below the bottom of the 7 CSCS tunnel inlet pipes. This one foot limit is conservative as the bottom of the 7 CSCS tunnel inlet pipes are 18 inches above the CW pump bay floor.

The Safety Significance of this event is minimal as the bottom of the each of the 7 pipes that supply a suction path to the CSCS pumps is 18 inches above the CW pump bay floor. The depth of sediment in the area after the bar grills and after the traveling screens for the three Unit 1 CW pump bays was measured from 2 to 16 inches. This is below the bottom of the three normal CSCS tunnel inlet pipes in these bays. The depth of the sediment in the area after the bar grills and before the traveling screens was 0 inches with some small, 1 to 3 inch piles of light gravel which is well below the CSCS inlet bypass pipe.
