UNITED STATES
NUCLEAR REGULATORY COMMISSION
REGION II
101 MARIETTA STREET, N.W.
ATLANTA, GEORGIA 30323

Report No.: 50-269/91-08, 50-270/91-08, and 50-287/91-08

Facility Name: Oconee Nuclear Station Units 1, 2, and 3

Inspection Conducted: March 12-15, 1991

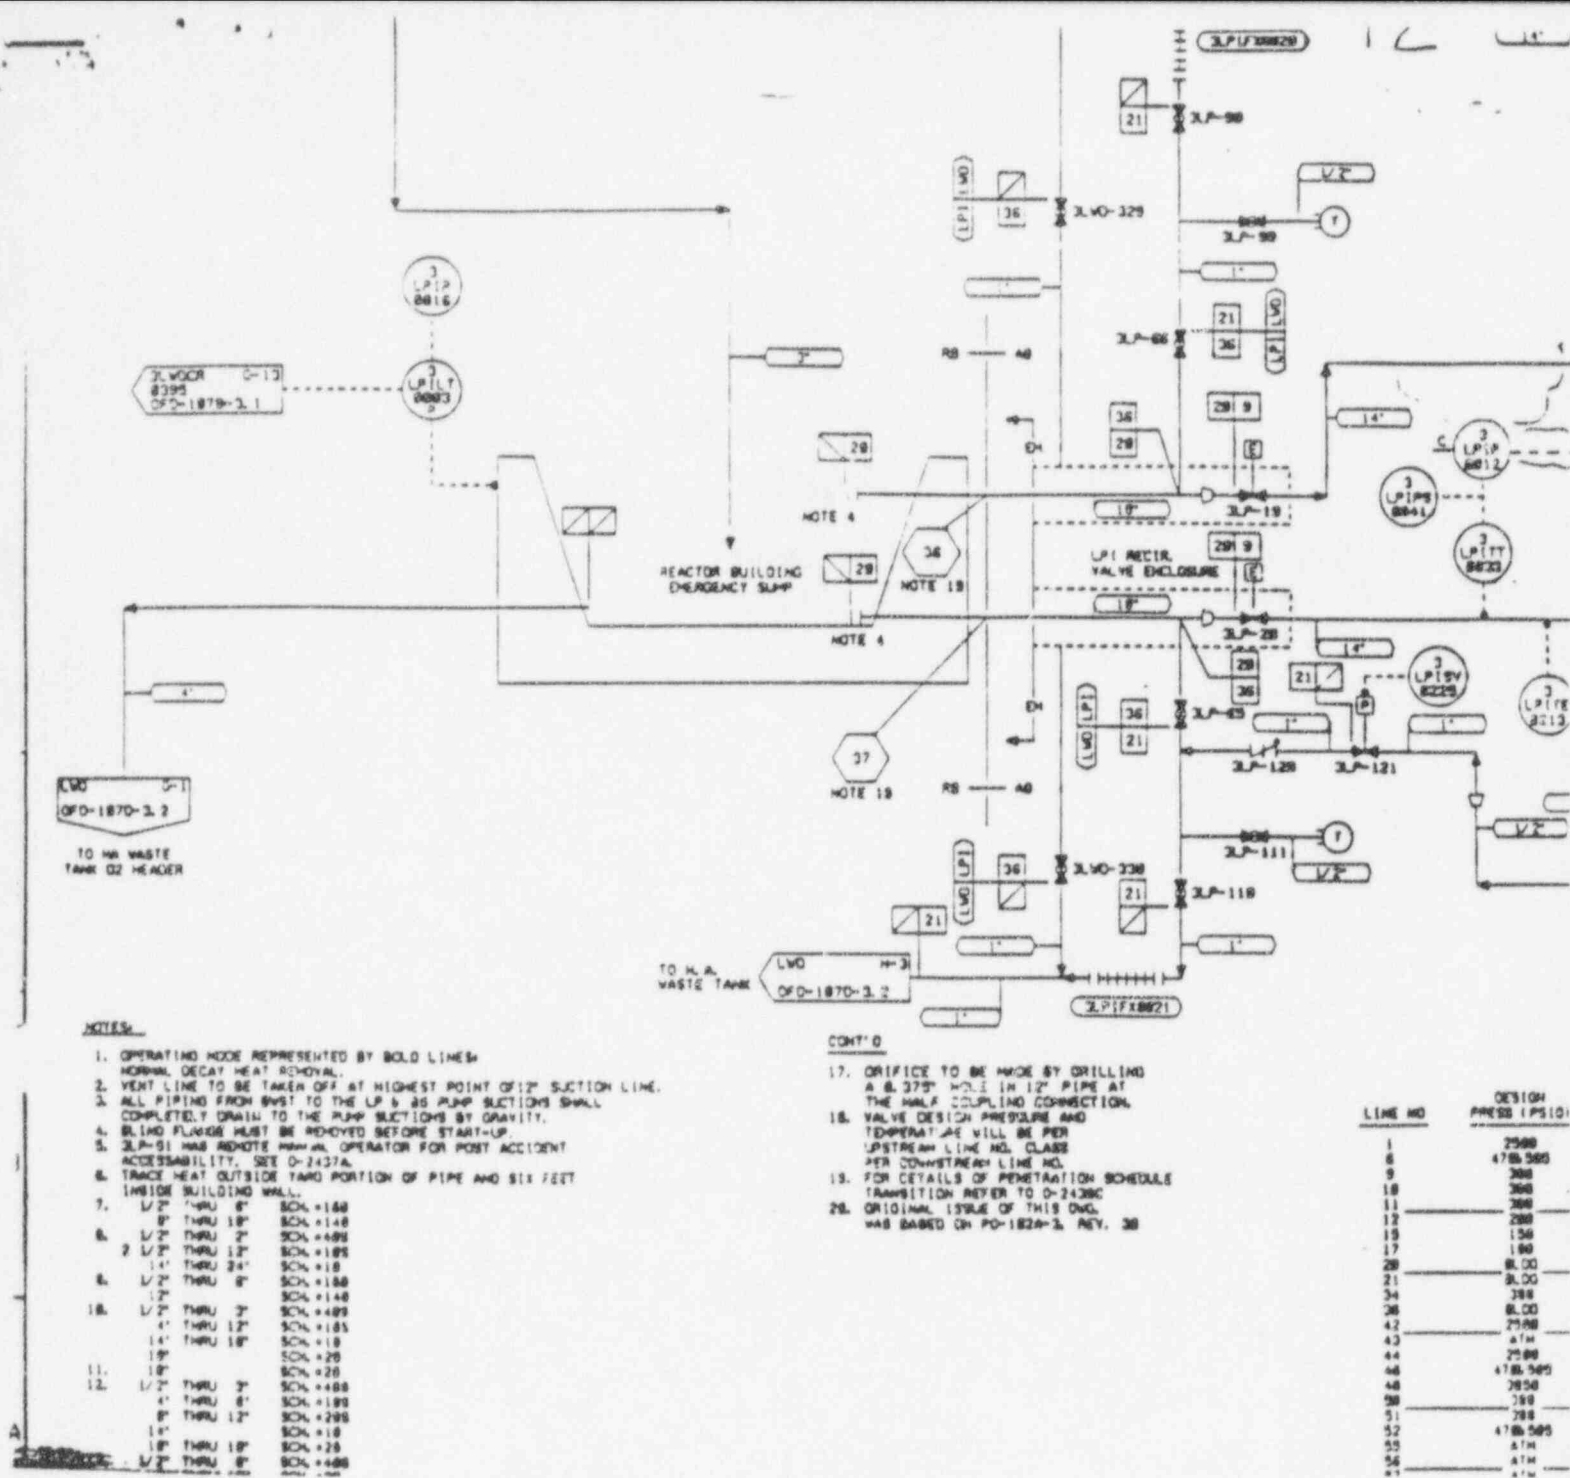
FIGURE 2

The licensee's investigation into this event determined that a blank flange was installed on 3LP-20 instead of 3LP-19. This was due to a labeling error and miscommunications between the workers installing the flange and their supervisor.

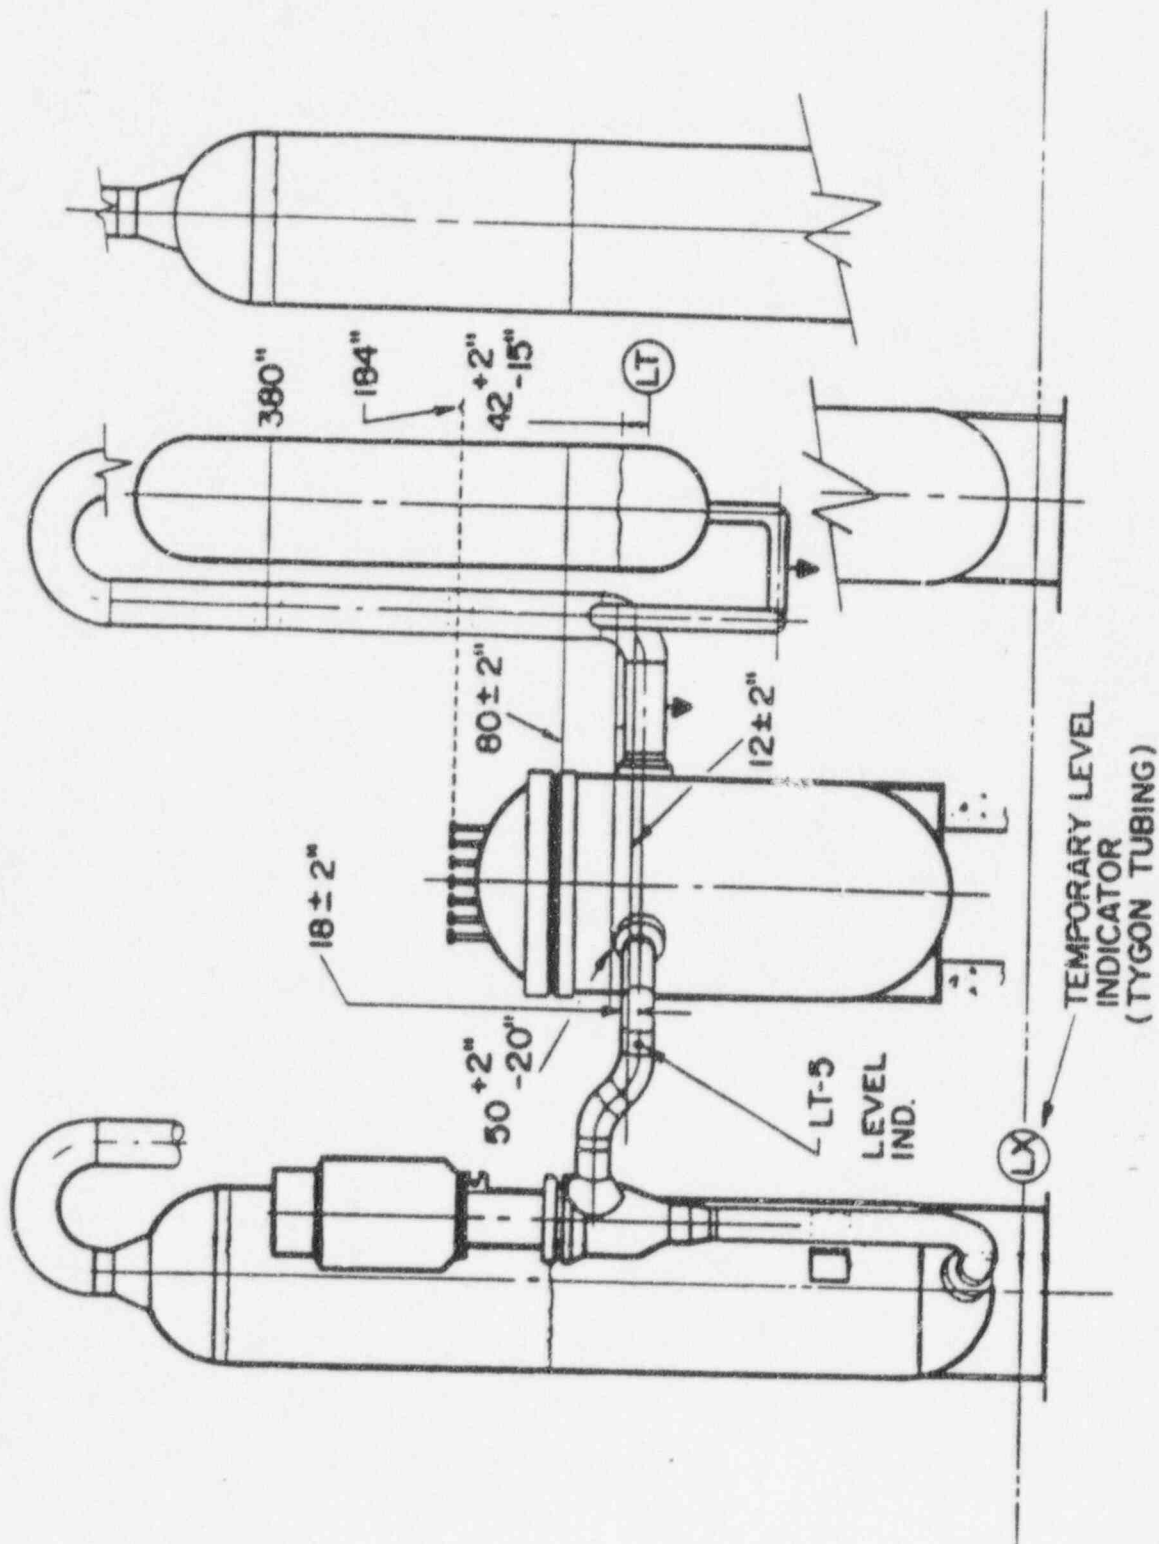
LT-5 LOCATION

08:48 A CRO noticed LT-5 (See Figure 3), reactor vessel level instrument, was at 20 inches and decreasing. This indicated the primary system had an excessive leak or the instrument had failed. The CROs on shift discussed the possible causes of the decreasing level. This instrument had failed in the past.

The operator questioned his supervisor with regard to possible testing on LT-5 since the instrument had failed in the past. They decided that the instrument was correctly indicating a problem.

The level drop was confirmed by the RV ultrasonic level alarm which appeared on the front panel display. The operators observed LT-5 reactor level offscale low. The operators thought that it took only 1 minute for LT-5 to drop to offscale low.

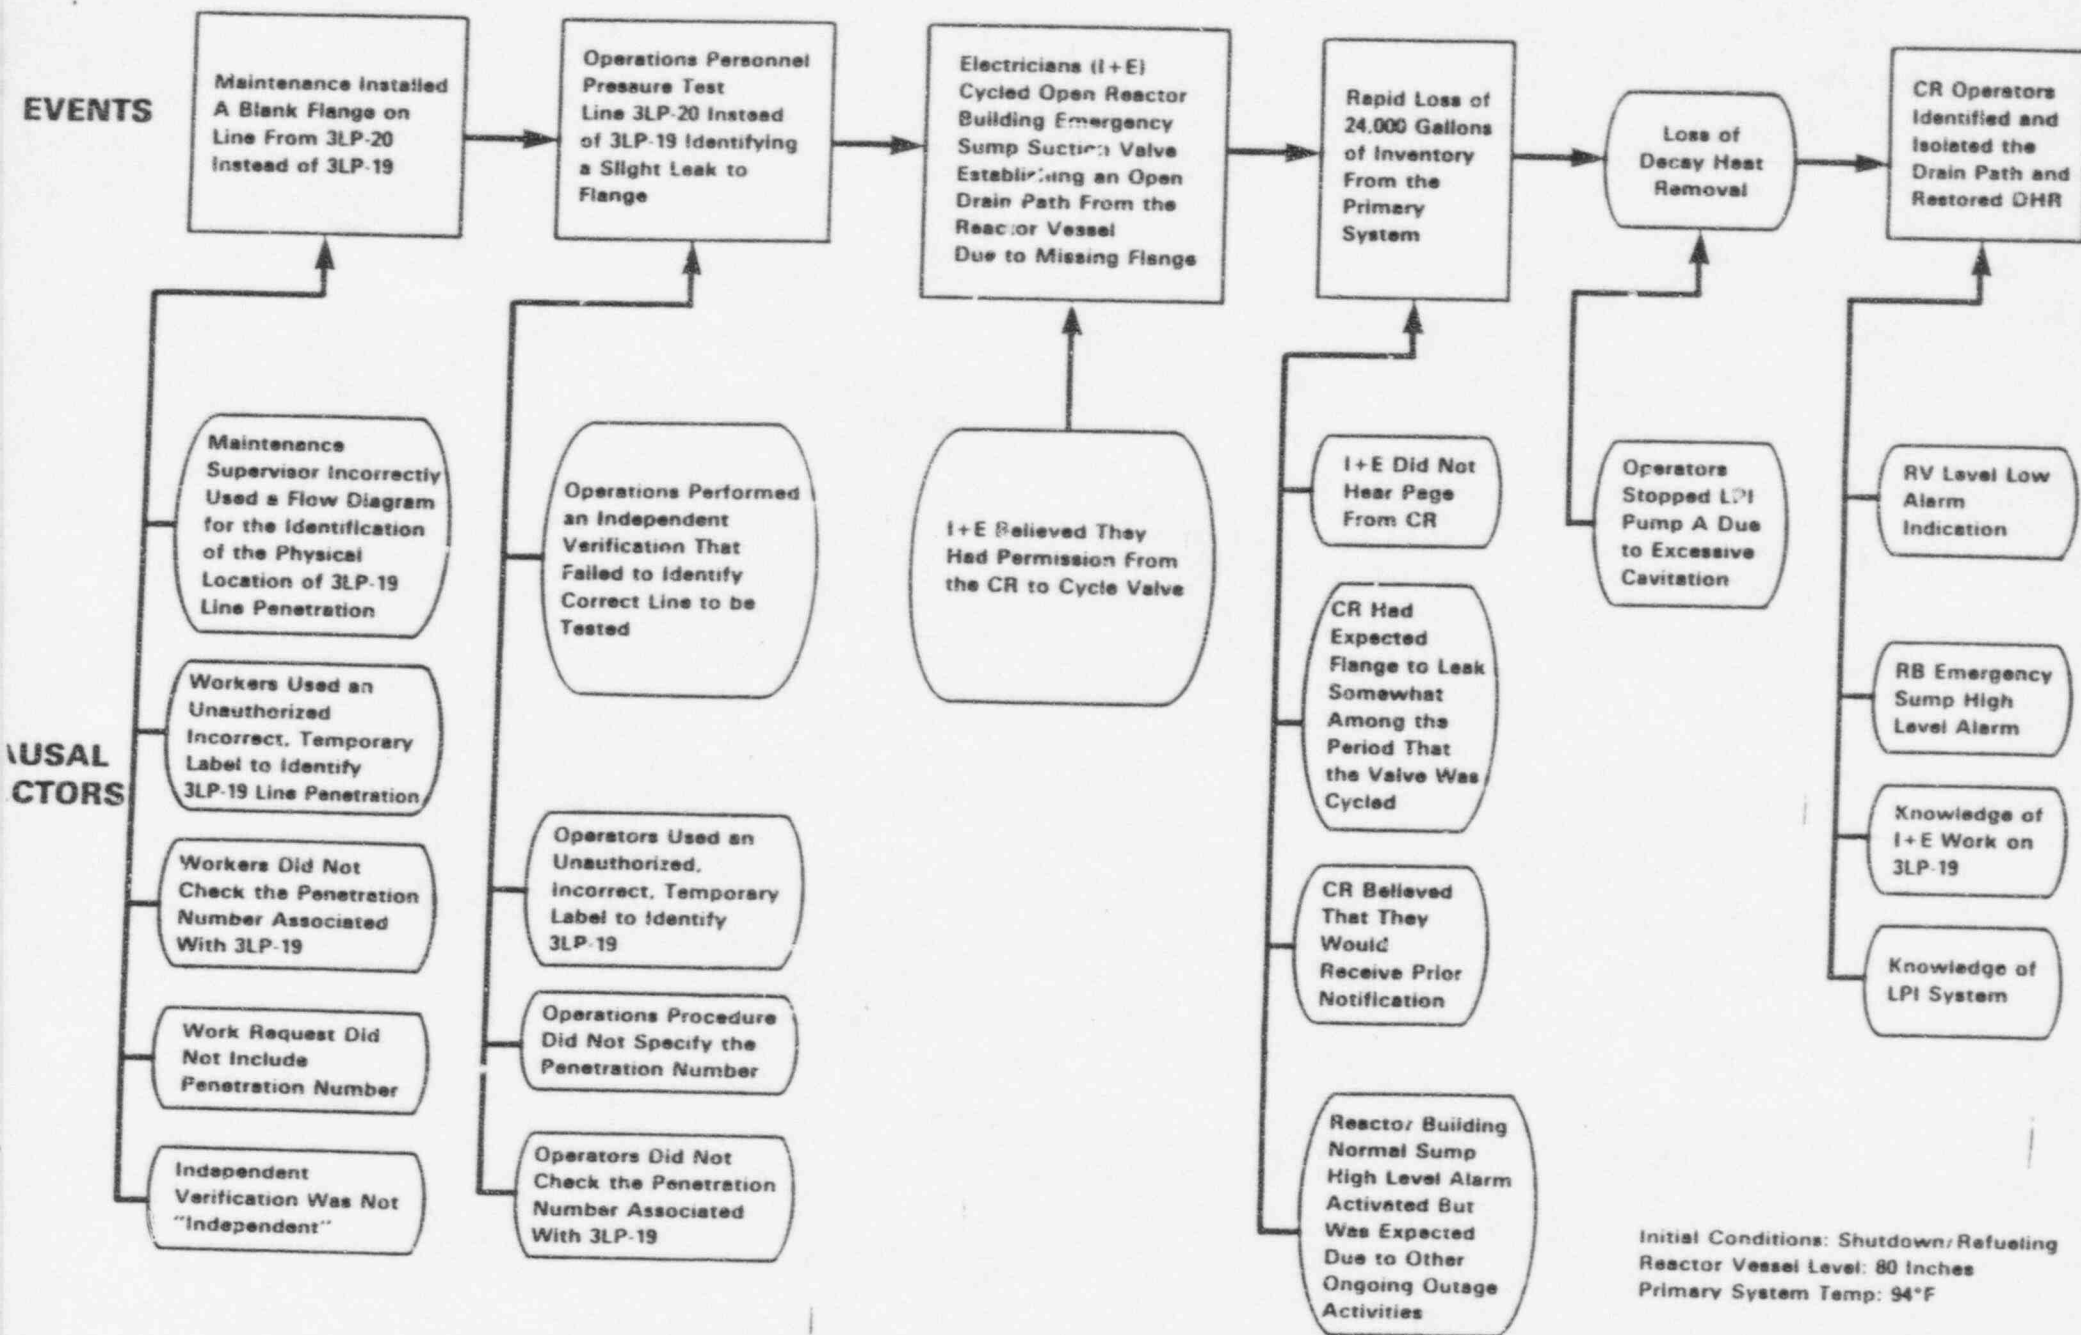
OCONEE UNIT 3 LOSS OF DECAHEAT REMOVAL EVENTS AND CAUSAL FACTORS CHART

To aid in understanding of the human performance implications of this event, an EVENTS AND CAUSAL FACTORS CHART was constructed. (See Figure 5). The chart is a visual presentation of the sequence of events and the causal factors for those events. The sequence of events is along the top, from left to right and the causal factors are listed below each event. From the chart it is clear that numerous causal factors are involved in this event; no individual cause stands alone. The human factor implications section of the AIT addresses most of the causal factors identified in the chart.

The failure of plant maintenance personnel to install the flange on the correct emergency sump suction line as part of a LPI system leakage surveillance procedure resulted in the discharge of reactor water to the RB emergency sump. Defense in depth is important to maintaining safe operation of nuclear plants. Contributing causes are factors which reduce the level of protection by reducing the defense in depth. Human errors are seldom the result of a single "root cause." The following discussion of contributing causes ranks these causes in approximate priority of their importance as the AIT judged them.
