Subject: Docket No. 50-362
30-Day Report
Licensee Event Report No. 96-004
San Onofre Nuclear Generating Station, Unit 3

LICENSEE EVENT REPORT (LER)																				
Facility Name (1) SAN ONOFRE NUCLEAR GENERATING STATION, UNIT 3										Docket Number (2) 0 5 0 0 0 3 6 2 1 of 0 8			Page (3) 1 of 0 8							
Title (4) RCS Pressure Boundary Leakage Due to Failed RTD Thermowell																				
EVENT DATE (5)			LER NUMBER (6)				REPORT DATE (7)			OTHER FACILITIES INVOLVED (8)										
Month	Day	Year	Year	///	Sequential Number	///	Revision Number	Month	Day	Year	Facility Names		Docket Number(s)							
0	9	1	9	9	6	9	6	0	0	4	0	0	1	0	2	3	9	6	NONE	0 5 0 0 0
OPERATING MODE (9)			THIS REPORT IS SUBMITTED PURSUANT TO THE REQUIREMENTS OF 10CFR (Check one or more of the following) (11)																	
POWER LEVEL (10) 1 0 0			20.402(b)				20.405(c)				50.73(a)(2)(iv)				73.71(b)

Plant: San Onofre Nuclear Generating Station, Unit 3
 Reactor Vendor: Combustion Engineering
 Event Date: September 20, 1996
 Mode: Mode 1, Power Operation
 Power Level: 100%

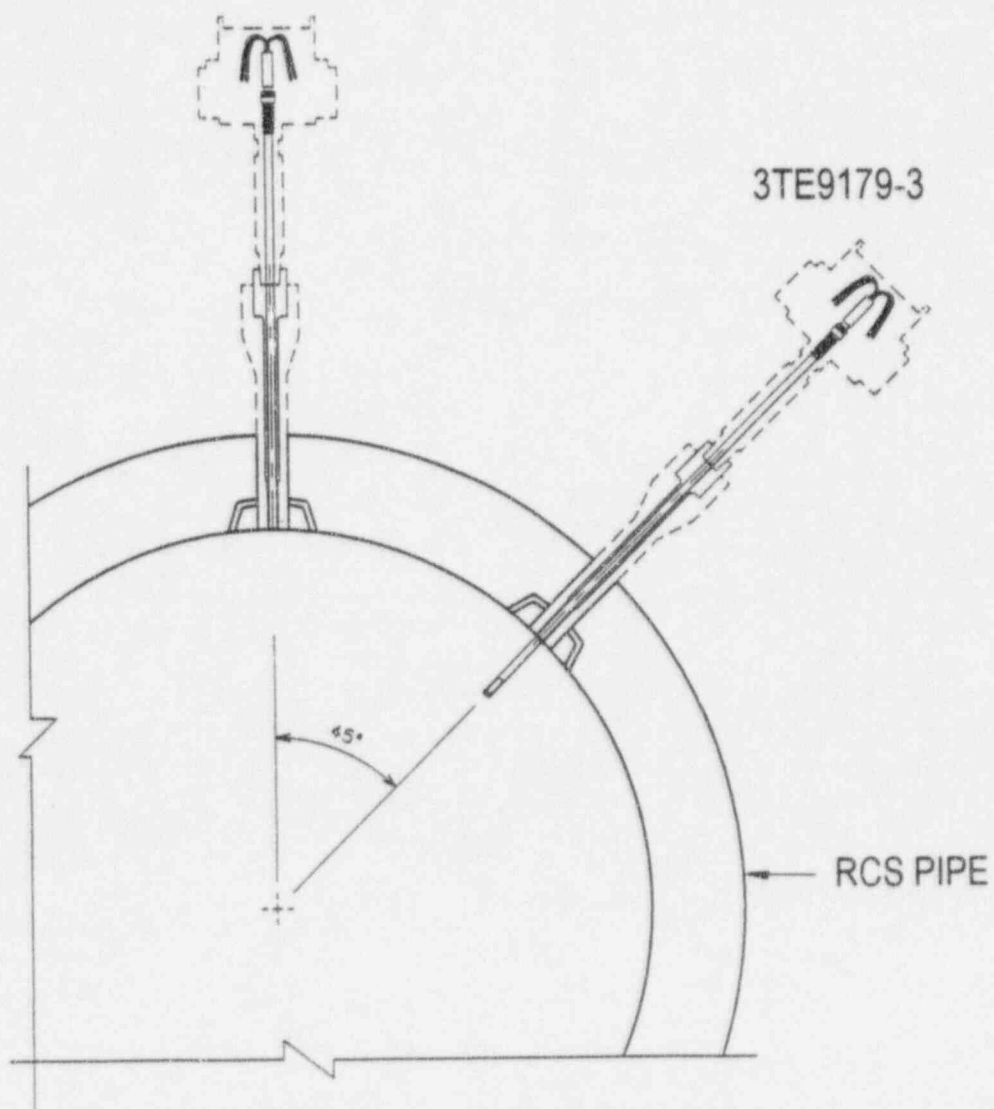
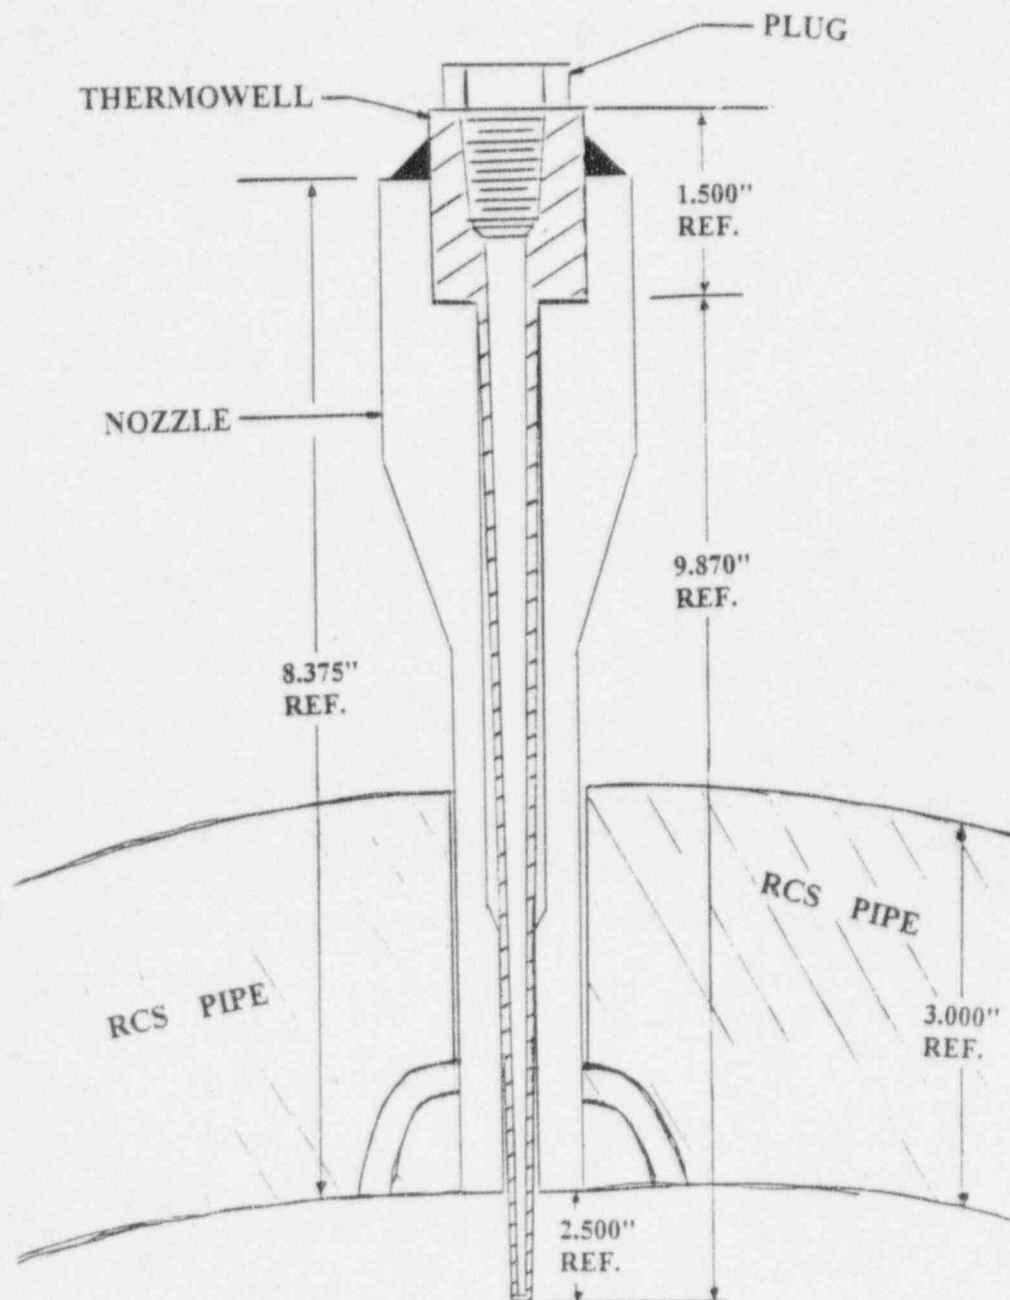
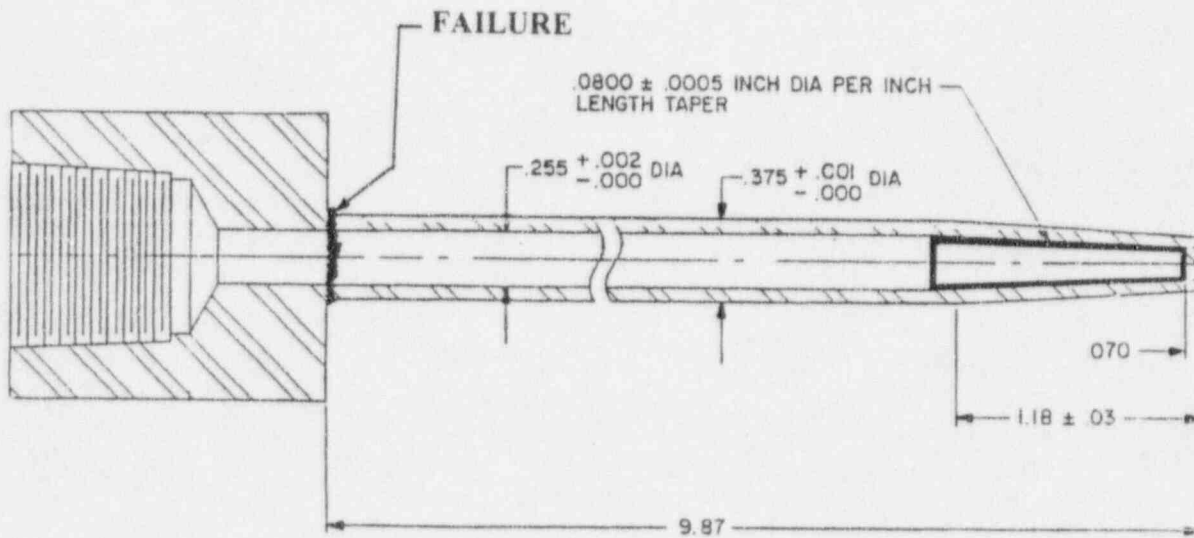
Upon removal of the thermowell nozzle, Edison discovered that the thermowell itself had broken off inside the RCS pipe. The broken piece (about 9 inches long if intact) was not present and is presumed to have been swept into the bottom of the reactor vessel. Edison preliminarily concluded the thermowell failure was caused by fatigue. There was no evidence of stress corrosion cracking.

Upon removal of the thermowell nozzle, Edison discovered that the thermowell itself (Rosemount model 89-287) had broken off inside the RCS pipe (Figures 1 - 3). The broken piece (about 9 inches long if intact) was not present and is presumed to have been swept into the bottom of the reactor vessel [RPV]. Although Edison has not completed the formal root cause evaluation, Edison preliminarily concluded the thermowell failure was caused by fatigue fracture which extended through about 95% of its circumference. While there was no evidence of stress corrosion cracking, the fracture surface had indications of oxidized surface rubbing and heavy oxidation.

Edison restored the broken thermowell for 3TE9179-3 to its design configuration. Edison performed an analysis confirming that plant operation can safely continue with the broken piece(s) of thermowell in the RCS (see safety significance section below).

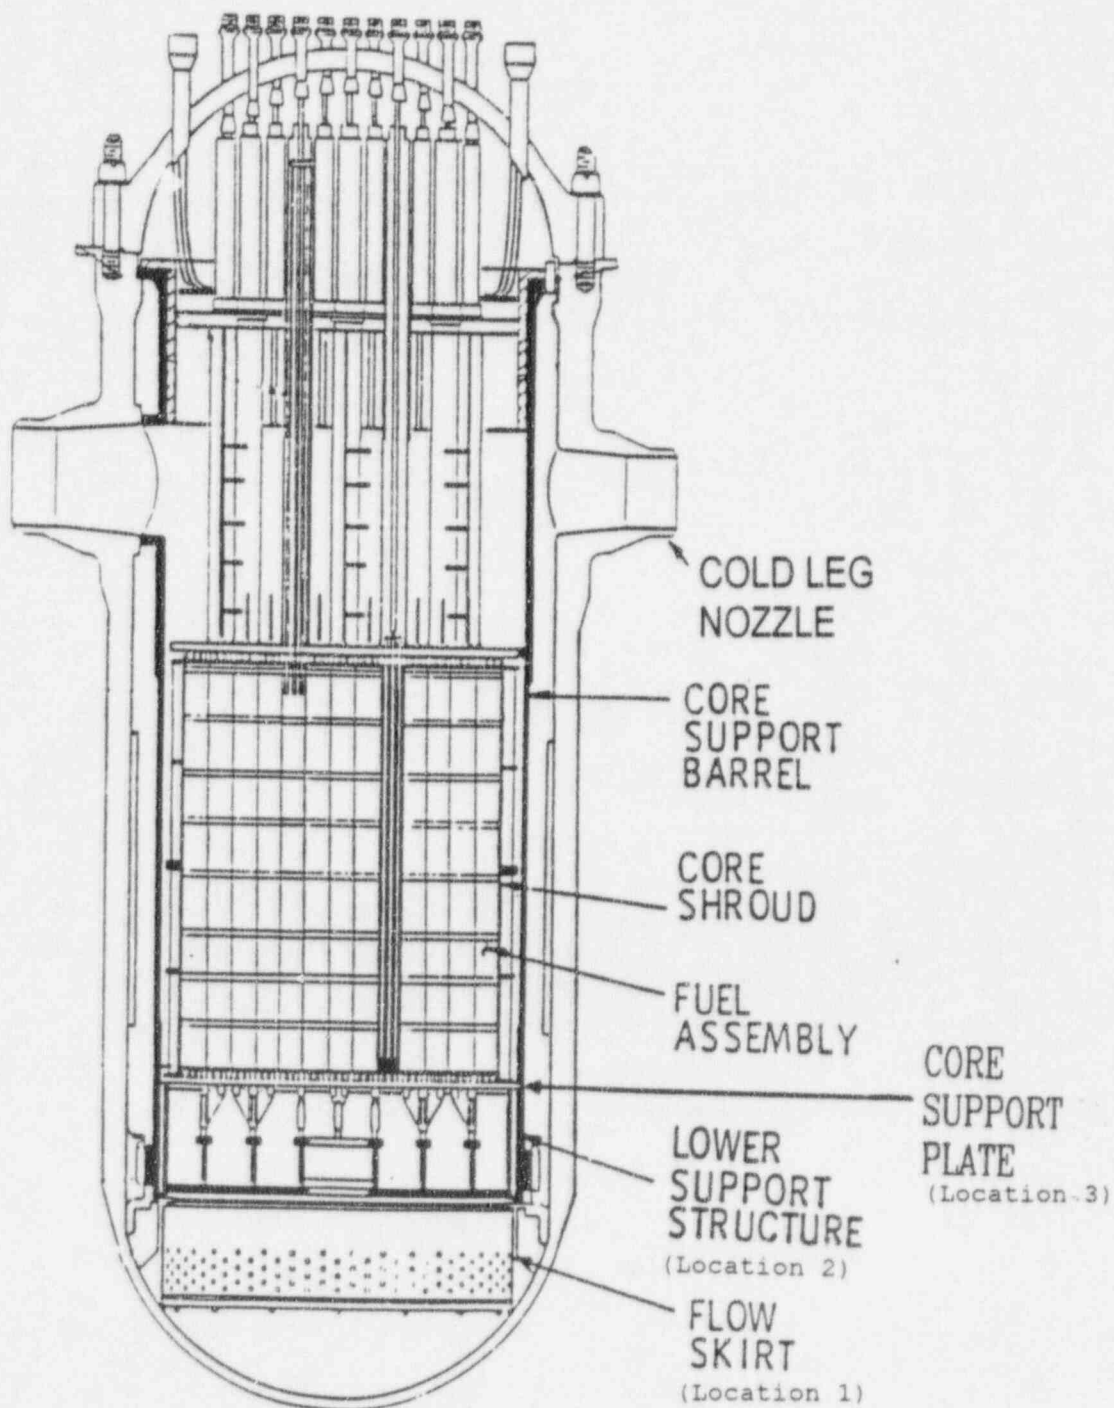
Figure 4

on the potential size(s) of the thermowell fragment(s), it/they would likely become lodged in one of the following vessel locations (Figures 4 and 5): (1) Reactor vessel flow skirt, (2) the lower support structure, (3) the core support plate, (4) fuel assembly lower support plate or (5) fuel assembly lower grid. Edison's evaluation concluded that potential coolant flow blockage resulting from these five potential end locations would still be bounded by departure from nucleate boiling ratio (DNBR) calculational uncertainties. Consequently, the thermowell fragment(s) could not prevent proper cooling of fuel.

Additionally, potential thermowell fragment(s) which succeeded in reaching vessel location (5) would not jeopardize fuel pin integrity because the bottom portions of the fuel pins are solid metal end caps (plugs). Consequently, potential fretting between thermowell fragment(s) and fuel pins would not degrade the fission product barrier (fuel clad). Moreover, the fuel assemblies are debris resistant, having long end caps or guardian grids designed to preclude RCS debris from interacting with the active portion of the fuel (fuel clad).
