Subject: Arkansas Nuclear One - Units 1 and 2
Docket No. 50-313/368
License No. DPR-51/NPF-6
Licensee Event Report 50-313/96-008-00

TITLE (4) Sluice Gate Leakage Resulted in the Inability to Maintain Emergency Cooling Pond Inventory for Thirty Days Following a Design Basis Accident Without Additional Action

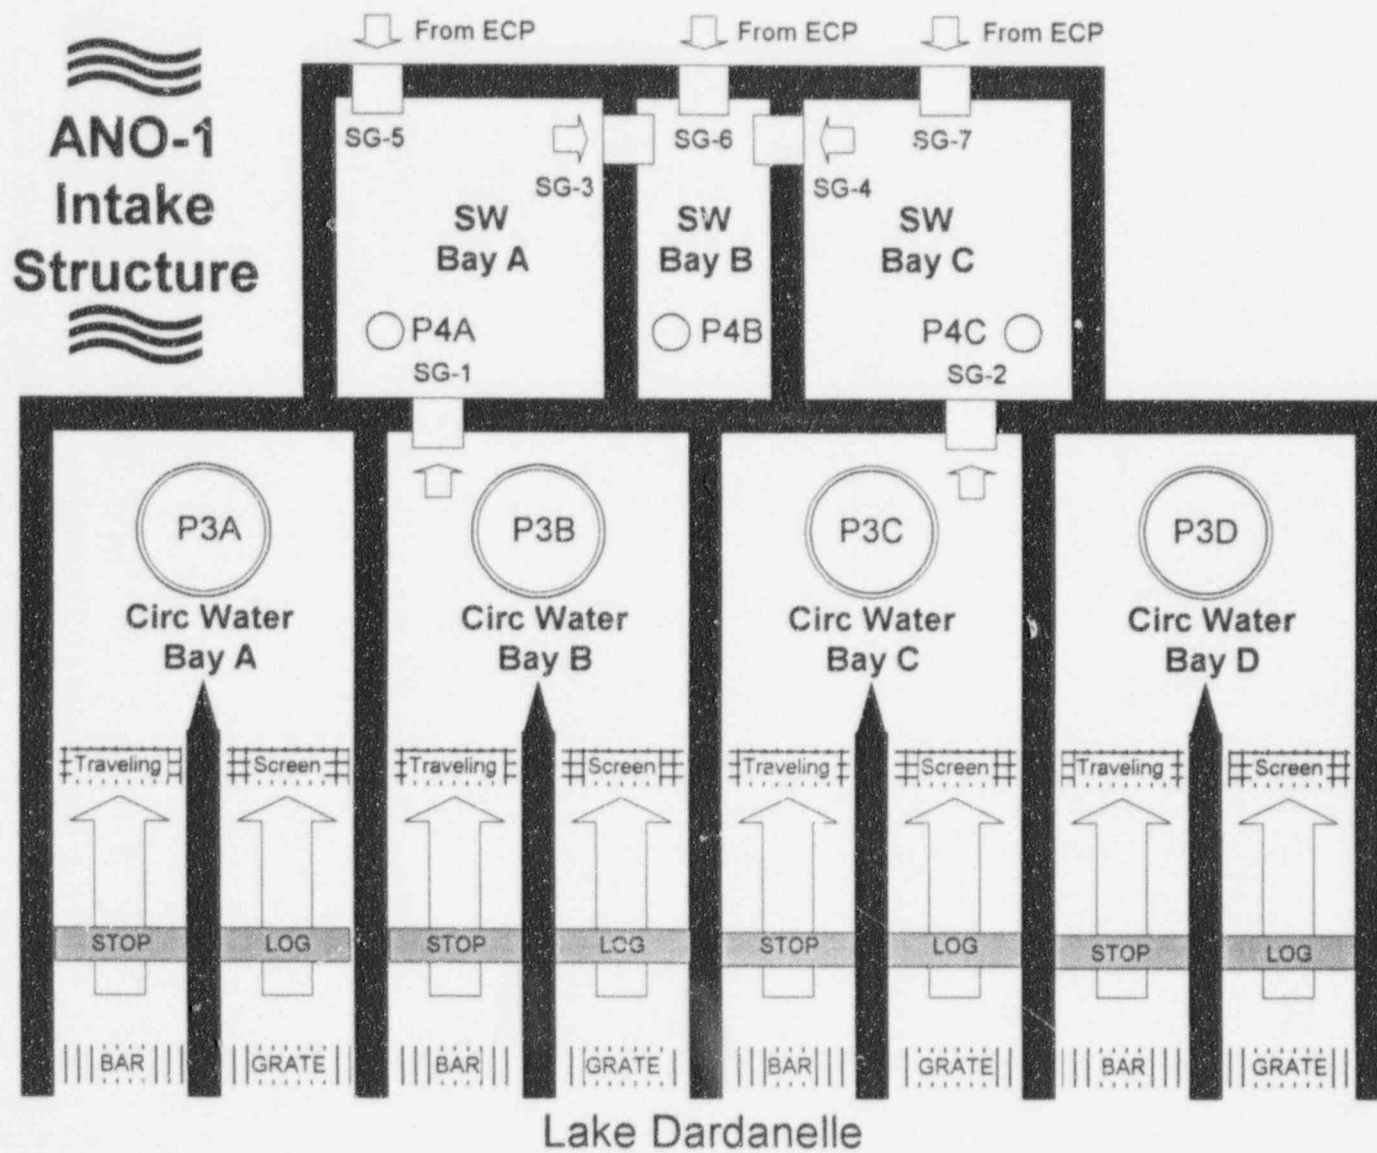
General Layout of ANO-1 Service Water and Circulating Water Intake Structures

On September 22, 1996, during an inspection of the ANO-1 Circulating Water (CW)[KE] bays, sluice gate SG-1 was electrically closed and the "B" CW bay was drained. A surveillance leakage test on SG-1, located between the "B" CW bay and the "A" Service Water (SW)[BI] bay (see attachment), demonstrated an as-found leakage rate of 103.1 gallons per minute (gpm). This leakage was in excess of the maximum allowable total sluice gate leakage from the five lake side sluice gates (two ANO-1 gates and three ANO-2 gates) that isolate the Dardanelle Reservoir from the SW bays as described in the ANO-2 Safety Analysis Report (SAR). The ECP supply sluice gates, SG-5 and SG-7, were leak tested to verify the ability of the gates to isolate their respective bay from the ECP to stop the loss of inventory.

An inspection of the condition of SG-1 on the CW bay side revealed that it was covered with zebra mussels. SG-1 was left closed and the "A" SW bay was pumped down to maintain any debris trapped under the gate. Prior to opening the gate, clusters of zebra mussels could be seen under the gate. The gate was between 1/16 and 1/8 inch above the seal. When the gate was opened and the rubber seal surface was examined, indented areas were found on the right and left ends. The material under the gate seal was loose and easily removed. In addition, the bottom of the gate was found to have a 1½ inch long

On October 1, 1996, after returning the "A" and "B" SW bays to service, the "C" CW bay was drained. The as-found condition of sluice gate SG-2, located between the "C" CW bay and the "C" SW bay, was similar to that observed on SG-1. It was determined that SG-2 exhibited a leakage rate of 41 gpm.

The root cause of the excessive leakage from SG-1 and SG-2 was determined to be due to zebra mussel infestation of the CW bays. The mussel shells prevented the gates from sealing properly at the bottom.

The seats of both SG-1 and SG-2 were repaired, the rubber seals were replaced, and all exposed surfaces were cleaned. The ANO-1 CW bays and SW bays were cleaned, as well as the area between the bar grates and stop logs on the "B" and "C" CW bays. Both sluice gates SG-1 and SG-2 were adjusted and the torque and limit switches were reset. The as-left leakage rates were 2.4 gpm and 3.25 gpm on SG-1 and SG-2 respectively.
