ARKANSAS POWER AND LIGHT  
ARKANSAS NUCLEAR ONE - UNIT 1  
CONTROL ROOM DESIGN REVIEW  
FINAL SUMMARY REPORT  
HUMAN ENGINEERING DISCREPANCIES  
VOLUME 2  
AUGUST 14, 1985

Category 1 HEDs

CORRECTIVE ACTIONS

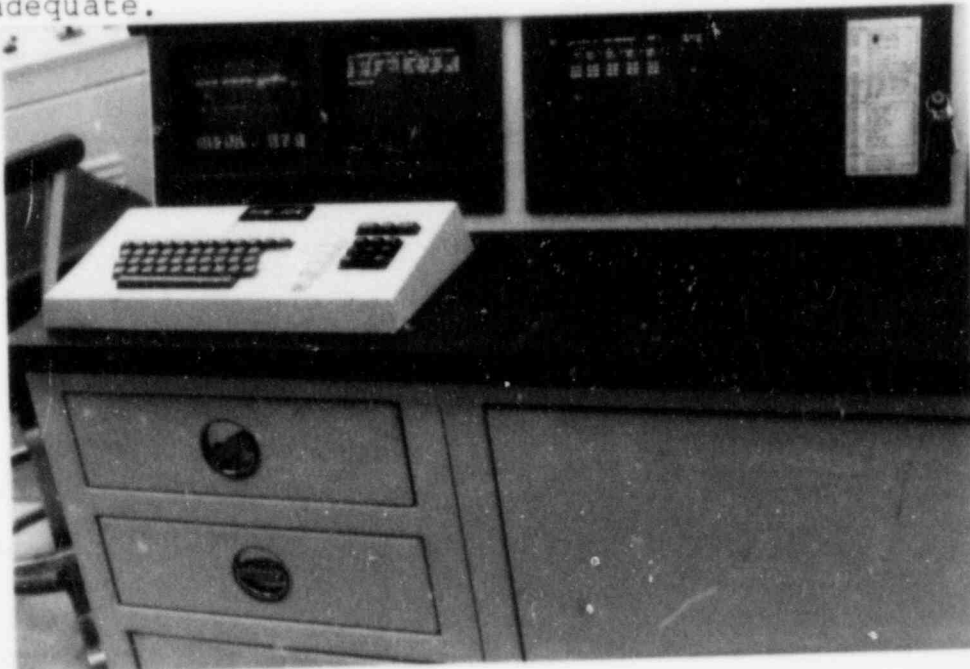
4917/a/5

The computer console is seldom used by the operator and is intended as a stand-up work station. It is primarily used to define trend points which takes very little time at the keyboard. Therefore, as a stand-up console, leg and foot room are adequate.

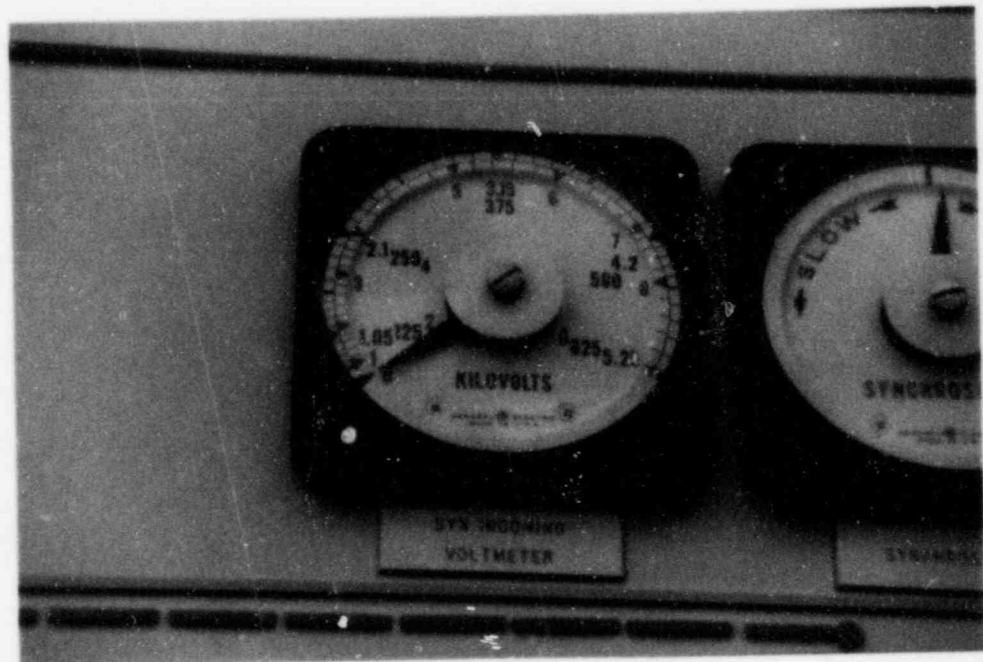
The multiscale indicators are difficult to use and a better display may be justified. Therefore, an evaluation of the available display options to correct this discrepancy is to be performed.

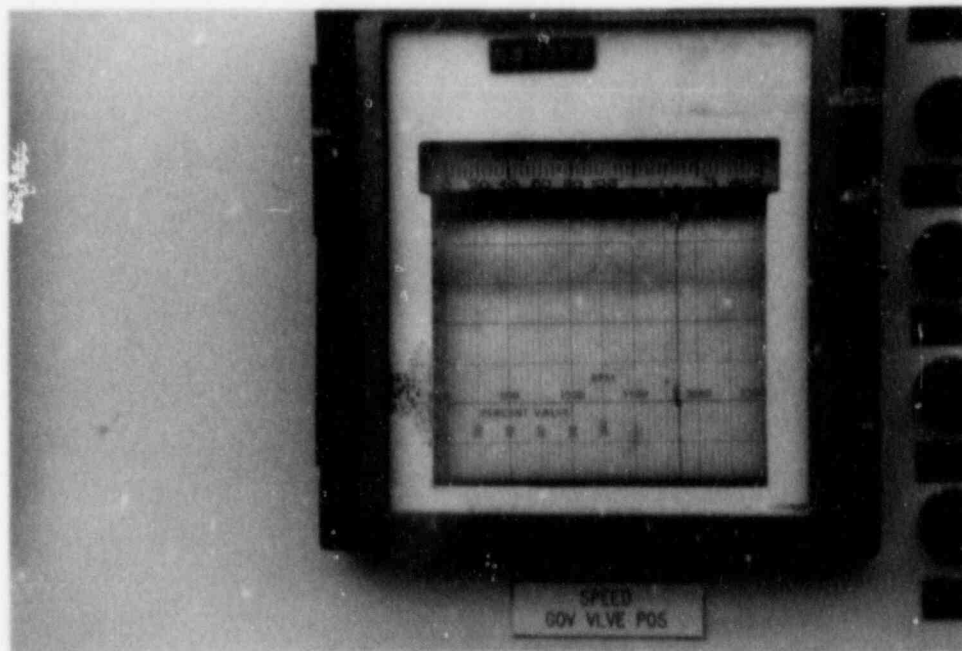
4918/a/47

The identified recorder is being evaluated for removal as part of a design change currently being prepared. Therefore, this discrepancy is being corrected.

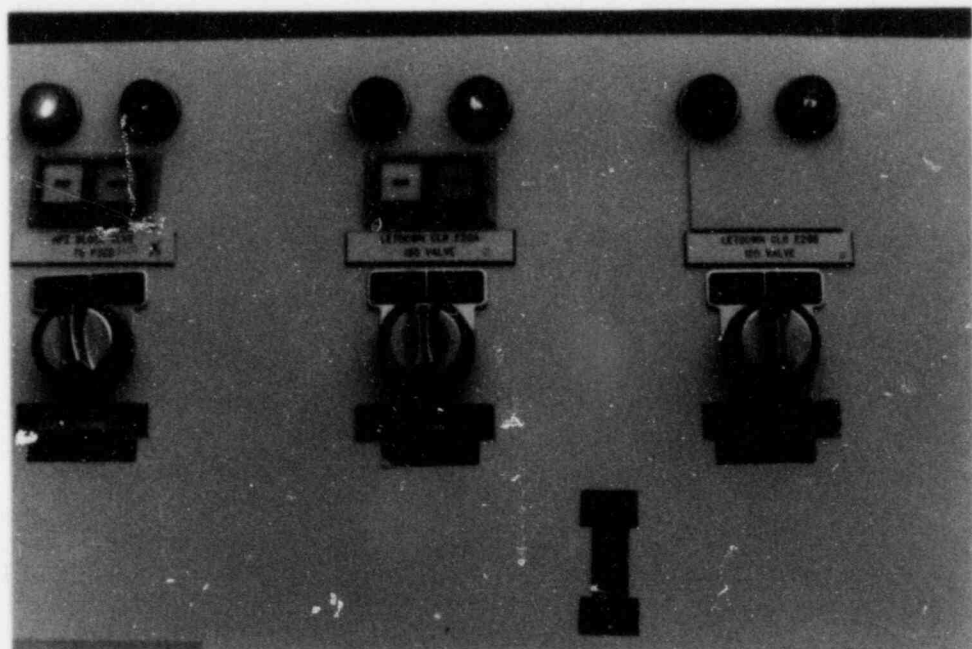
The arrangement of components by ES grouping was the original design for panel C-16 and C-18. However, due to the potential problems created by this arrangement pattern and subsequent design changes which made the original arrangement pattern partially obsolete, an evaluation will be performed to determine if other arrangement schemes would be better.
