U.S. NUCLEAR REGULATORY COMMISSION
REGION I
MEETING REPORT

Docket/Report No.: 50-336/85-26

Facility Name: Millstone Nuclear Power Station, Unit 2

REACTOR TRIP OF JULY 15, 1985

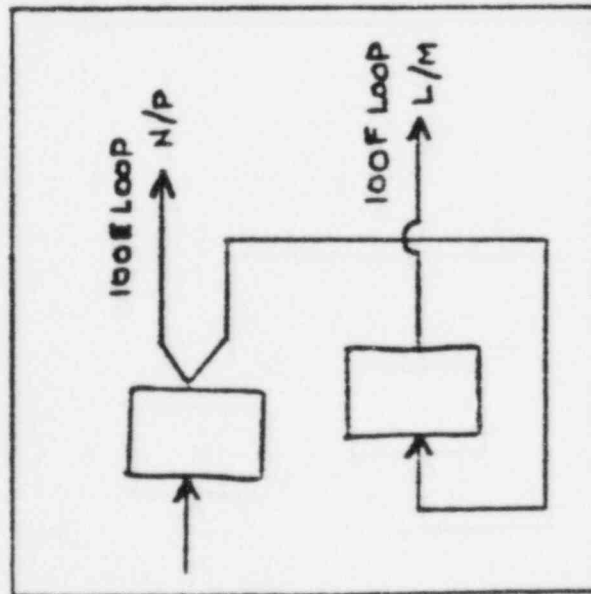
25203-28500
SHEET 50D

As indicated on the simplified sketch, three of the drawings included in the plant design change request contained the discrepancy which resulted in the wiring reversal. Sheet 50D identified wires N/P as carrying loop E signals while wires L/M carry the loop F signal. However, sheet 50E reversed the wires such that wires N/P supply the F loop and wires L/M supply the E loop. This reversal was repeated on sheet 50F in that output wires Q/R and S/T switched from F to E and E to F respectively.

When the wiring error was discovered an addendum was initiated to the plant design change request to correct the discrepancy. The change consisted of reversing the wires on the CO3 controllers and reversing the nameplates on the C21 controllers. To understand why the corrective actions are different the design of the control boards must be considered. On C21, facility separation is by a metal divider which splits the back panel in half. On CO3, three feet of space provides the separation.

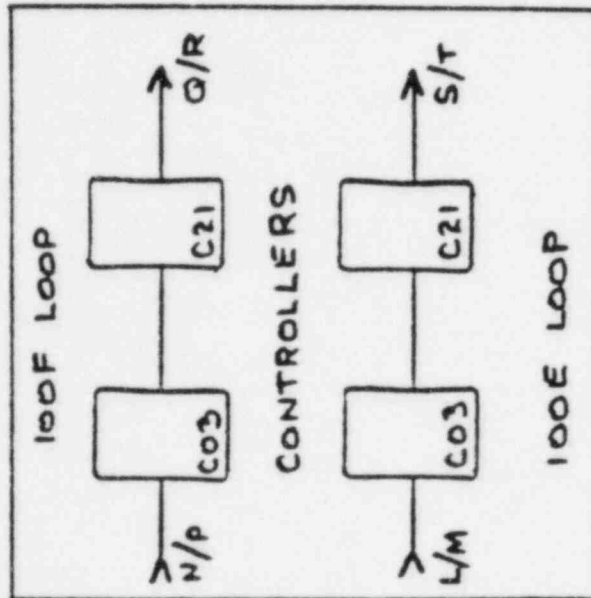
25203-28500
SHEET 50E

As a result of these wire reversals, the CO3 and C21 controllers, which were reflected on sheet 50E, were wired such that the E controller operated the F valve and the F controller operated the E valve. This discrepancy was not discovered during testing since valve operation was not verified. Rather, test meter deflections were observed. These meter deflections were observed at test points identified on the same prints which resulted in the reversal.

Concerning the original modification to CO3, identical controllers were placed in a new section of control board for the two valves. The labeling of these controllers was consistent with the design layout drawing which maintained the system mimic on the remainder of the panel. However, the design layout drawing reflected the mistake made on sheet 50E and the wrong wires were connected to the controllers. Therefore, the corrective action is to reverse the wires.

The modification on C21 consisted of identical controllers being placed in two holes in the control board. One of the holes was on each side of the divider plate. Since one hole was on each side of the divider plate and one cable was pulled to each side of the plate, the connections were made without reference to the layout drawings or connection drawings which were in error. The layout drawing was used for labeling, however, and the controllers were mislabeled. Thus, the C21 corrective action is to reverse the labels.
