SUBJECT: REVIEW OF TECHNICAL ASSIST REQUEST FROM REGION III OF THE  
STRUCTURAL INTEGRITY REPORT FROM ADVANCED MEDICAL SYSTEM,  
INC.

Re: USNRC Inspection Report No. 030-16055/95006 (DNMS)

**SEISMIC AND STRUCTURAL REVIEW OF ADVANCED MEDICAL SYSTEMS  
LABORATORY FACILITIES**

NUCLEAR REGULATORY FACILITY INSPECTION REPORT ON THE  
ADVANCED MEDICAL SYSTEMS LABORATORY FACILITY

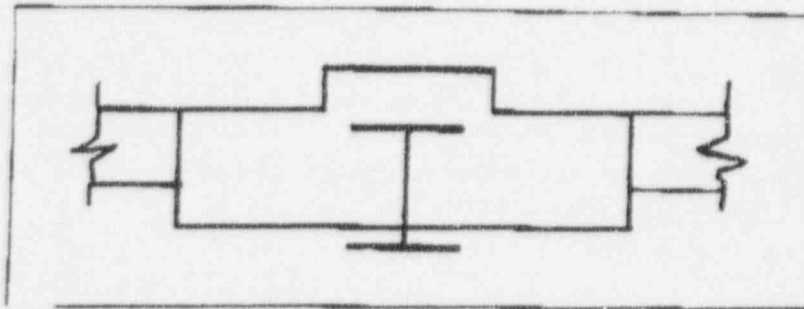
Figure A-1. Masonry pilasters and steel columns.

The north-south walls, the short dimension (~60 ft) of the building, are also constructed in the same fashion as the east-west walls. The only difference is the vertical columns at pilasters do not support any vertical load and the wall itself, between columns, supports one-half of the roof load that the trusses and columns support.

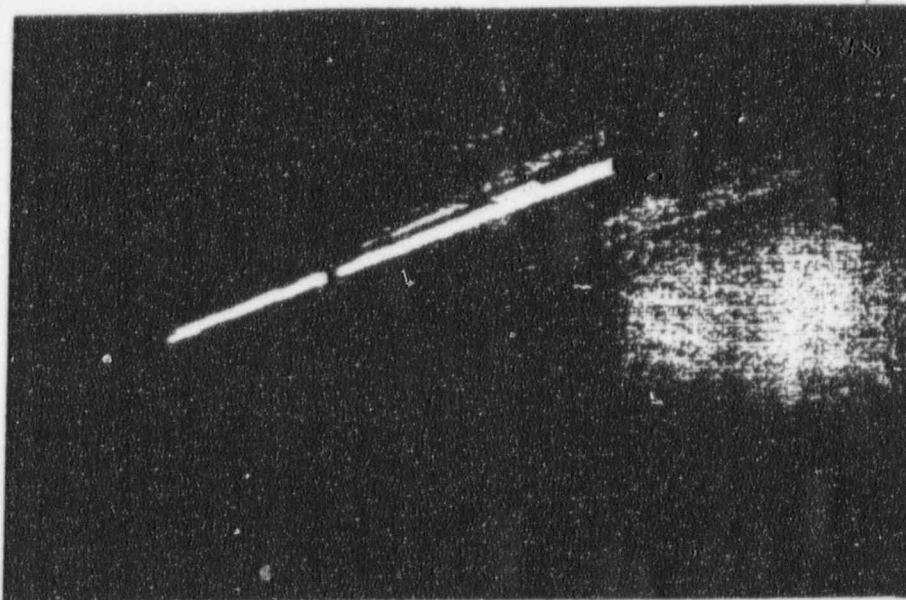
outside the area to occur. This may have been the original intent; however, at both the conduit and ventilation chases, the risers are only two inches. In addition, at the ventilation chase, the riser has a 1/4-inch notch in it. Thus, the maximum fluid that can be contained within the equipment is about 40 gallons. Therefore, the fluid runs over the 1/4-inch riser, down the chase onto the false ceiling. The first time a leak of significance occurred, the fluid collected in the false ceiling and was held there until the plaster of the false ceiling gave way as shown in Figure A-2.

Figure A-2. Ceiling water damage.

This leakage caused no deterioration of the second floor slab's structural strength, and the fluids did not penetrate the concrete floor slab. There is no visible degradation of the floor slab, and it is highly unlikely there has been any degradation. In addition, the main part of the equipment room is over the radiography room where the floor slab is 2-feet thick.

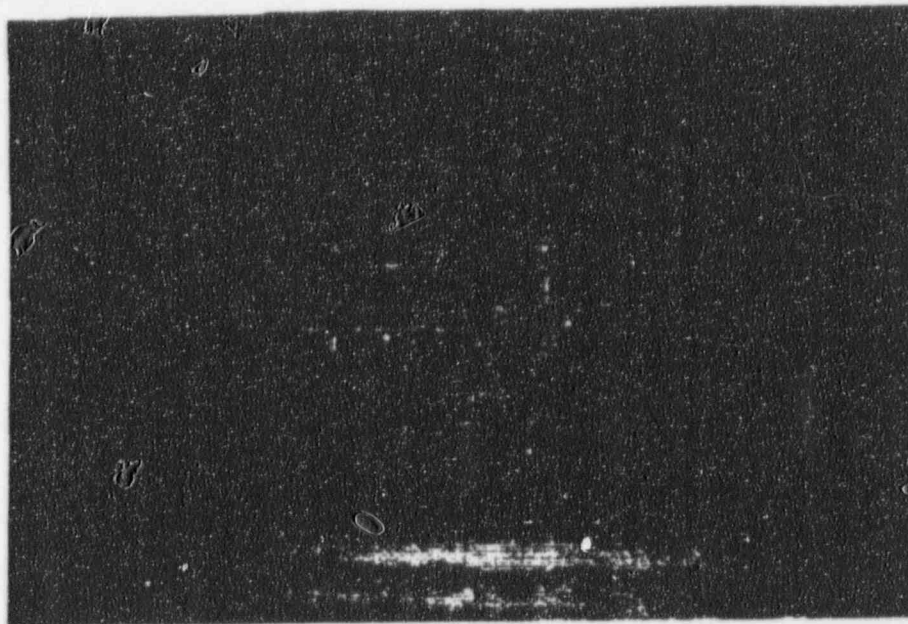
Figure A-5. Cracking on the inside wall.

Unfortunately, it is difficult to tell what actually caused cracking at the southeast corner of the building. As noted in the NRC report, the structural support of the 1958 building is a mix of load and non-load bearing masonry and concrete block, reinforced concrete, and steel framing. These materials are not compatible from an aging and expansion standpoint. In addition, the stiffness properties of the structure vary from extremely stiff (the test cell and radiography room) to very flexible (the lobby area). Thus, in a building over 30 years old with these types of similarities, one should expect to see cracking of this type; however, this cracking appears to have a unique cause. As noted in the NRC report,

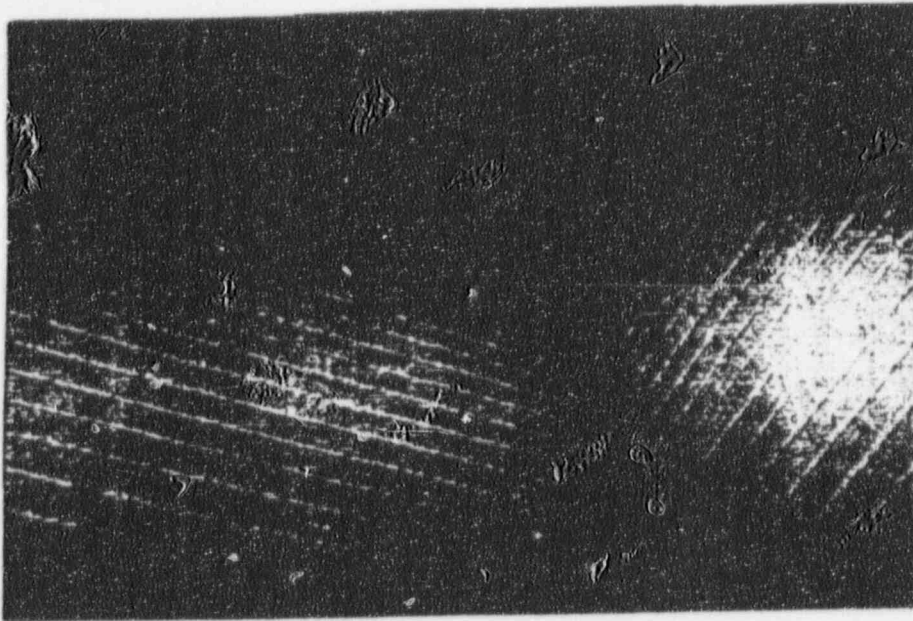
Figure A-7. Wall movement at purlin in corner.

wall was noted from the outside, however, some cracking was noted in the load bearing wall beneath the purlin.

5.14 RESPONSE: It is the opinion of the reviewer that this movement has nothing to do with what has happened at the southeast corner of the building. The biggest problem with the construction of this building is that none of the interior non-load bearing walls were interlocked or tied in with any of the structural members, and most of the non-load bearing walls have separated leaving visible cracks from adjoining walls. The location of the cracking in question is shown in Figure A-8 and, as indicated in the NRC report, the crack opening is approximately one inch. This wall is the west side of a right angle interior wall forming a small room in the southeast corner. If the north side of the interior wall is compared to the paint lines on the roof decking, it is evident that the entire top of the non-load bearing wall has moved northward about one inch. There is no evidence that the purlin has moved southward at this location.

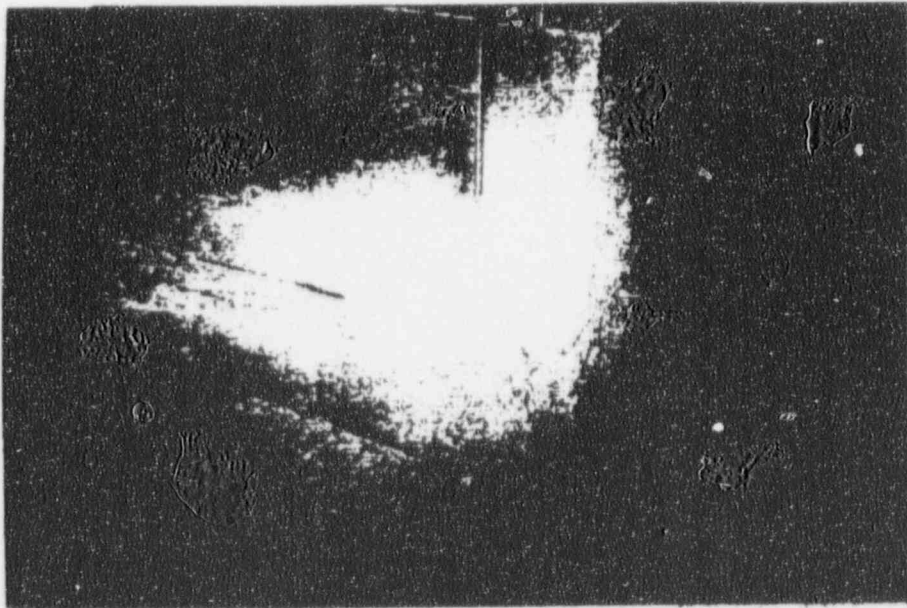
5.16 RESPONSE: It is believed that the failure of the stone corner at the bottom of the wall has resulted from a totally different cause, but may have something to do with the in-filled wall movement at the second floor. This stone corner is located next to the lobby entrance of the 1958 building. Upon inspection of the site, it is very apparent that the joint failure of the mortar has been caused by salting the lobby entrance to remove snow and ice. The stone facing is discolored where the salt was thrown as shown in Figure A-9, and where discoloration has occurred, mortar in the joint was attacked. At a distance of approximately one foot north of the south corner of the stone, there is no stone discoloration and the joint is intact. As a result of joint failure, the stone has fractured. Again this is a life-safety issue and has no bearing on the structural stability of the 1958 building.

Figure A-9. Lobby stone showing salting.

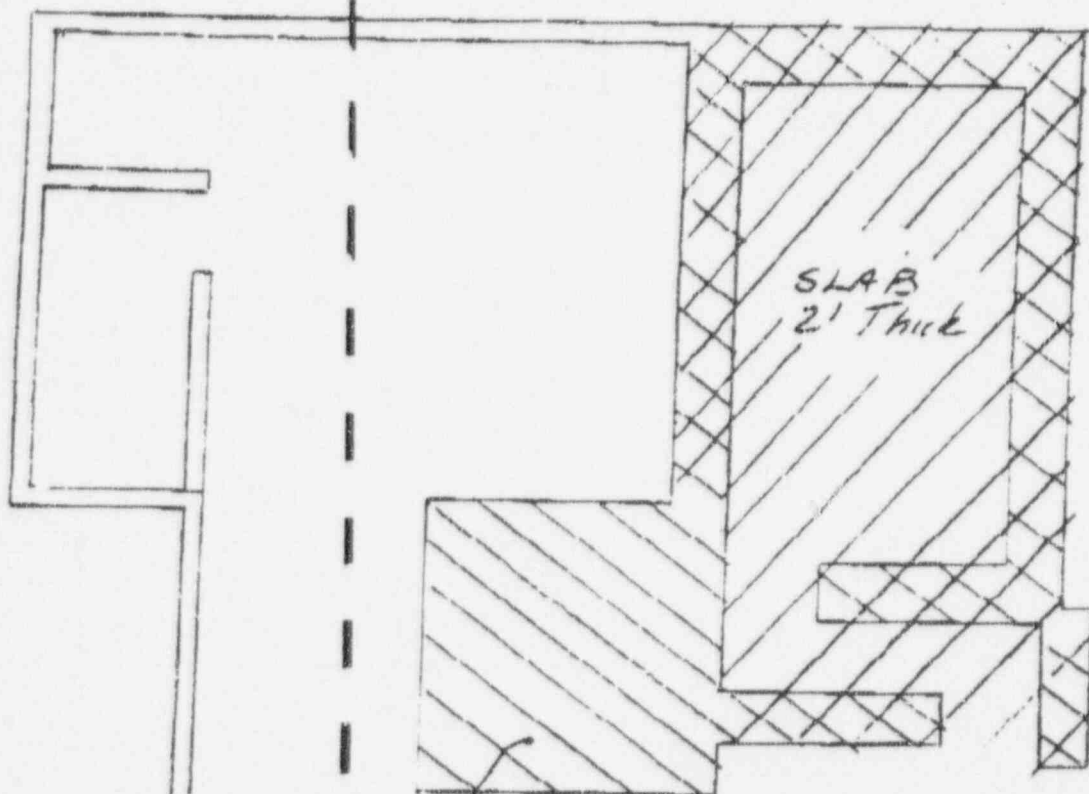
Test Cell & Radiography  
Rigid Bodies

All lateral load transferred to second  
floor will go into test cell and  
radiography rigid bodies

Above the second floor you have a rigid roof diaphragm

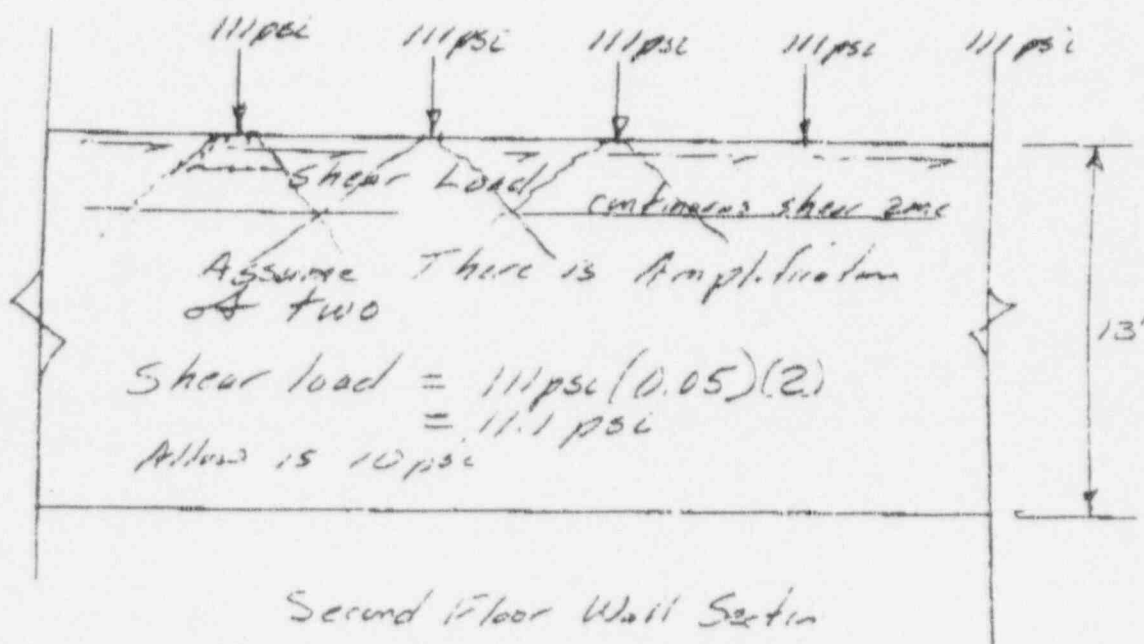
Allowable Shear Load In Unreinforced Masonry is 10 psi

Gross Area Supporting Purlin Load is approximately  $8' \times 8' \times 12" = 768 \text{ in}^2$

$$\text{Shear} = \frac{6240}{768} (.05) (2) = 0.82 \text{ psi} < 10 \text{ psi}$$
