U.S. NUCLEAR REGULATORY COMMISSION

Reports No. 50-454/85022(DRSS); 50-455/85020(DRSS)

Facility Name: Byron Nuclear Power Station, Units 1 and 2

Inspection Summary

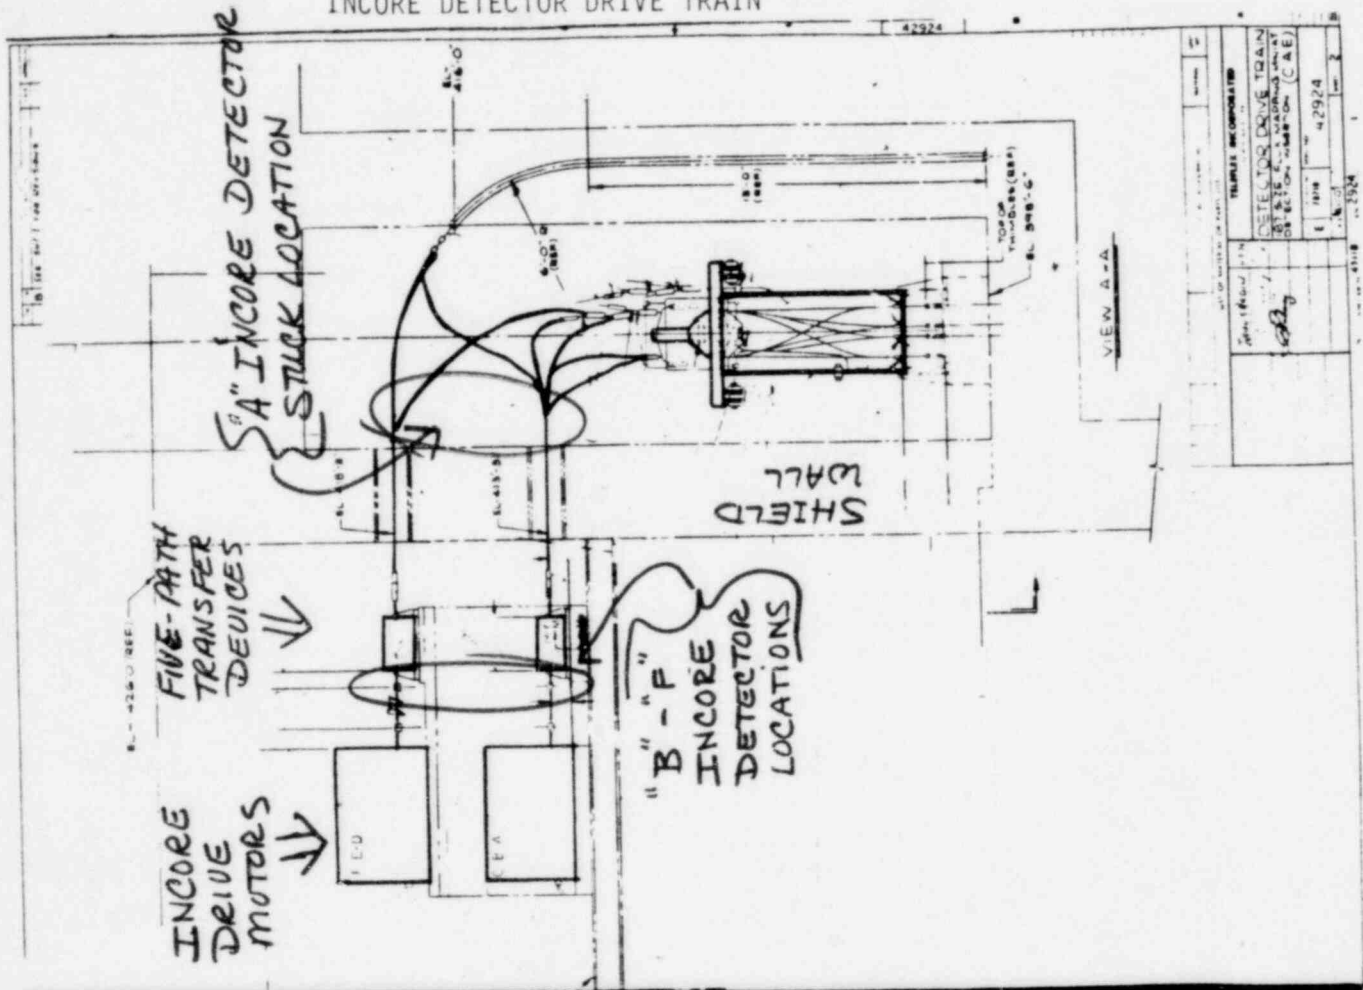
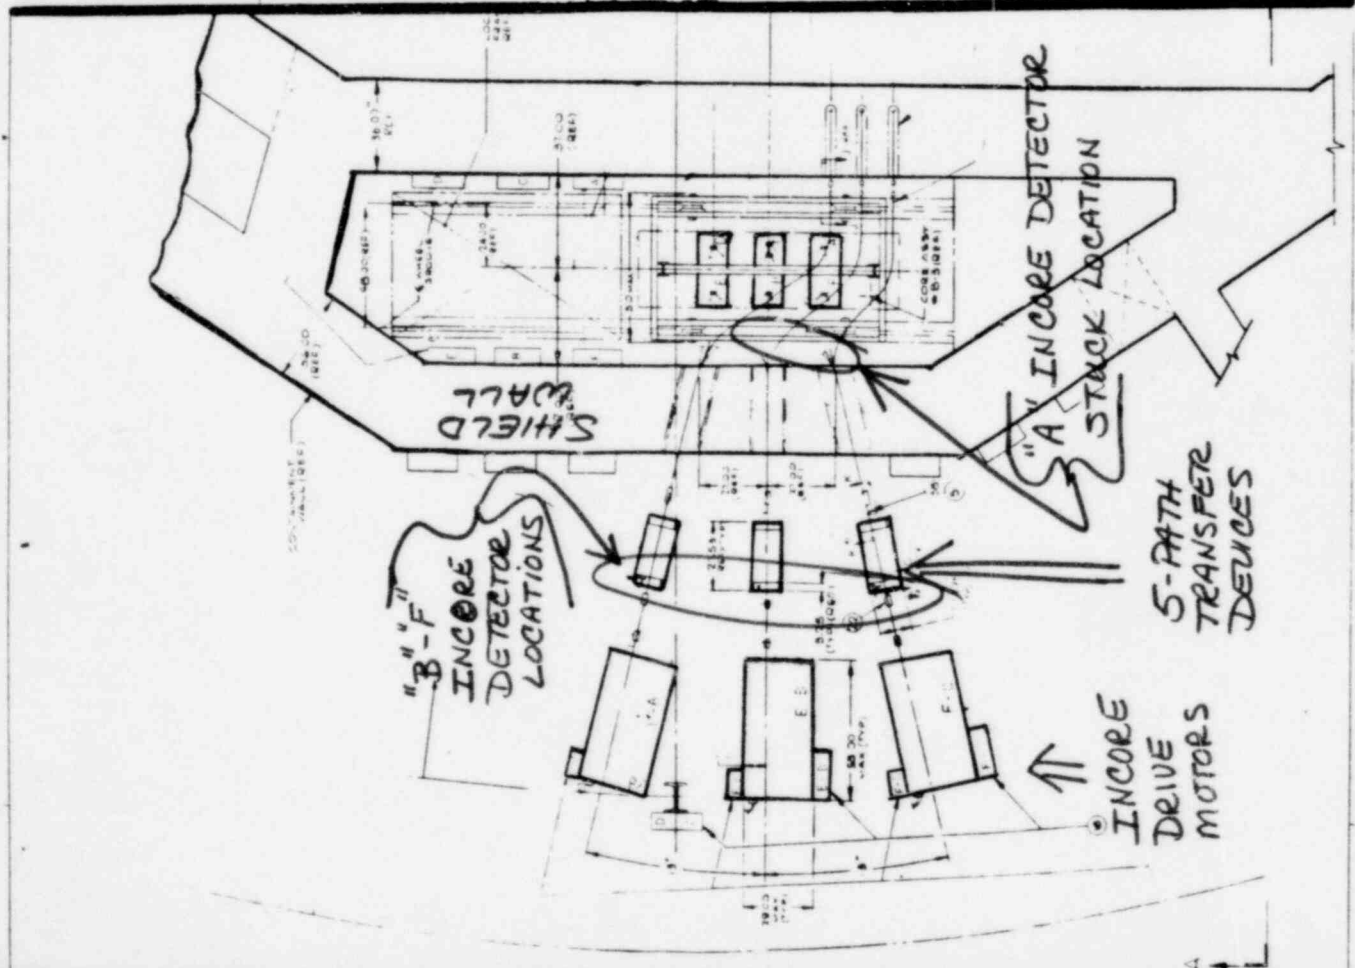
# INCORE DETECTOR DRIVE TRAIN

The SE, HP foreman, RCTs, and EMs were unaware of the withdrawn position, of the incore detectors, and the associated high radiation fields while planning this entry. This resulted from (1) inadequate communications between the technical and control room staff involved in the flux mapping procedure, who were aware of the potential radiological hazard, and the SE, who stated he was unaware of the incore detector locations and the radiological hazards, and (2) inadequate followup by the SE and HP foreman to verify the incore detectors' positions. Also the HP foreman and RCTs did not recognize the inherent radiological hazards associated with the incore detectors. A review of the radiation-chemistry training program indicated that no formal training addressing reactor systems and associated radiological conditions had been provided to radiation protection personnel.

The incore detectors, other than the stuck detector, should have been returned to their shielded storage positions prior to a containment entry. They were not, partially due to the communication and evaluation problems noted above, but also because of the lack of adequate precautions in the procedure used for flux mapping. Flux map testing was conducted in accordance with BOP-IC-03, Incore Moveable Detectors - Partial Core Flux Mapping, just before the detector became stuck. This procedure did not include a restriction prohibiting containment entry while the incore detectors were withdrawn as did a comparable procedure, BOP-IC-01: Incore Moveable Detectors - Flux Mapping Procedure. It is standard practice to prohibit containment entry with the incore detectors in unshielded locations.

No area monitor was located at the incore drive area; therefore local radiological conditions could not be predicted before entry. An area monitor was located in the 401' level seal table room, which is shielded from the incore drive area by approximately 36 inches of concrete. This monitor readout reflected the stuck incore detector but not the other five incore detectors at their five-path position near the jobsite. Although it was determined that the rad/chem personnel involved in this event were unaware of the monitor's location, this weakness did not affect the licensee's involvement in this incident since the monitor readout was not evaluated by the rad/chem personnel before this entry.
