HOMESTAKE MINING COMPANY

RE: Docket No. 40-8903
License No. SUA-1471
Quantitative Review of Outslope Rock

Quantitative Review of Outslope Rock

Photographs of Test Area No. 1

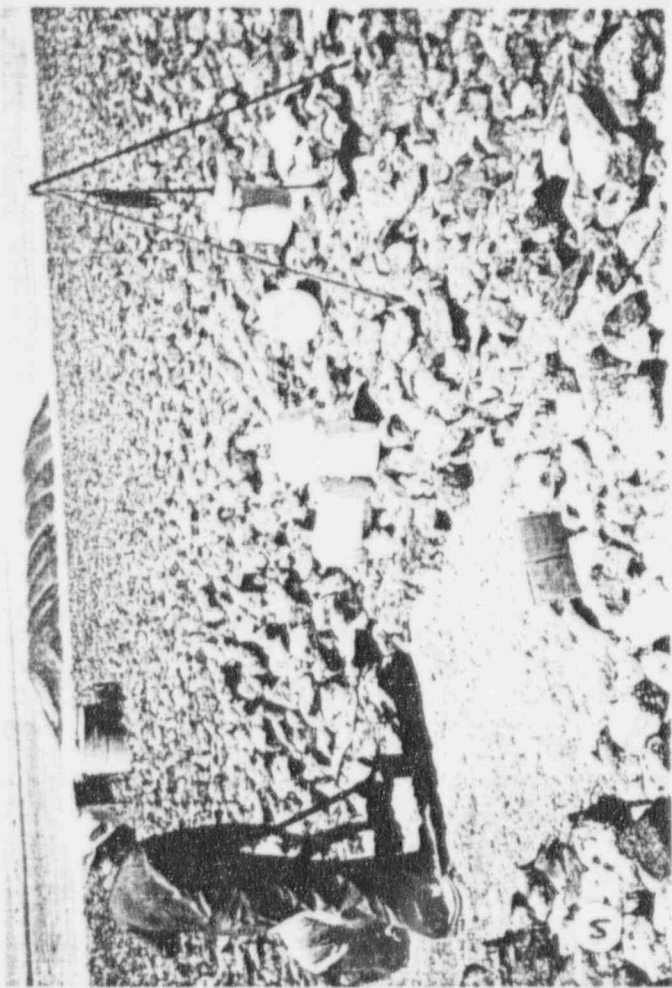
Picture No. 5

TEST AREA NO. 1 - PREPARE
BED TO REPLACE ROCK

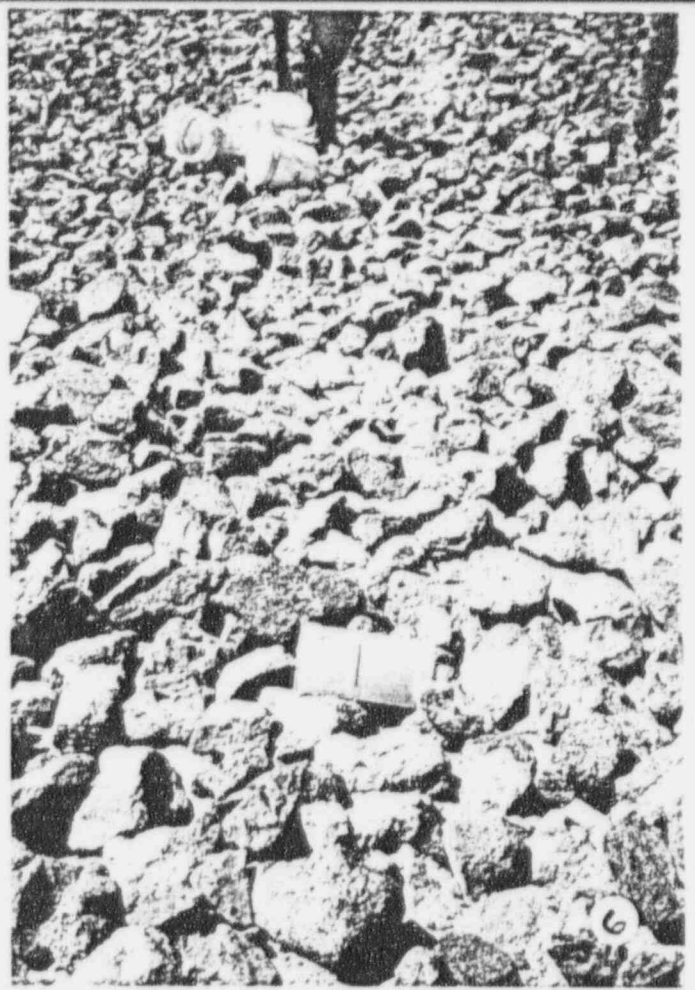
Picture No. 6

TEST AREA NO. 1

Completed - ROCK
REPLACED
