Subject: Arkansas Nuclear One - Unit 1
Docket No. 50-313
License No. DPR-51
Additional Information Related to Inservice Inspection of Once Through Steam
Generator Tubes (TAC. No. M97485)

Response to NRC Request for Additional Information Related to Inservice Inspection of the Once Through Steam Generator Tubes

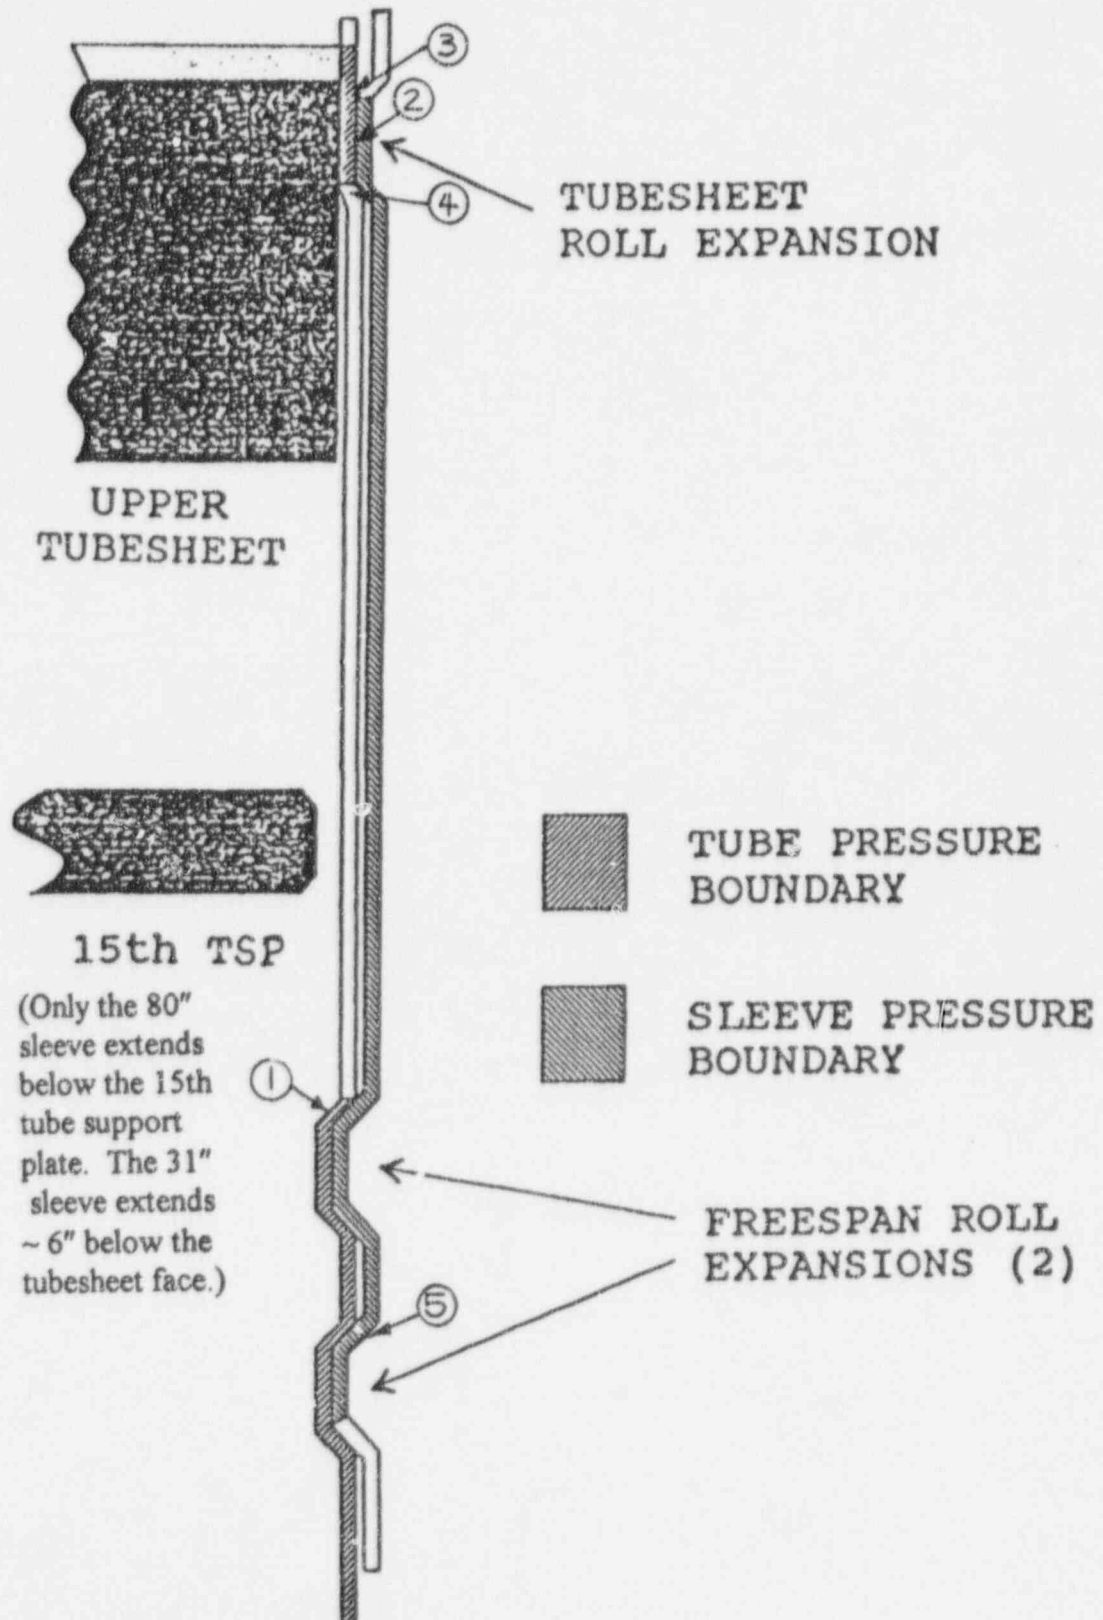
Typical OTSG Sleeve Arrangement

A 100% Plus Point inspection of the inservice sleeve roll transitions was performed in 1R13. Ten sleeved tubes were identified with degradation type indications. Nine of the indications were determined to be in the parent tubing, while the last one was in the sleeve. Of the nine indications in the parent tubing, six were circumferential and three were axial. The single sleeve indication was circumferential. The following table provides a summary of the tubes and indications. The attached figure depicts the locations of the indications.

Upper Lower Roll, Upper Transition Indication (1): The single indication detected in this region of the sleeve was in the parent tube. The pressure boundary in this region of the sleeve consists of the combined wall thickness (.079") of the tube and sleeve. Conservatively assuming that the tube defect was a complete sever, the remaining sleeve wall thickness of 0.45" is more than adequate to maintain integrity for 3ΔP loadings. Qualification testing for the OTSG sleeve conservatively simulated the tube in a severed condition between the two roll regions and utilized 3ΔP loading conditions. The testing produced a maximum end-of-life leak rate of 11.39 ml/hr (5.0×10^{-5} gpm) and an average leak rate of 3.51 ml/hr (1.55×10^{-5} gpm) for the sleeve.

Upper Roll Expansion (2); Upper Roll, Upper Transitions (3); Upper Roll, Lower Transition (4): These indications were detected in the parent tubing in the upper rolled joint of the tube and sleeve. The indications would be precluded from burst at 3ΔP based on the increased wall thickness of the pressure boundary. Additionally, tubes with flaws constrained within the tubesheet have been tested by EPRI and the B&W Owners Group without bursting. Any leakage associated with these indications under accident conditions would be limited by the interference fit between the tube expansion and the tubesheet, and is not expected to contribute to the total accident leak rate. The sleeve qualification testing showed that the majority of sleeve leakage is attributed to the lower freespan roll region of the sleeve, not the tubesheet rolled region.

Lower Lower Roll, Upper Transition (5): This indication was detected in the sleeve in the upper transition of the lower roll. This indication is typical of an installation anomaly that has been identified in post-installation eddy current examinations of newly installed I-690 sleeves in other OTSGs. These types of sleeve inner diameter (ID) indications have been re-created in mock-up testing by Framatome Technologies, and were mainly due to the heel of the roller catching or dragging on the transition during the retraction of the tool. However, because this sleeve had been in service since October, 1988, and was fabricated of I-600, a material more susceptible to primary water stress corrosion cracking (PWSCC) degradation, the affected tube was conservatively removed from service. Based on the eddy current testing results from 1R13, no indications were reported in the parent tube in the vicinity of the reported sleeve indication. The parent tube therefore maintains its ability to withstand the primary-to-secondary pressure differential. Failure of the tube by burst is therefore precluded.
