**EXAMINATION OF A BOLT WITH BORIC ACID ATTACK  
FROM THREE MILE ISLAND NUCLEAR GENERATING STATION**

**February 1995**

**Environmental and Waste Technology Center  
Department of Advanced Technology  
Brookhaven National Laboratory  
Upton, New York 11973**

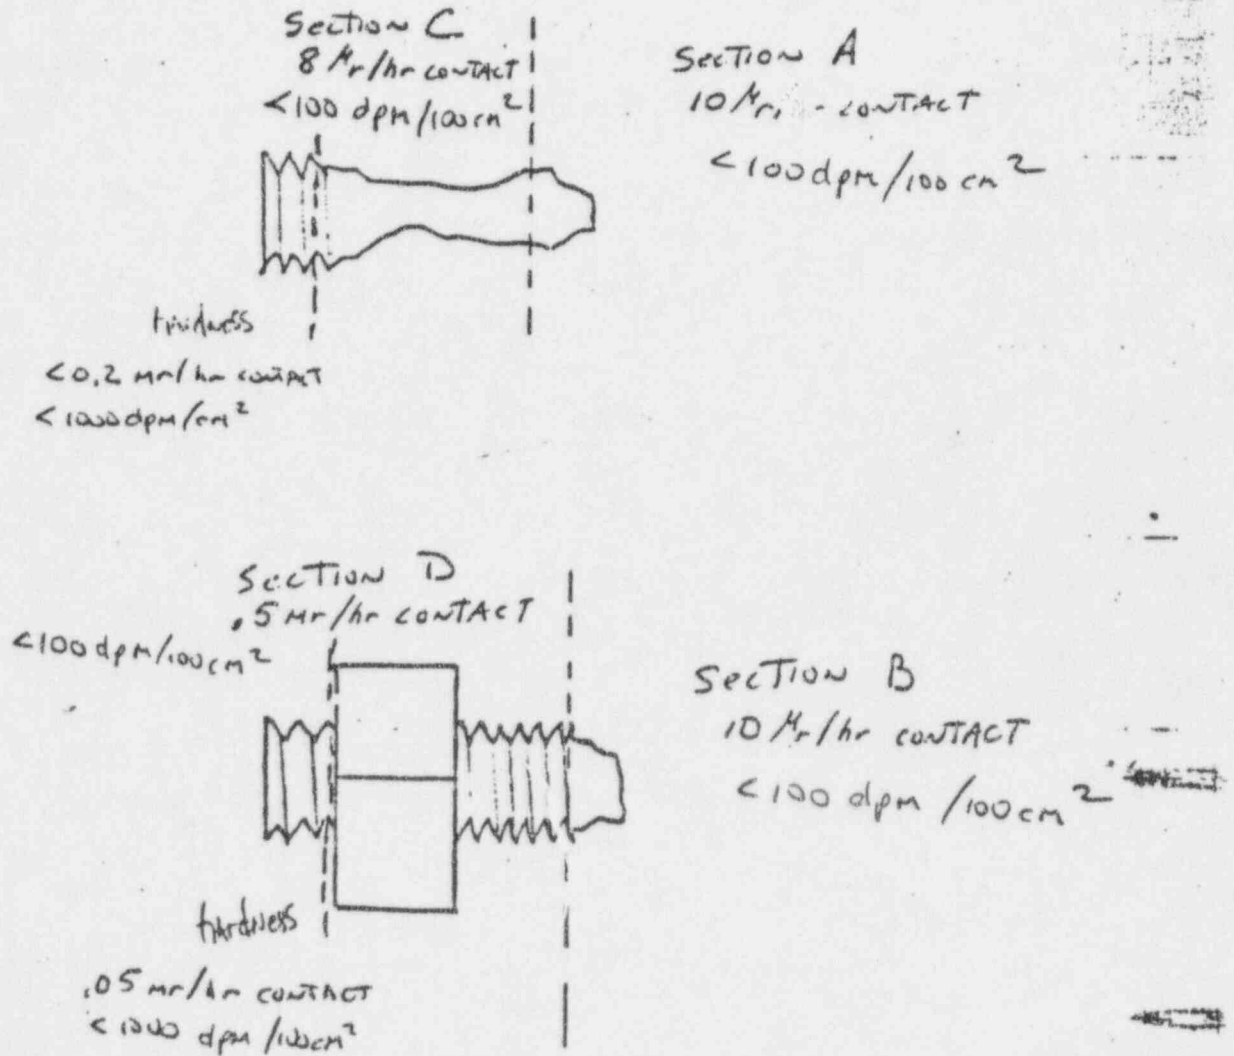
Figure 2. BNL Drawing of TMI Stud pieces showing cuts for hardness test and SEM samples.

Two pieces of the "bolt" to be examined were received at BNL, accompanied by the paperwork shown as Figure 1. According to this document, the pieces were stated to be item #2 in the drawing having 46,000 disintegrations per minute (dpm) smearable contamination and a contact reading of 4 millirem/hour (mrem/hr). The "bolt" was actually a threaded stud, and was covered with rust-colored corrosion. A BNL drawing of the stud pieces "as received" is shown in Figure 2. This figure also indicates the section cuts for the tests described below.

Hardness tests were conducted on the two stud piece ends cut as shown in Figure 2, such that the cut piece was as long as the thickness (5/8 in). Test results are shown in Table 2.

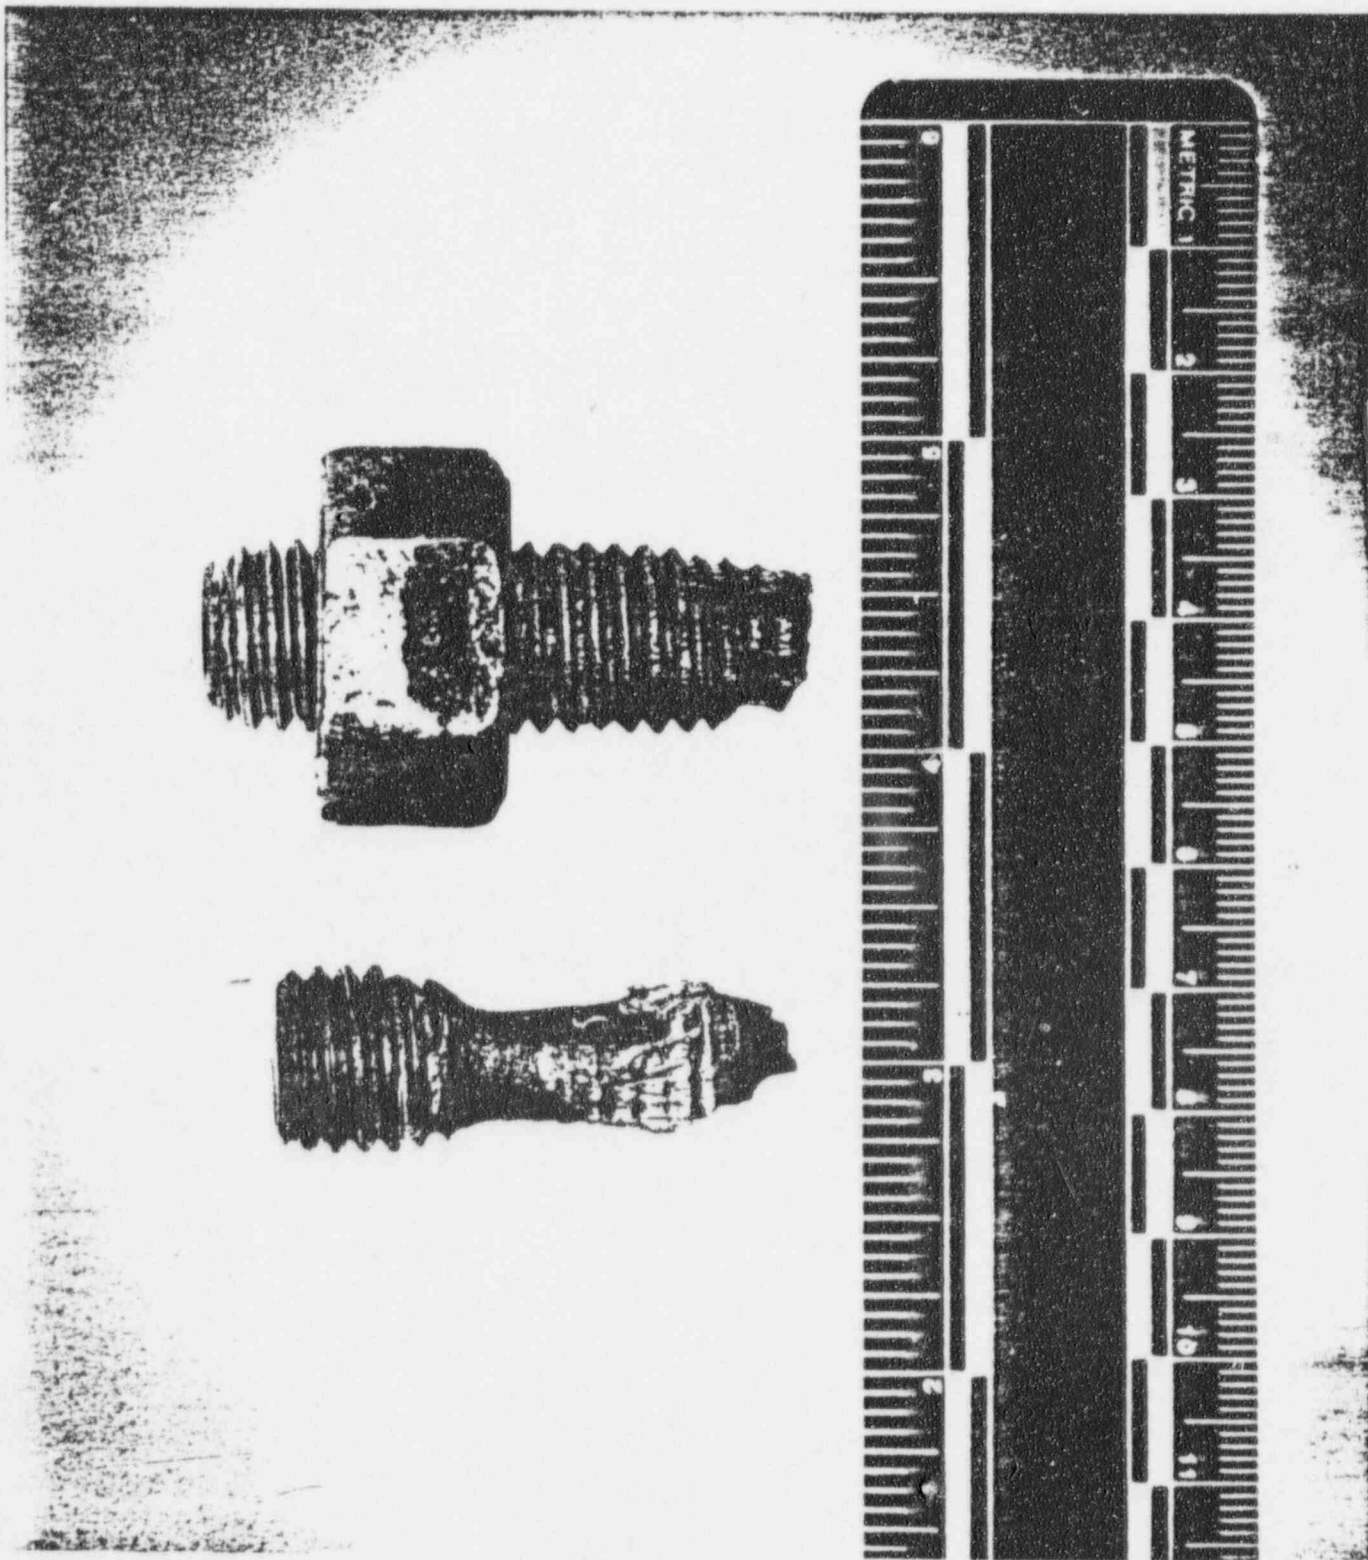
Figure 3. Side view of TMI stud pieces.

The bolts were photographed following decontamination, as shown in Figures 3, 4 and 5. In spite of the cleaning for decontamination purpose, the surfaces of the nut and stud pieces exhibited significant corrosion. Stud piece A (no nut) showed visual evidence of having been stretched, with the threads deformed, as if they had been stripped. The threads on the stud piece B with the nut in place were deformed (possibly due to galling) on the side of the nut with the fracture face present. (The ASM [Ref. 2] defines galling as "developing a condition on the rubbing surface ... where excessive friction between high spots results in

Stud pieces A and B were sectioned as shown in Figure 2, to remove the fracture faces for scanning electron microscopy (SEM). Figure 3 is a side view of the two pieces before sectioning, and after decontamination.

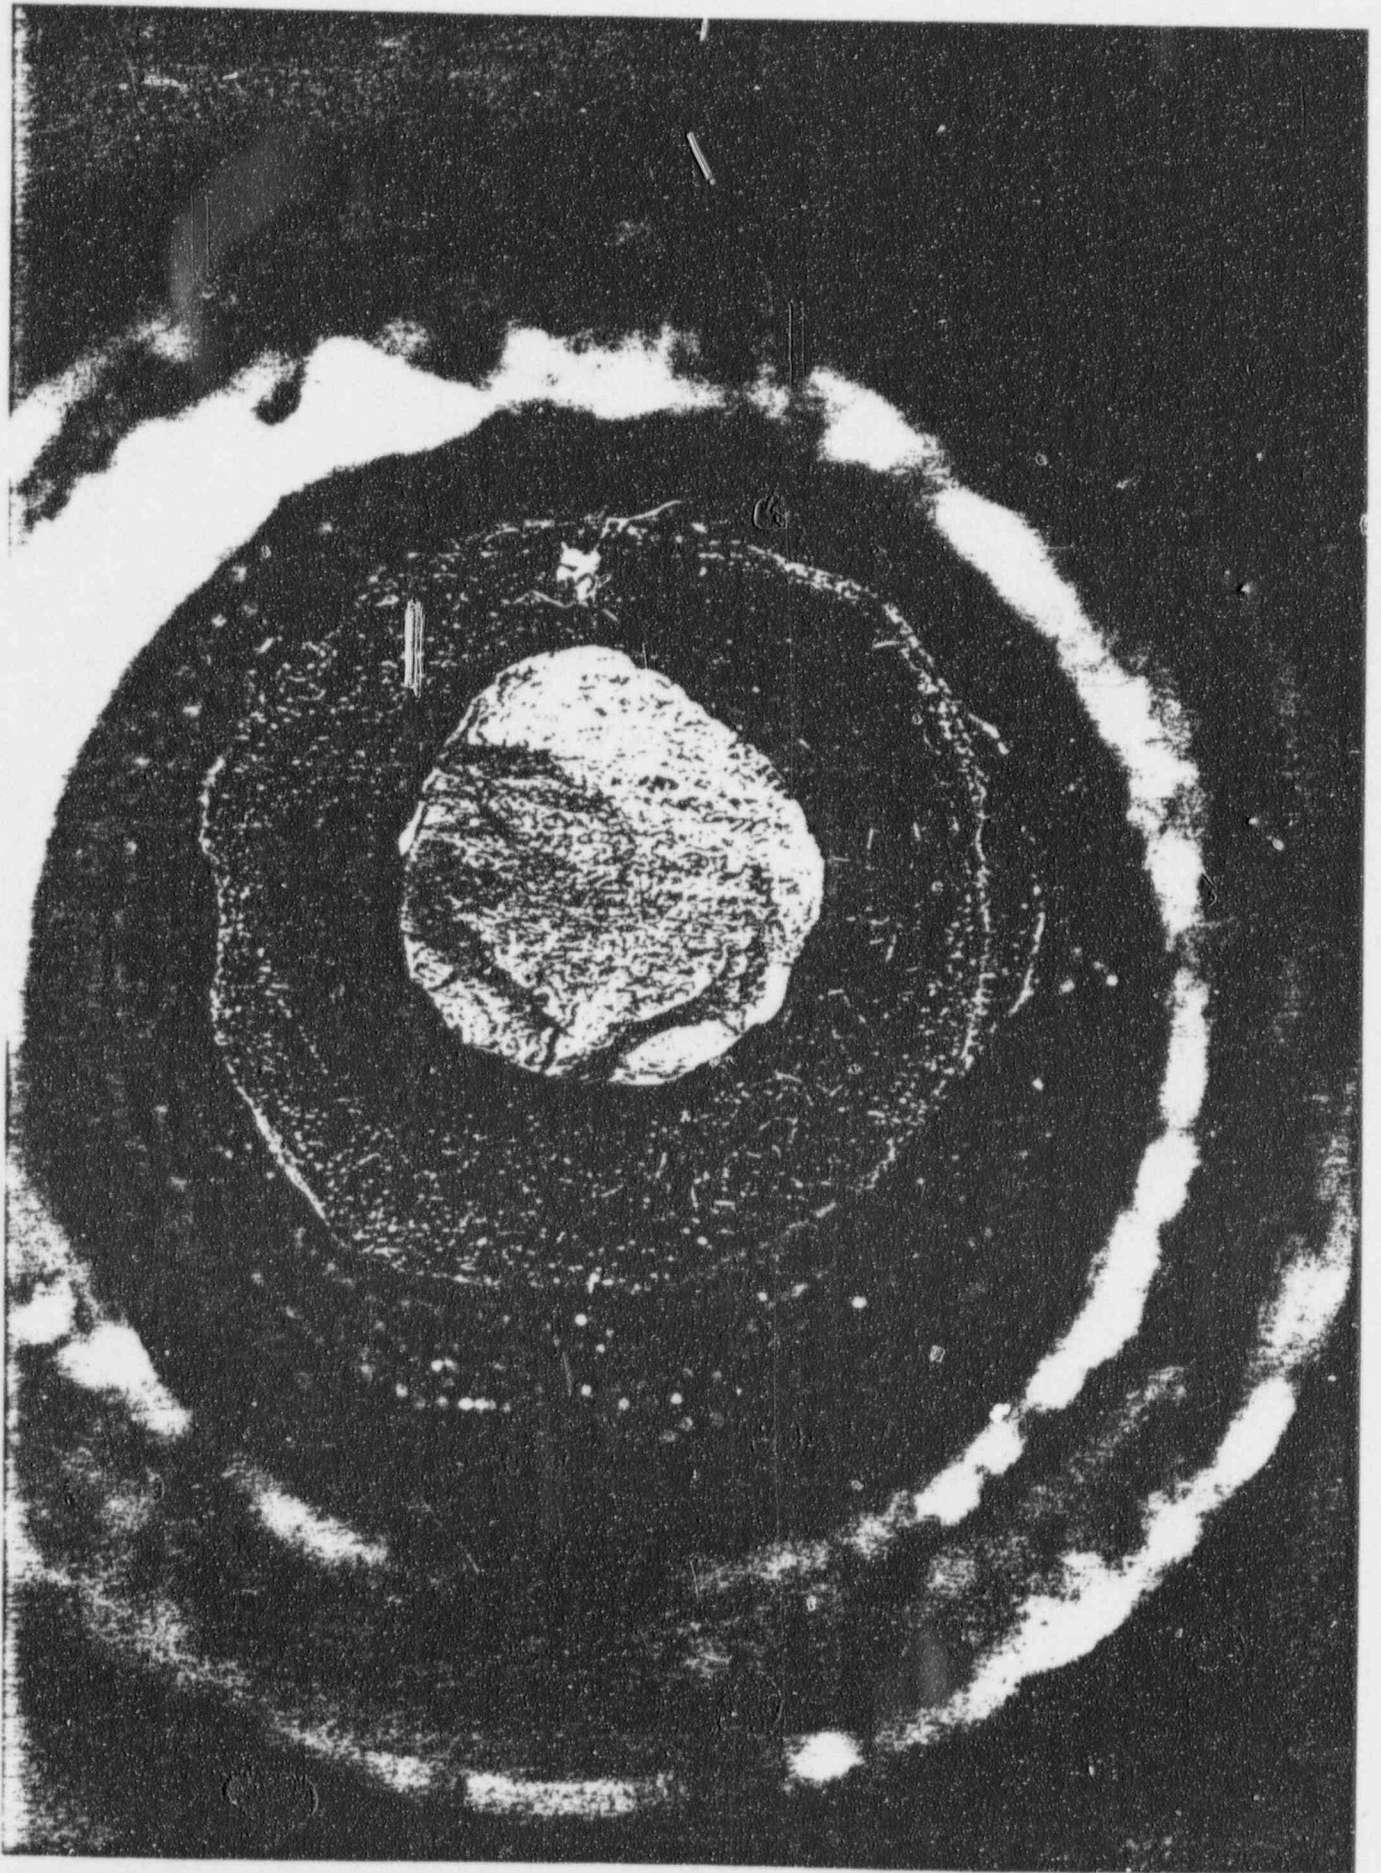
Figure 4. Fracture face of TMI stud piece B.

The visual appearance of the fracture faces (Figures 4 and 5) indicate that the stud pieces were from two separate failed studs. Fracture face B (Figure 4, from the stud piece with the nut) was heavily corroded around the threads, but the fracture face appeared as the tip of a relatively intact central core. Fracture face B is relatively flat compared to face A (Figure 5) on the other piece. Face A is pointed, being much smaller in area, and is surrounded by a larger area of general corrosion. The general corrosion seen in these and the SEM photomicrographs below is consistent with the wastage corrosion seen in other cases of component failures due to boric acid attack (Ref. 6).

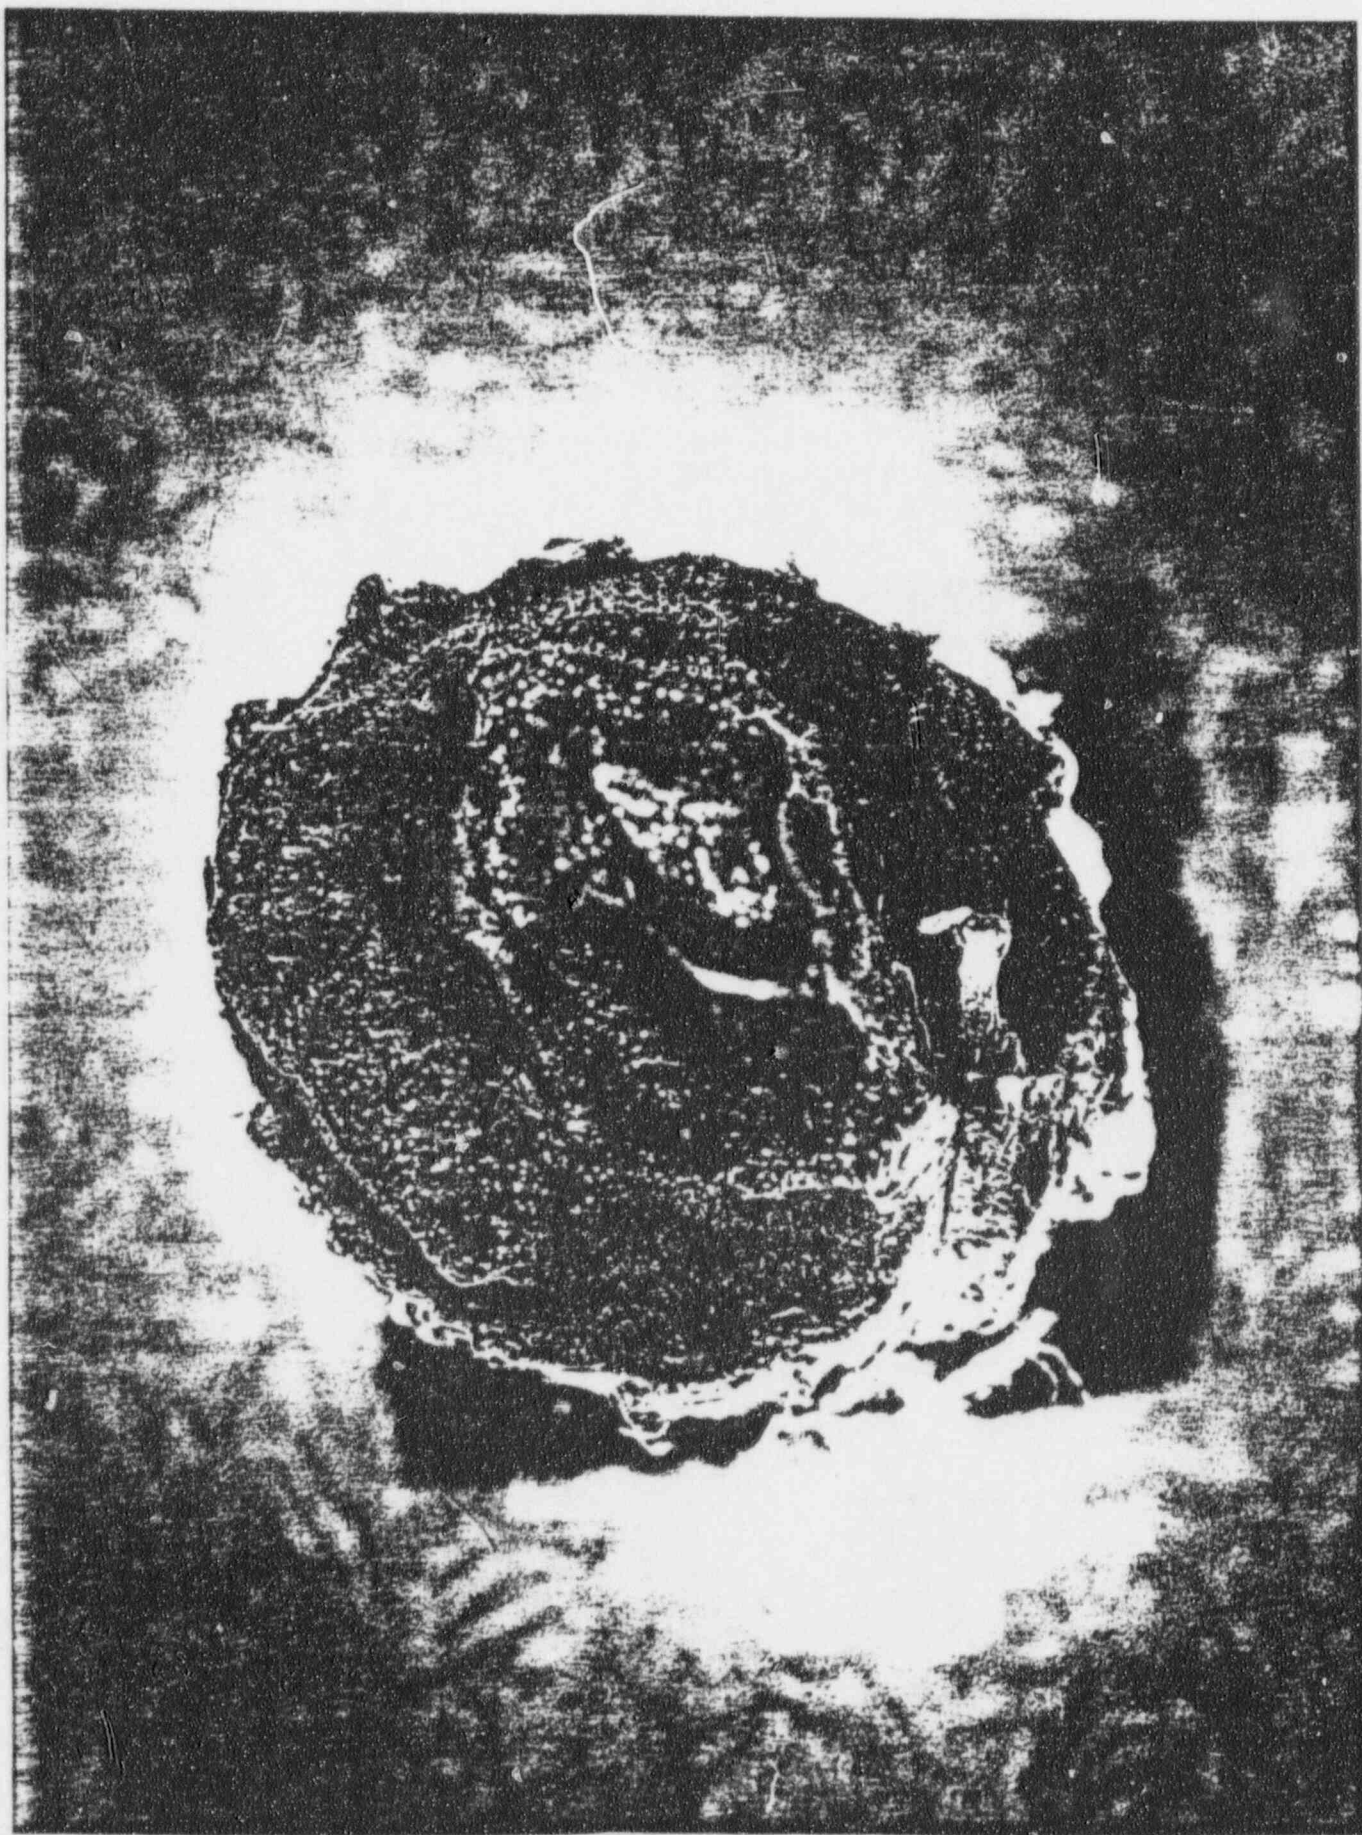
Figure 5. Fracture face of TMI stud piece A.

Visual and SEM examination of the two fractures confirm the presence of general corrosion in both pieces which contributed to the failure of the studs. Face A appears to have undergone more corrosion and some wear before failure, which seems to have been induced by tensile stress. In Face A, the wear before failure is evidenced by the stretched and missing threads on the stud. Face B, in addition to the possible fatigue marks in two locations, has indications of a torsional stress in its overall appearance. It may have failed when the stud was removed.

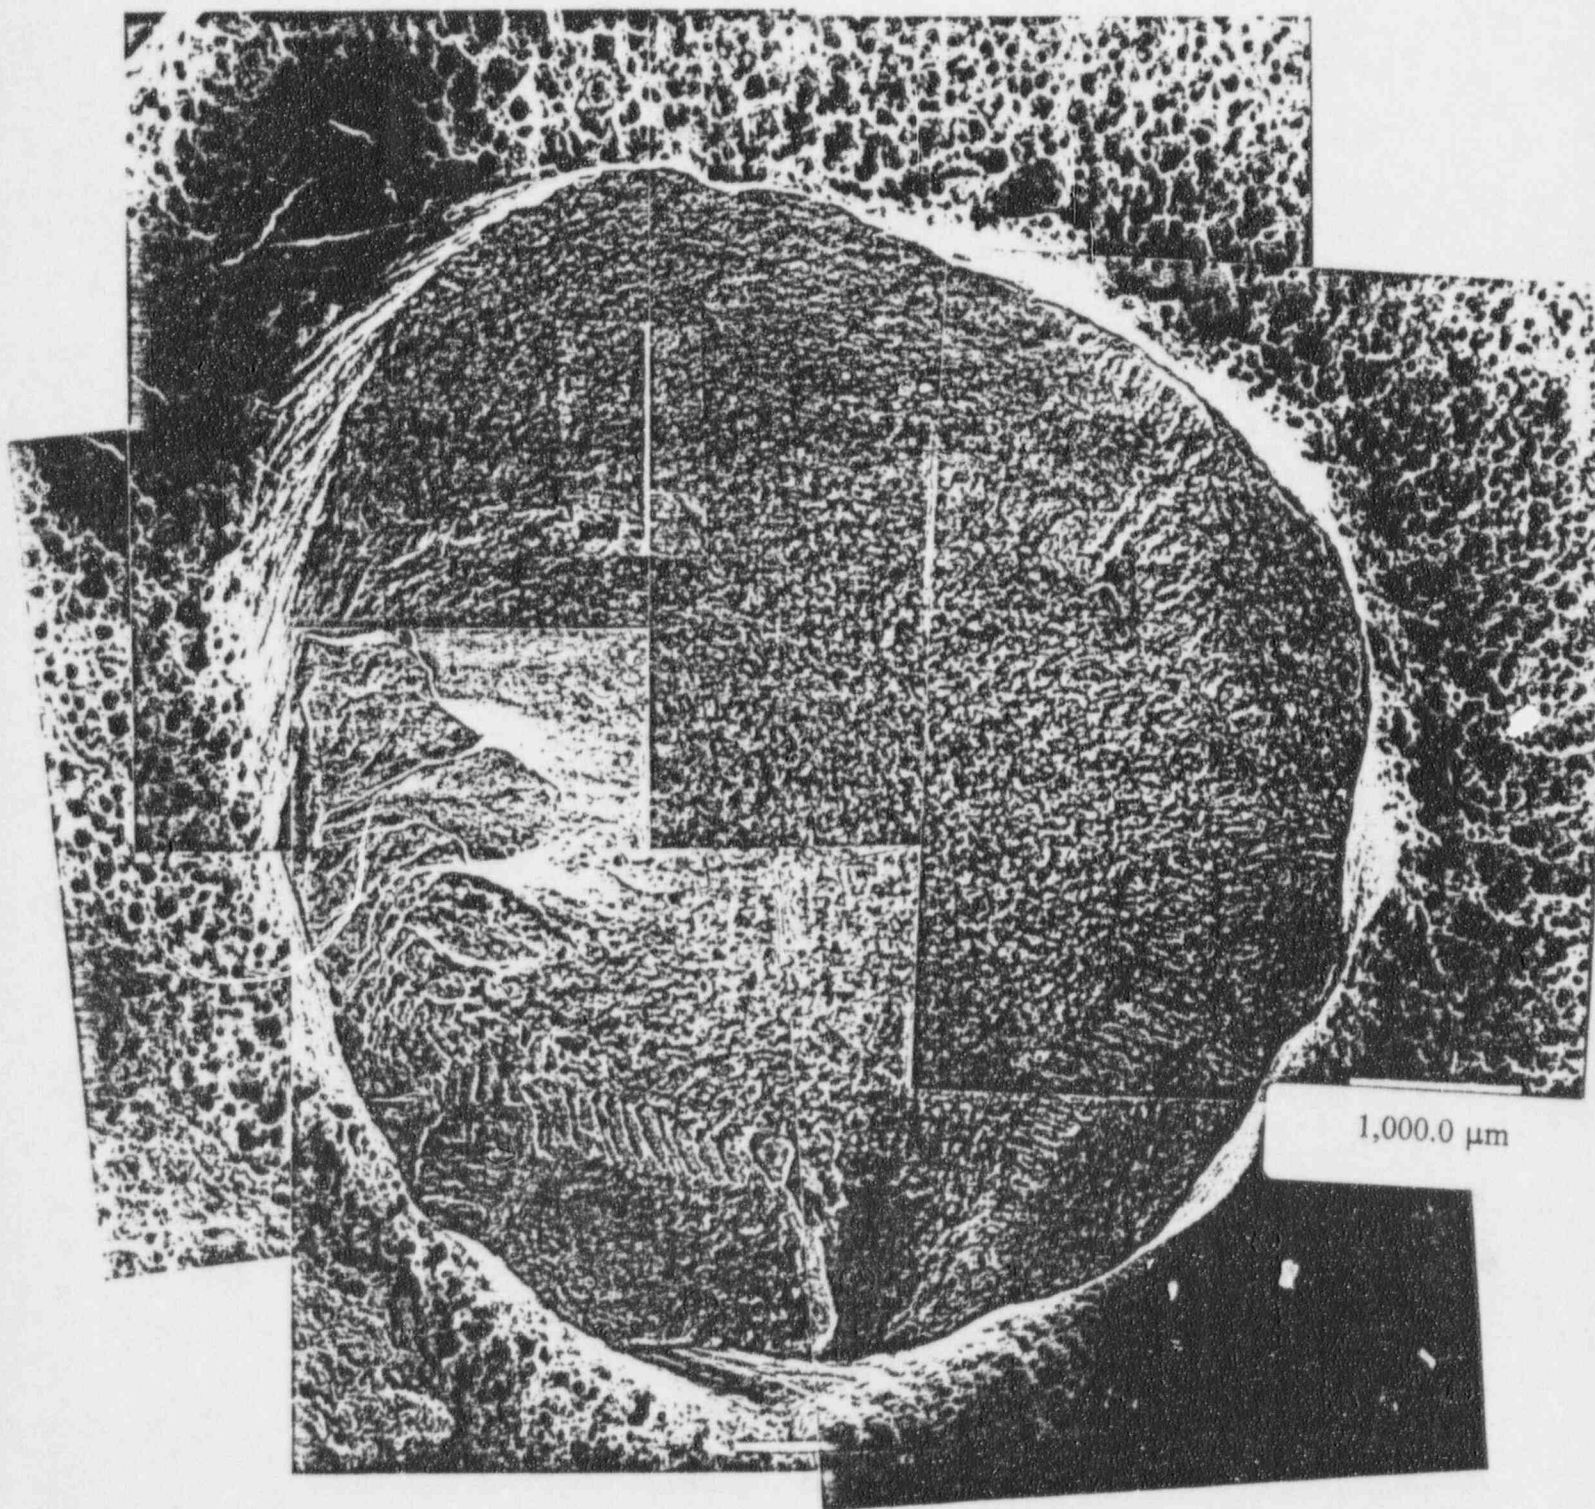
Figure 6. SEM photomicrograph of stud fracture face B (25 kV, 22 x magnification)

SEM photomicrographs of the fracture faces are shown in Figures 6 and 7 (both at 22X magnification). Fracture face B (Figure 6) has two areas with ripple marks which suggest a fatigue-assisted failure. The non-corroded portions of both faces A and B indicate ductile rupture. The SEM micrographs of both fracture faces confirm that they are from two separate studs.
