PERRY NUCLEAR POWER PLANT DEVIATION ANALYSIS REPORT

ITEM Ruskin Fire Dampers	LOCATION Perry Nuclear Power Plant	QUANTITY 85
ORIGINATOR <i>MAB</i> M. A. Brown <i>RLV</i>	ORGANIZATION Construction Quality Engineering	DATE 8/8/80
RESPONSIBLE ORGANIZATION Ruskin Manufacturing Company	SPECIFICATION SP-49/91	REFERENCE DOCUMENTS See Attached

Subject: Ruskin's Vertical Spring Close IBD Fire Dampers

Subject: Vertical Spring Closure NIBD23 Fire Dampers

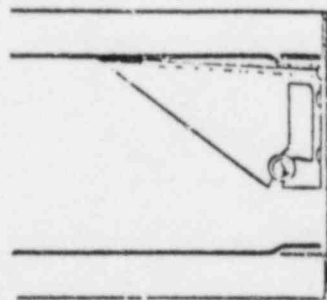
Although it appears that this method should have eliminated the problem, an engineering firm has indicated to us that some of the screws worked loose during shipment. This raises the possibility that the use of screws as a fix is questionable. We therefore request that you stop any activity relative to the installation of this fix.

ORIGINAL FIX USING
#6 SCREW, WASHER, NUT
LOCKWASHER & NUT

INSTALLATION OF
PROPOSED BRACKET
CLAMP (SEE DETAIL
PAGE ALSO)

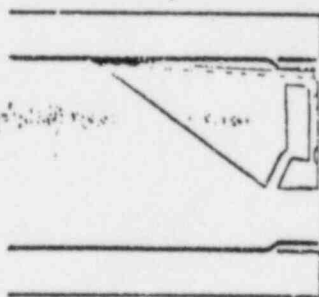
TOP EDGE OF BRACKET
TACKWELDED TO PROVIDE
EXTRA SUPPORT FOR
BRACKET & RESULTING
ALTERATION OF SPRING
SLOT

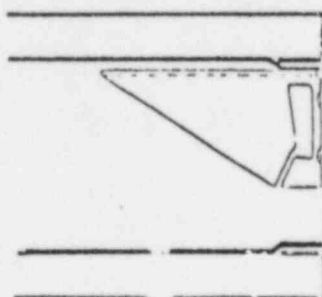
ORIGINAL INSTALLATION
(VERTICAL FIRE DAMPERS
WITH SPRING CLOSURE)

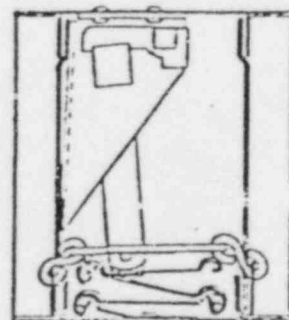
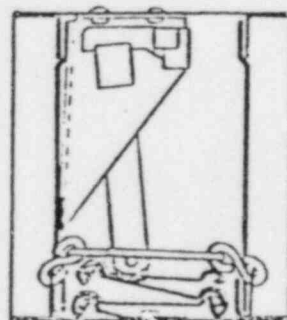
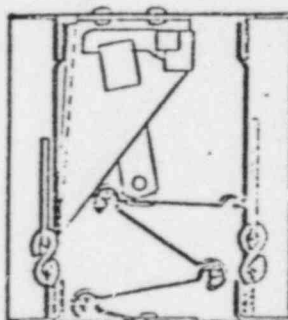
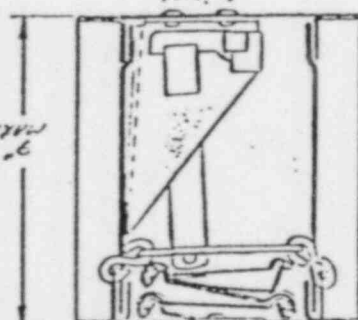
A second problem has also been brought to our attention. If the blade package in vertical units less than 9" high is shifted such that the leading edge of the bottom blade rests higher than the trailing edge, the blades may jam when released.

ABOVE THE GLASS PICKUP
HAS BEEN SHIFTED PLACED
THE LEADING EDGE OF
THE BOTTOM BLADE TO BE
ABOVE THE TRAILING
EDGE - IF THE FUSE
LINK MELTS WITH THE
BLADES IN THIS POSITION,
THEY WILL JAM AS IN
THE NEXT DETAIL

BLADE PICKUP JAMMED

Ruskin has developed a snap-in strip which when installed will hold the bottom blade in the proper orientation and insure complete and consistent closure (see drawing 5565).

VERTICAL DIBOZ
AS SHOWN, THE ORIFER
WILL CLOSE COMPLETELY
AND CONSISTENTLY WHEN
THE FUSE LINK MELTS

CAMPER WITH SLIP IN
STRIP (SHOWN AT RIGHT)
INSTALLED, SIDE LEADING
EDGE IS HELD BELOW
TRAILING EDGE OF BOTTOM
BLADE, UNIT CLOSSES
COMPLETELY & CONSISTENTLY
