U. S. NUCLEAR REGULATORY COMMISSION

Report No.: 45-25088-01/96-01

Licensee: Professional Service Industries, Inc.

Professional Service Industries, Inc.
Bristol, Virginia
Inspection Report 45-25088-01/96-01

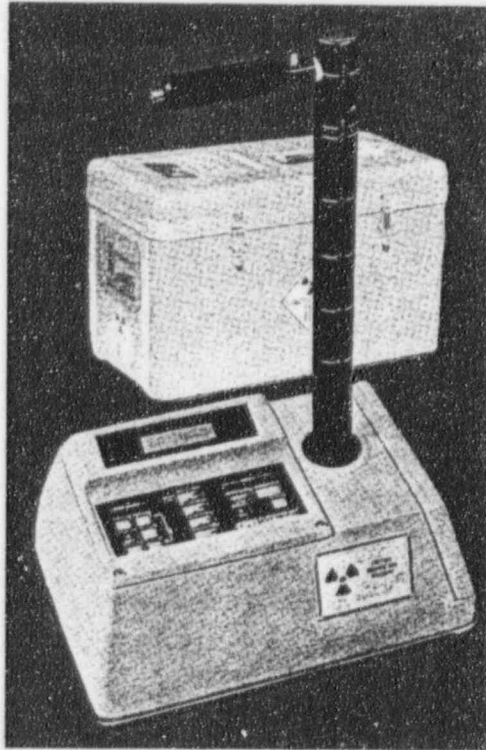
Figure 1

The Boart Longyear Company (previously CPN Products) Model MC-1, is a portable moisture density gauge (see Figure 1) used to measure moisture and density of various items such as soils, embankments, concretes, and

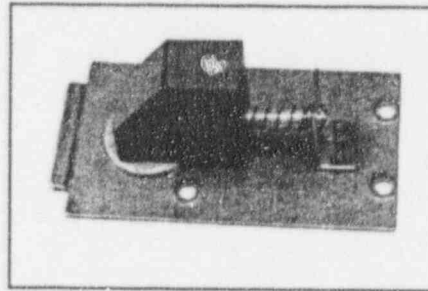
Figure 2

A shutter assembly is located beneath the end of the guide tube and shields the end of the source rod. The shutter assembly consists of a carbide/tungsten block, bolt/spring combination and a shutter plate (see Figure 2).

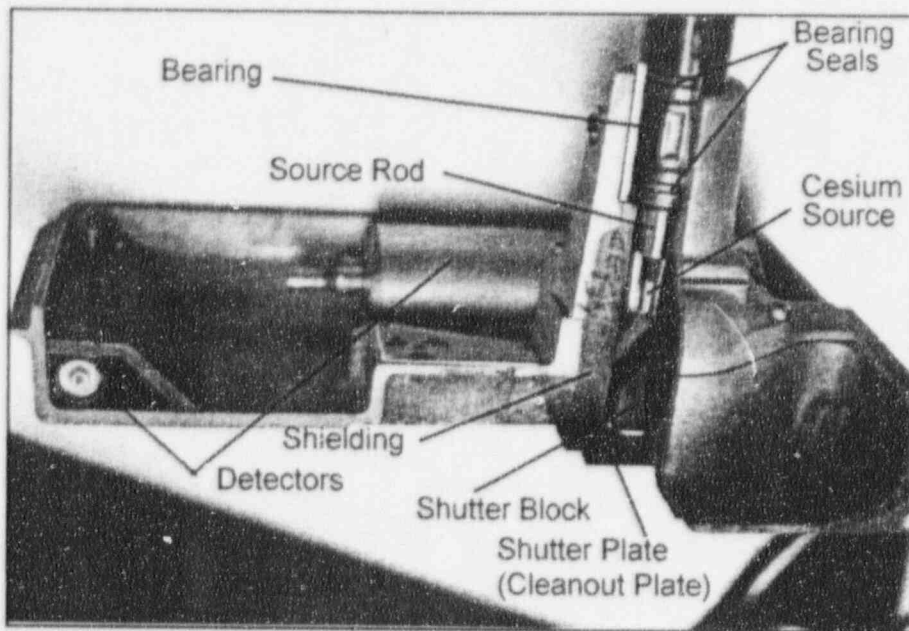
Figure 3

In discussions with representatives of the gauge manufacturer, and review of the gauge design, the AIT determined that the components that could cause difficulty in the source rod movement if they were broken, significantly worn, or dirty included: 1) the shutter assembly; 2) the handle assembly; 3) the source rod; 4) the linear bearing; and 5) the source guide tube. Listed below are the conditions of these components as found during disassembly and their corresponding evaluation performed by the manufacturer and the AIT member. (See Figures 3, 4, and 5.)

Initial observations of the gauge found the gauge to have been modified electrically (AC adapter added), and mechanically (padlock through the handle assembly) and was dirty, but had no signs of abuse. The manufacturer's representatives, based on
