UNITED STATES
NUCLEAR REGULATORY COMMISSION

SUBJECT: NRC VISIT OF THE KAISER ALUMINUM SPECIALTY PRODUCTS FACILITY

This memorandum documents an NRC visit to the Kaiser Aluminum Specialty Products facility on November 16, 1994.

Docket: 40-2377

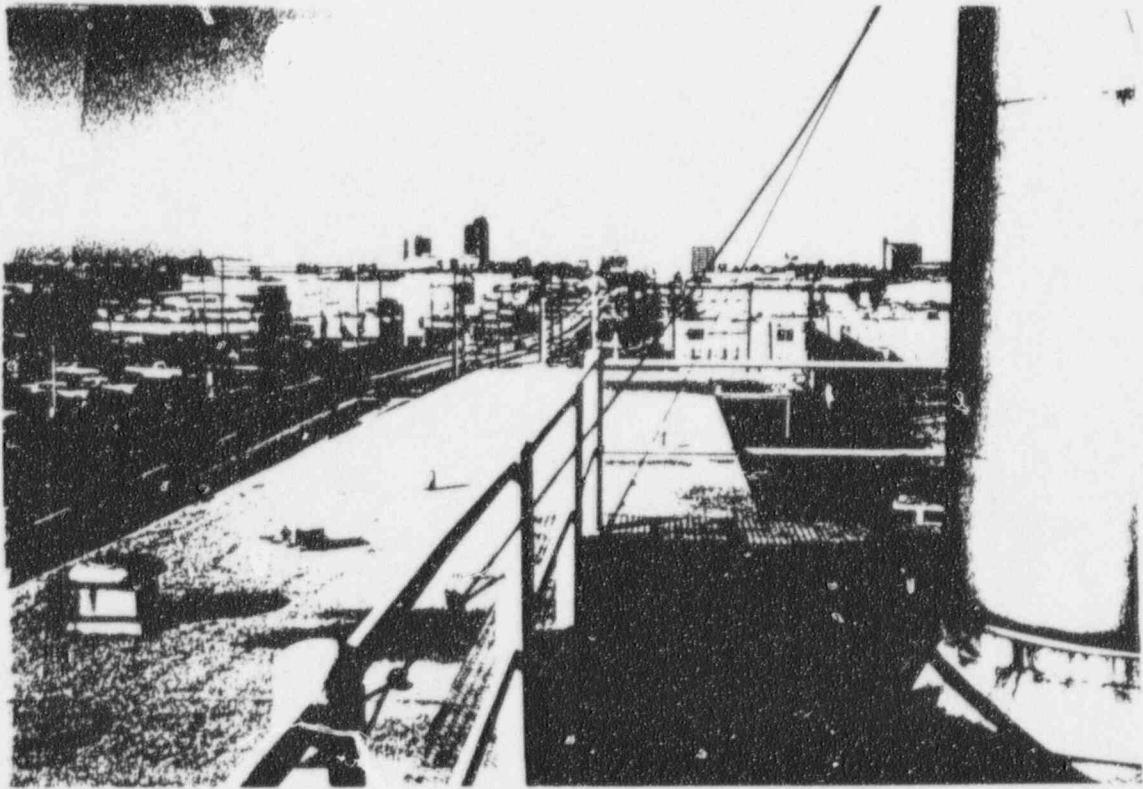
Photograph 2: The 7000 block of Saint Alit Street, looking west.

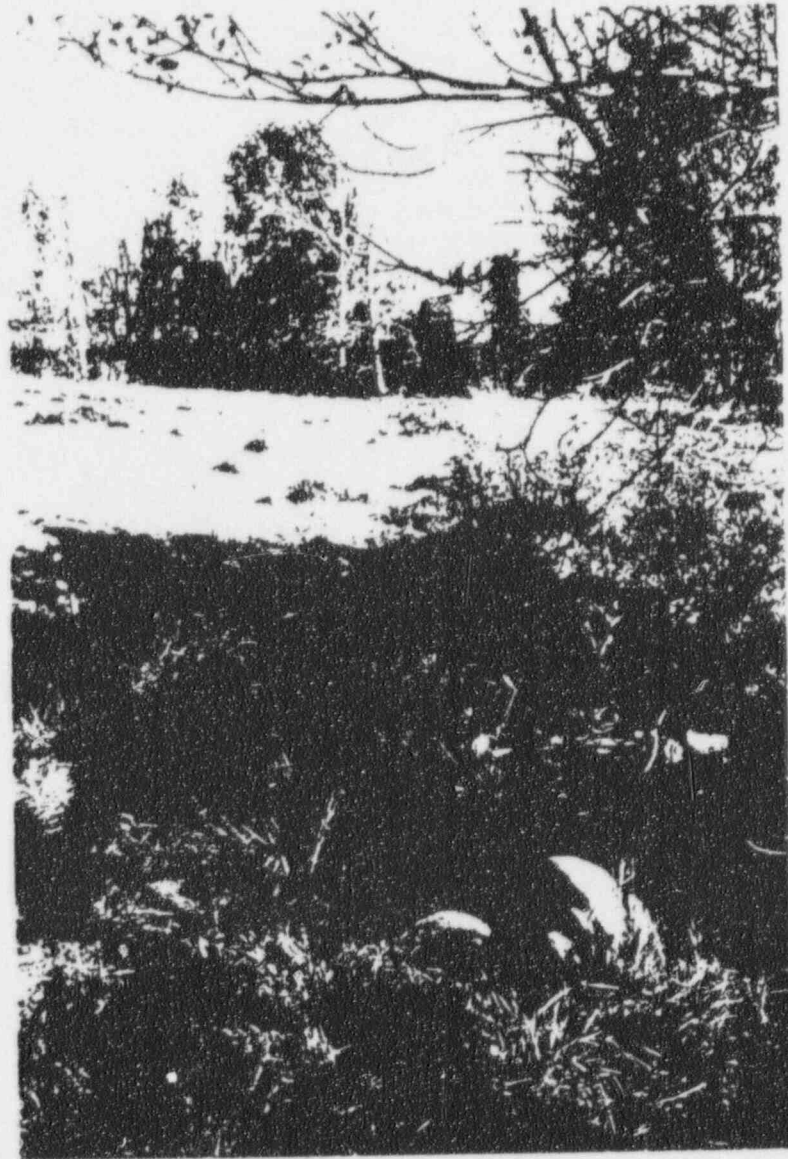
Photograph 10: Drainage Gully, which flows to No Name Creek in background (Reserve Pond area is located on left side of the gully).

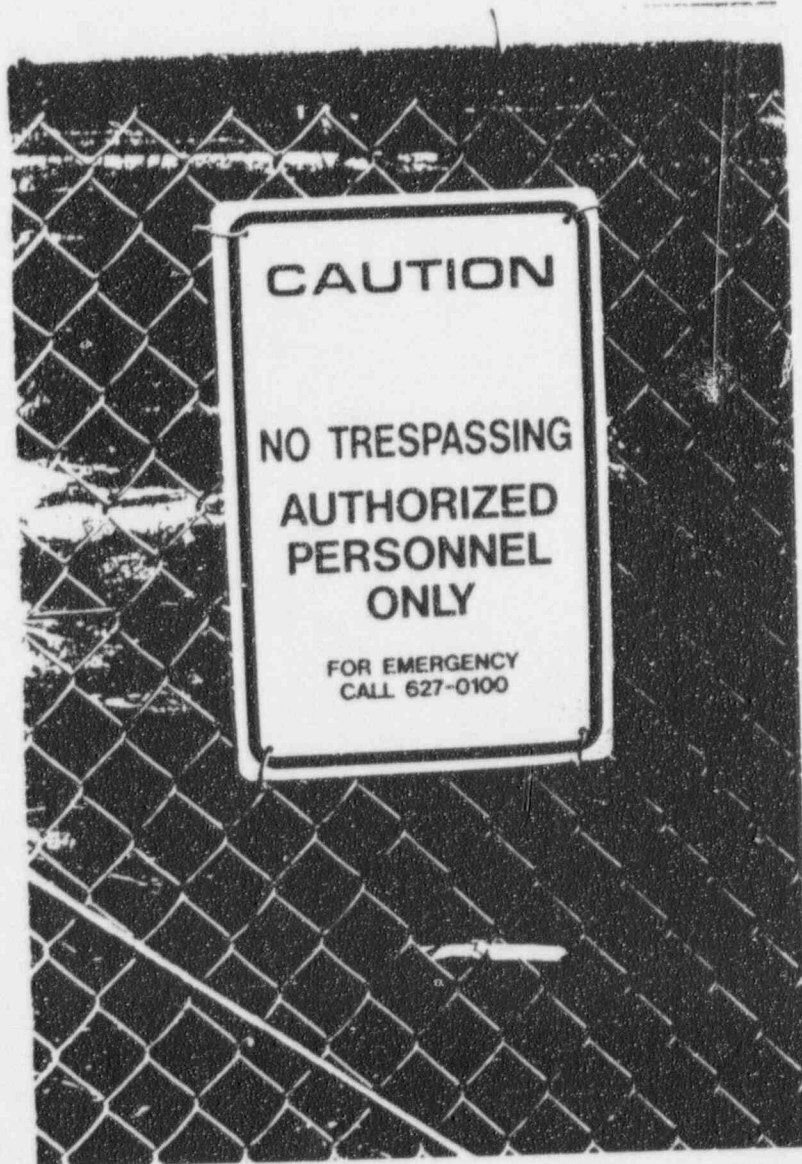
Since the last NRC visit of the facility, Kaiser Aluminum personnel installed new signs on the fences (see photograph) and removed miscellaneous scrap material from inside the fenced area enclosing the ponds. Additionally, as a conservative measure, the facility now requires all visitors who enter the

Photograph 11: Caution Sign (Caution signs recently added to fenced area enclosing the ponds).
