Advanced Medical Systems, Inc.

Re: Application to Amend USNRC License No. 34-19089-01 to Clarify Provision 23(J)

**RESPONSE TO NOTICE OF VIOLATION FROM
ROUTINE USNRC INSPECTION OF ADVANCED MEDICAL SYSTEMS, INC.**

AN ASSESSMENT

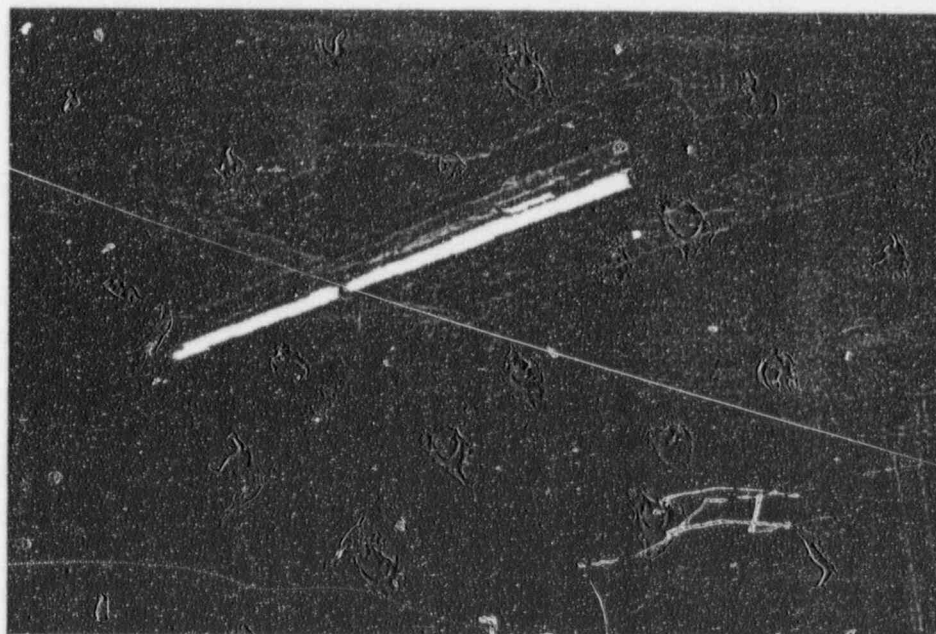
Figure A-2. Ceiling water damage.

outside the area to occur. This may have been the original intent; however, at both the conduit and ventilation chases, the risers are only two inches. In addition, at the ventilation chase, the riser has a 1½-inch notch in it. Thus, the maximum fluid that can be contained within the equipment is about 40 gallons. Therefore, the fluid runs over the ½-inch riser, down the chase onto the false ceiling. The first time a leak of significance occurred, the fluid collected in the false ceiling and was held there until the plaster of the false ceiling gave way as shown in Figure A-2.

This leakage caused no deterioration of the second floor slab's structural strength, and the fluids did not penetrate the concrete floor slab. There is no visible degradation of the floor slab, and it is highly unlikely there has been any degradation. In addition, the main part of the equipment room is over the radiography room where the floor slab is 2-feet thick.

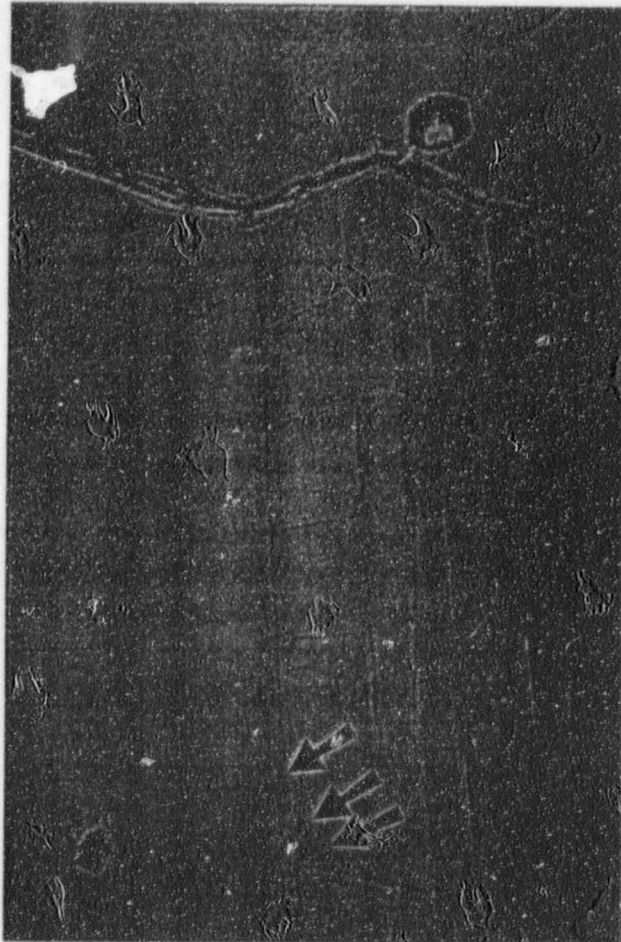
Figure A-3. No ceiling tile water damage but evidence of fluid on the wall

A second inspection was conducted on June 3 to determine the discrepancy. While no water damage was noted in the false ceiling, it was quite apparent that fluid had run down the wall as shown in Figure A-3.

5.3 RESPONSE: After discussing the potential source of the fluid with the operations manager and other staff, it became clear that most of the leaks had occurred as a result of equipment failures. For example, in the fall of 1995, a massive heat exchanger failed resulting in approximately 50 gallons of water being spilled into the equipment room which leaked

through to the first floor, as had previous leaks. In January 1995, a boiler leak occurred that caused leakage at the same location. Previous leaks caused the ~2 ft-by-2 ft ceiling plaster to fall from the false ceiling in this area. No one at the AMSLF knows the origin of the original leaks; however, most likely the leaks were caused by similar mechanical failures in the equipment room and possible roof leakage, especially since two major ventilation penetrations through the roof exist. However, it would take a serious roof leak to accumulate over 40 gallons of water.

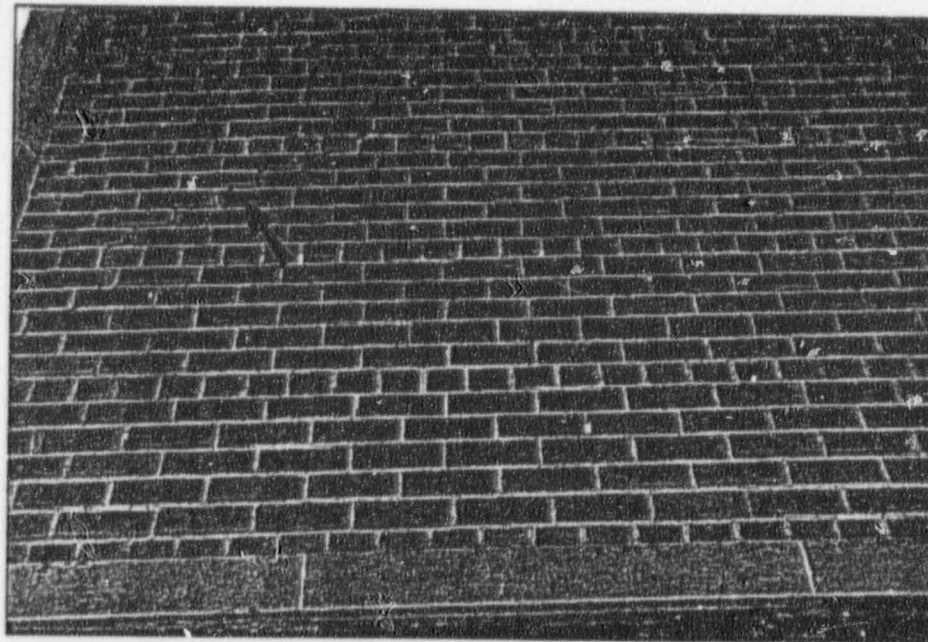
Figure A-4. Cracked southeast corner wall.

5.7 RESPONSE: As described in the NRC report, cracking does exist and is shown in Figure A-4. From the outside, the cracking appears to stop just short of the area where the second floor slab ties into the common wall brick. From inside the building below the second floor, it is evident that cracking does extend through the wall; however, it is not continuous, i.e., the cracking on the inside of the wall is almost an opposite pattern, as shown in Figure A-5.

Unfortunately, it is difficult to tell what actually caused cracking at the southeast corner of the building. As noted in the NRC report, the structural support of the 1958 building is a mix of load and non-load bearing masonry and concrete block, reinforced concrete, and steel framing. These materials are not compatible from an aging and expansion standpoint. In addition, the stiffness properties of the structure vary from extremely stiff (the test cell and radiography room) to very flexible (the lobby area). Thus, in a building over 30 years old with these types of similarities, one should expect to see cracking of this type; however, this cracking appears to have a unique cause. As noted in the NRC report,

MMI VI was only recorded in a radius of 10 miles of the epicenter. In addition, the directional motion of the seismic wave should have been in a southwest direction. The southeast corner of the building has moved perpendicular to that motion. Thus, this reviewer believes this damage is the result of a different loading mechanism.

If a significant lateral or vertical load were to be applied to this location of the building, a localized corner failure of the building would occur between the first and second floors, while, due to the purlin bearing on the east wall at the corner, a much broader area of the roof in the west direction would collapse. However, due to the construction of this building, this reviewer does not believe that such a loading would lead to overall collapse of the building. The cracking has reduced the total vertical load carrying capacity of the wall. However, this corner and its associated purlin is carrying only half the load of the next northern purlin. See Response 5.12 for more discussion of the roof loads. In the long run, this is a life-safety issue, since failure of the building would not result in breach of the concrete core structure where the cobalt and other radioactive waste are located.

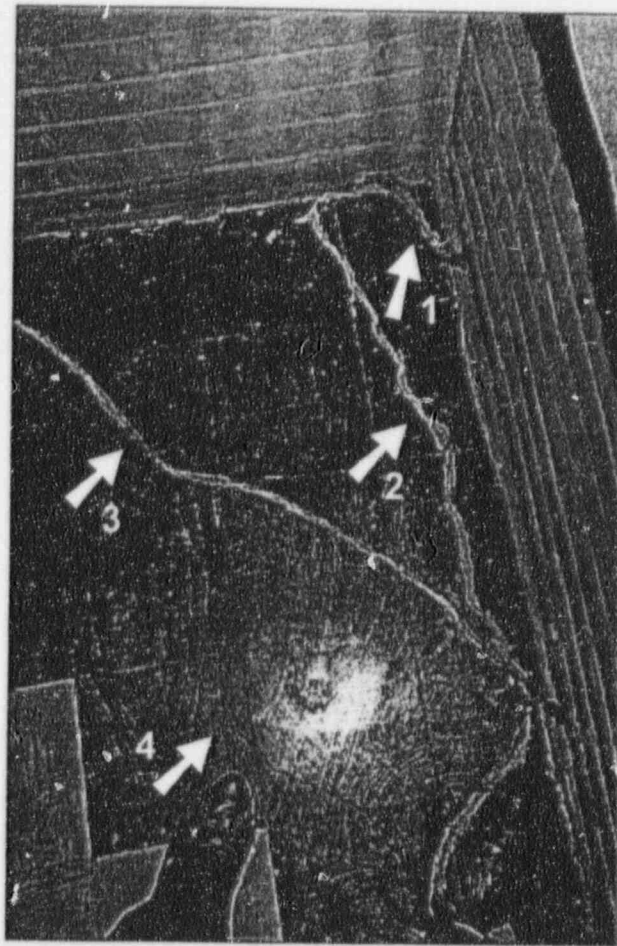
Figure A-6. Cracked second floor slab at southeast corner wall.

From inside the building above the second floor, the east and south walls in the corner show no cracking; however, as shown in Figure A-6, there are four cracks in the second floor slab that are visible to the human eye. One very large crack is nearest the corner, is at an approximate 45° angle to each wall, has a width of one-half inch, and has a length from wall to wall of about six inches. Based on the width of this crack, it must be assumed that the crack continues through to the slab edges underneath both the east and south walls. No reinforcing steel was found in this crack. A second crack runs almost parallel to the south wall, appears to cross the third crack, and then merges into the fourth crack. The third and fourth cracks are also at about a 45° angle to each wall. Based on the width of the crack nearest the corner, it appears that the southeast corner has moved southeast a distance of as much as $\frac{1}{2}$ to $\frac{3}{4}$ -inch. These floor cracks seem to indicate excessive bending moment in the floor slab at this corner, which would be indicative of significant settlement at the corner. Underneath the second floor slab, matching crack patterns were found. It was determined that the as-built dimension of the floor slab was six inches.

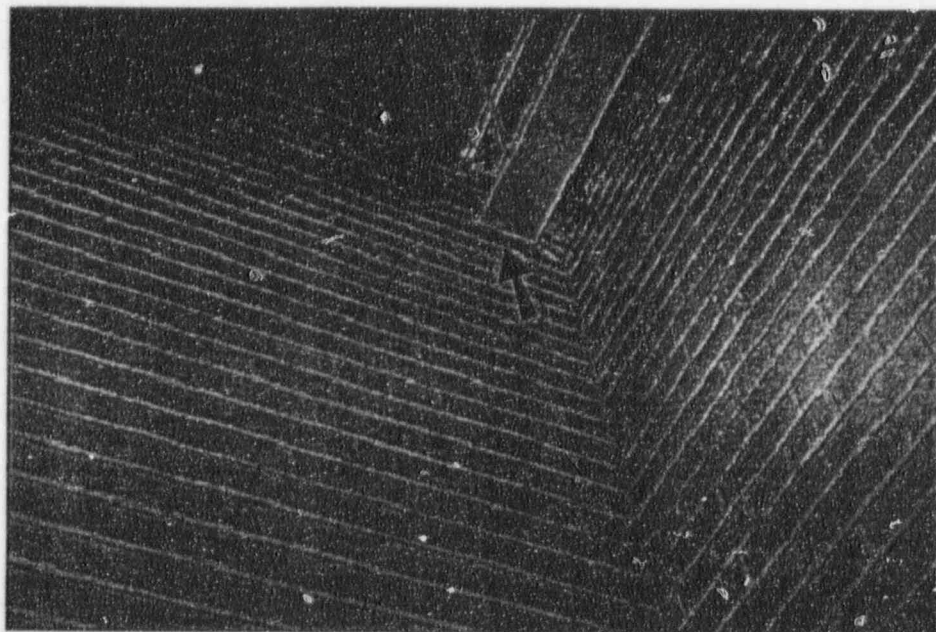
Figure A-7. Wall movement at purlin in corner.

- 5.13 RESPONSE: This movement appears to be approximately 1/4-inch as shown in Figure A-7. Although such movement may occur for a building having a mix of materials involving steel, concrete, and masonry as main structural elements, this movement must be attributed to the corner moving to the southeast at the second floor. According to Dwg. S-1, all beams bearing on the masonry wall have wall anchors. These anchors are two angles, 6 inches by 4 inches by 3/8 inch. Thus, the wall anchor should be holding the common masonry wall from moving further eastward at the top. No sign of distress in the veneer

wall was noted from the outside, however, some cracking was noted in the load bearing wall beneath the purlin.

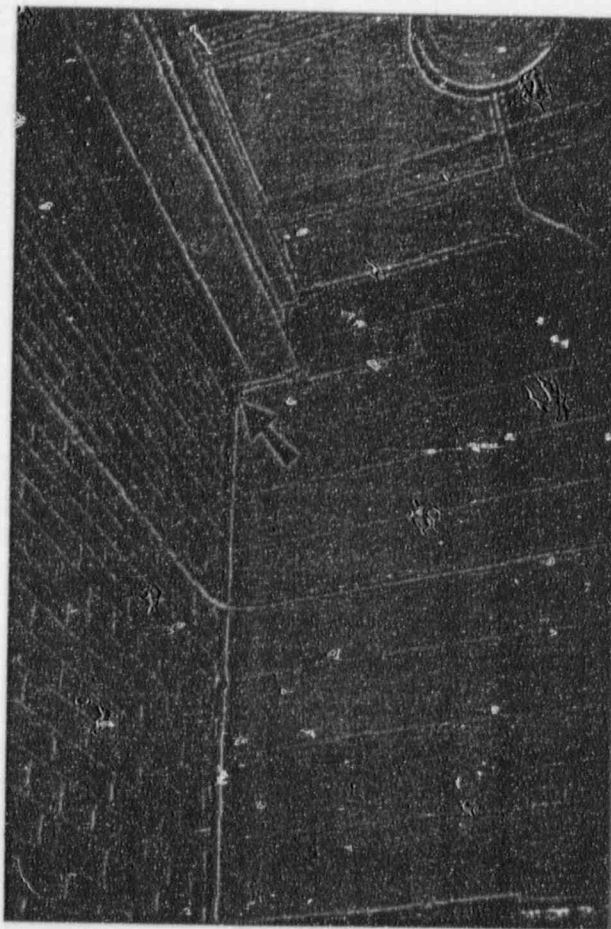
Figure A-8. Purlin and Wall Movement.

5.14 RESPONSE: It is the opinion of the reviewer that this movement has nothing to do with what has happened at the southeast corner of the building. The biggest problem with the construction of this building is that none of the interior non-load bearing walls were interlocked or tied in with any of the structural members, and most of the non-load bearing walls have separated leaving visible cracks from adjoining walls. The location of the cracking in question is shown in Figure A-8 and, as indicated in the NRC report, the crack opening is approximately one inch. This wall is the west side of a right angle interior wall forming a small room in the southeast corner. If the north side of the interior wall is compared to the paint lines on the roof decking, it is evident that the entire top of the non-load bearing wall has moved northward about one inch. There is no evidence that the purlin has moved southward at this location.

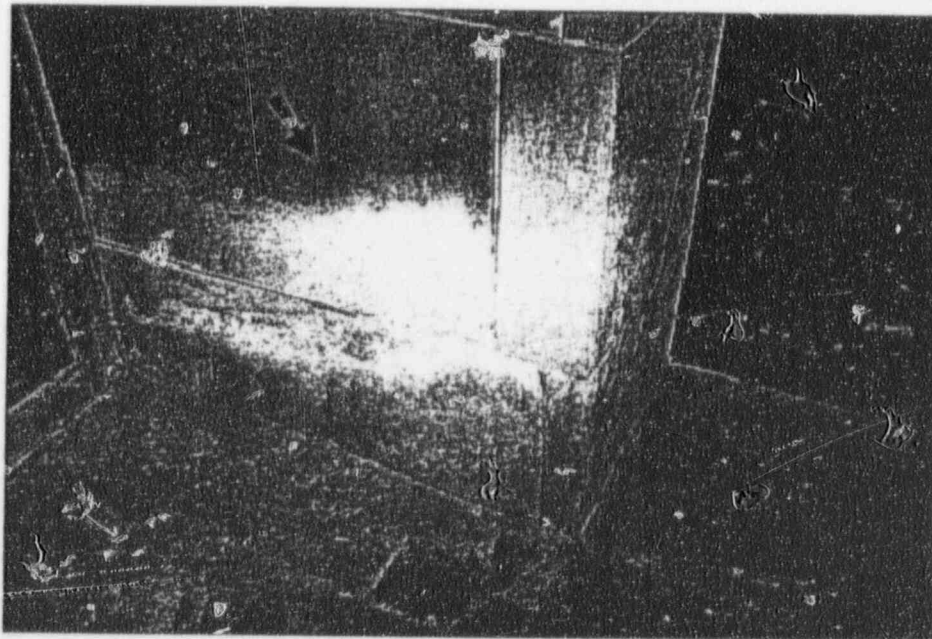
Figure A-9. Lobby stone showing salting.

5.16 RESPONSE: It is believed that the failure of the stone corner at the bottom of the wall has resulted from a totally different cause, but may have something to do with the in-filled wall movement at the second floor. This stone corner is located next to the lobby entrance of the 1958 building. Upon inspection of the site, it is very apparent that the joint failure of the mortar has been caused by salting the lobby entrance to remove snow and ice. The stone facing is discolored where the salt was thrown as shown in Figure A-9, and where discoloration has occurred, mortar in the joint was attacked. At a distance of approximately one foot north of the south corner of the stone, there is no stone discoloration and the joint is intact. As a result of joint failure, the stone has fractured. Again this is a life-safety issue and has no bearing on the structural stability of the 1958 building.

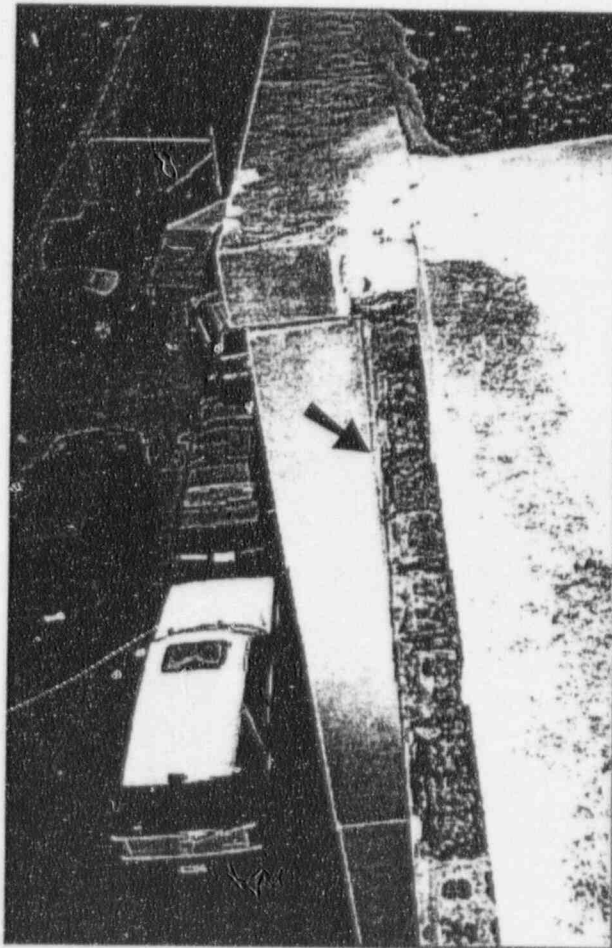
Figure A-10. 1963 building parapet.

5.17 RESPONSE: While there is significant distortion of the stone coping on the parapet of the 1963 building as shown in Figure A-10, with the 1958 building parapet being in the background, this distortion is not believed to be associated with Concerns 5.15 or 5.16 discussed above. Rather, it is believed to have been caused possibly by a crane or crane-like piece of equipment placing workers or equipment on the roof. The movements of the stone coping of the 1963 building do not relate to the movements that have occurred at the northeast corner of the 1958 building.
