# Flashover Failures from Wet-Wire Arcing and Tracking

F. J. CAMPBELL

December 17, 1984

NAVAL RESEARCH LABORATORY  
Washington, D.C.

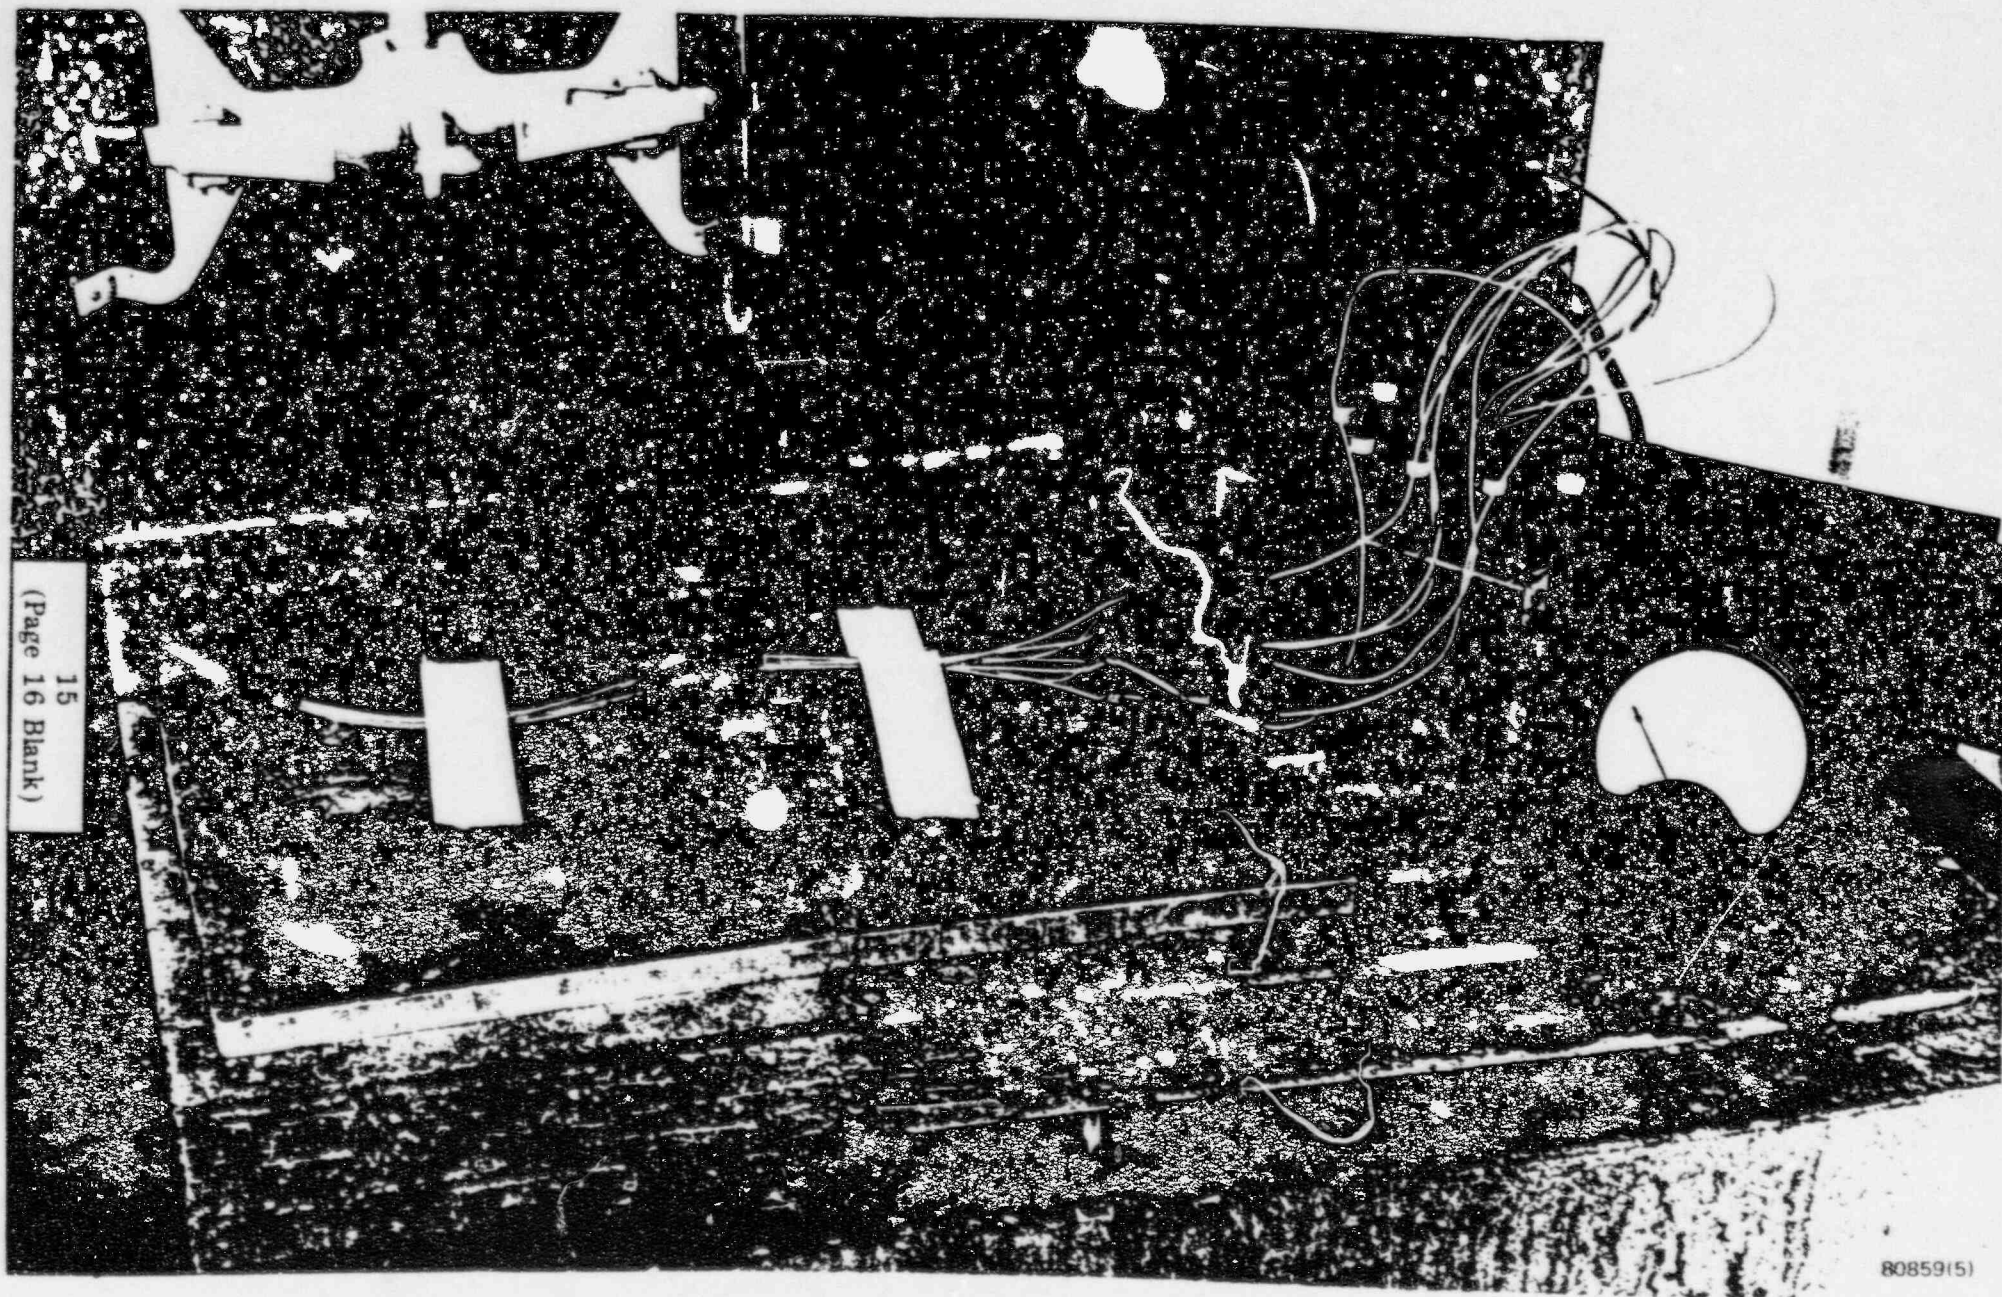
A seven-wire bundle was used in this laboratory simulation experiment because of its simple symmetry (six of the wires encircle the inner one). The insulation on one of the outer wires was radially cut to simulate the cracking produced by hydrolytic degradation. The bundle was secured on both sides of the crack with heat-shrinkable tubing. The damaged wire was positioned on the outer ring so that it was on top when the bundle was draped over a 1.25 cm diameter aluminum rod. This rod was laying on an aluminum plate. Each wire in the bundle had about 1 cm of insulation stripped from one end so they could each be clipped to wires leading from the circuit breaker box in which each was in series with a Klixon\* 5-amp circuit breaker (Series 7274-11) leading from the bus bar on the positive side of the power line. Thus, each wire in the bundle was at a 120 volt potential with respect to the aluminum rod clipped to the ground side of the circuit. This assembly was then positioned under a pipet from which a one-percent solution of sodium chloride in water was dropped directly onto the cracked segment of the damaged wire at a constant rate of approximately ten drops per minute. The drop rate was controlled by a very slow-acting peristaltic pump equipped with a flow rate controller. A photograph of this system, taken after the flashover failure occurred, is shown in Figure 1.

The ammeter shown in Figure 1 provided an indication of the approaching failure as the experiment progressed. During the initial tracking and arcing of the cracked wire, the current surges generally remained below 0.5 amps. As the tracking and arcing became more continuous and severe, a more constant current ranging between 0.5 and 1.5 amps was detected. At this point the spikes in the current exceeded 5 amps and caused the circuit breakers to blow. This occurred with an instantaneous, blazing flashover in which the conductor of the damaged wire melted and splattered, causing the melting and burning of some of the adjacent wires in the bundle at the same instant.

Figure 1: Flashover experiment set-up, showing a bundle of kapton insulated wire after the failure.

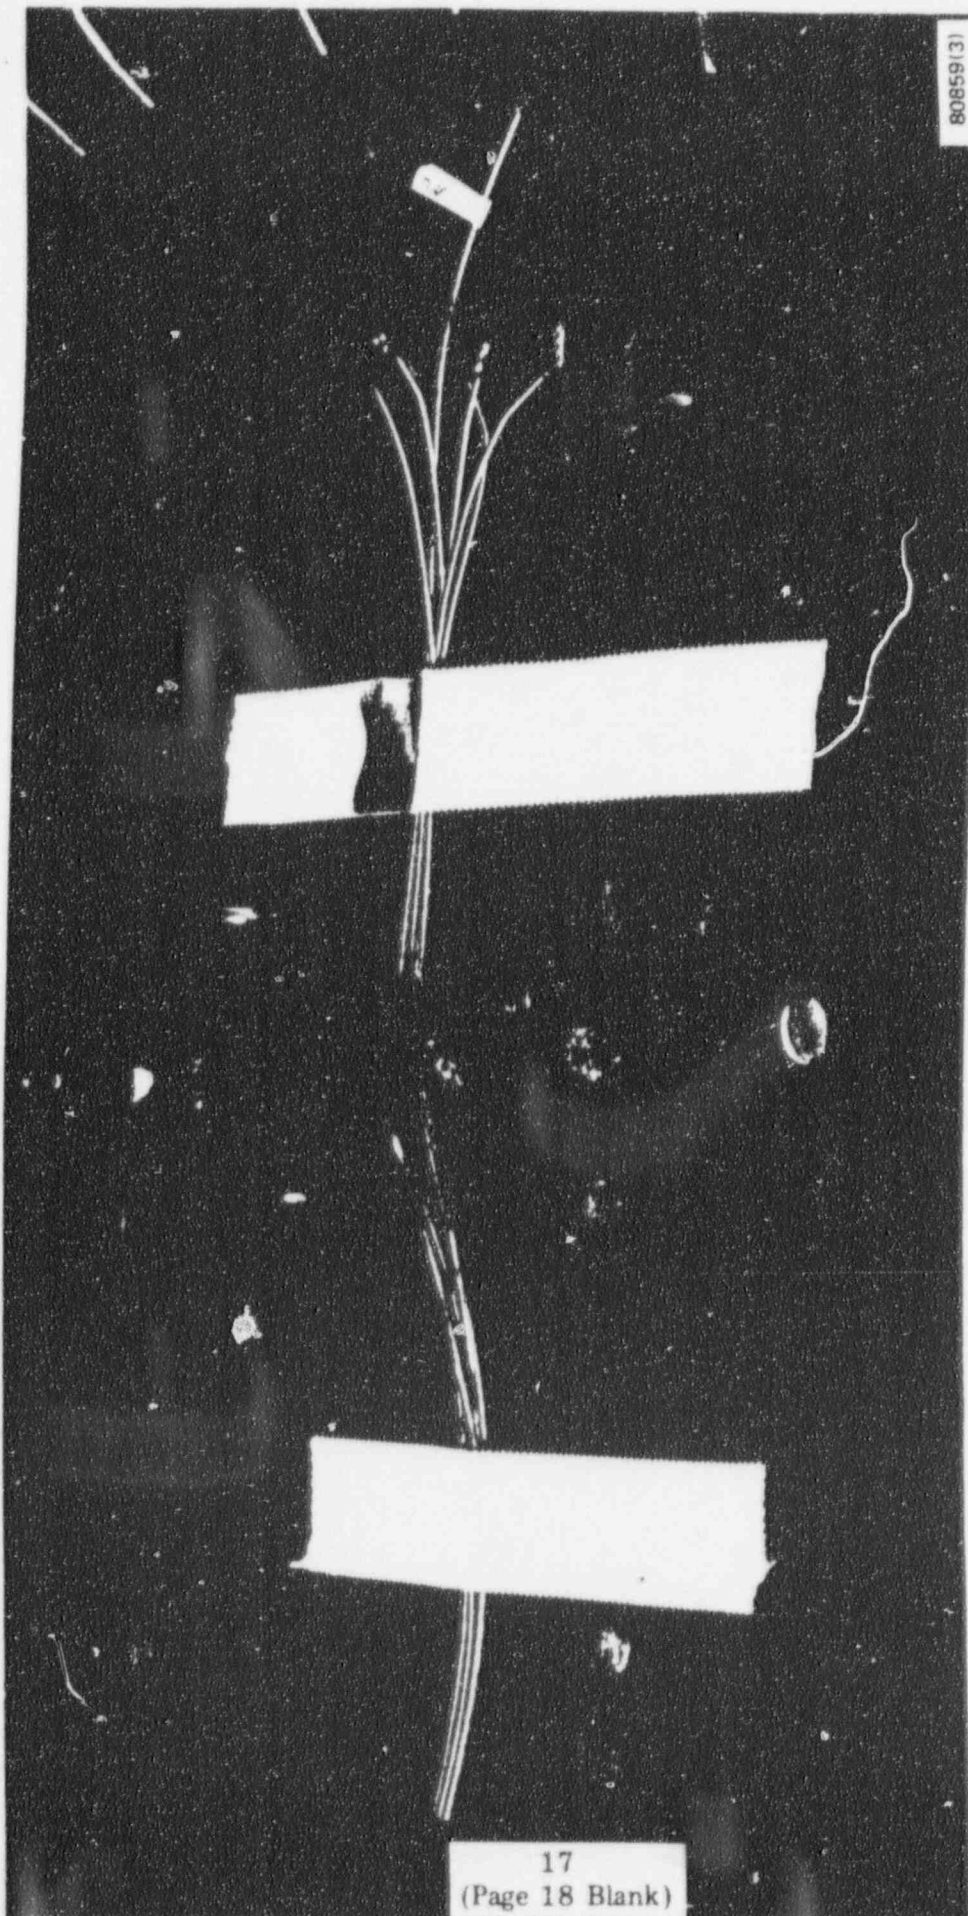
In order to illustrate this sequence more completely a videotape was prepared that shows each of the above steps, from the preparation of the bundle to the after effects of the flashover. Two of the frames were photographed from this film in order to capture the fast moving action. Figure 3 shows the arcing which occurs as it becomes more severe (6 min, 1 sec from the start), and Figure 4 shows the intense flash, with streaks of molten copper and aluminum coming out of the burning area (6 min, 41 sec.). A photo of the remains is shown in Figure 2, where the wire surfaces are covered with char, and the tips of the conductors and the aluminum rod show evidence of melting and cratering from the blast of the flashover.

Figure 2: Close-up photo of the failed Kapton bundle after the flashover, showing the melted wires and crater in the grounded aluminum rod resulting from the intense heat of the flashover blast.

Figure 3: One frame from the videotape taken during the initial arcing and tracking that leads to flashover failure.

Figure 4: The instant of failure, showing the streaks of molten metal coming from the burning flashover.
