DUKE POWER COMPANY

August 23, 1985

Regarding: Catawba Nuclear Station
Docket No. 50-413 and 50-414
Resolution of Outstanding Items on Diesel Generators

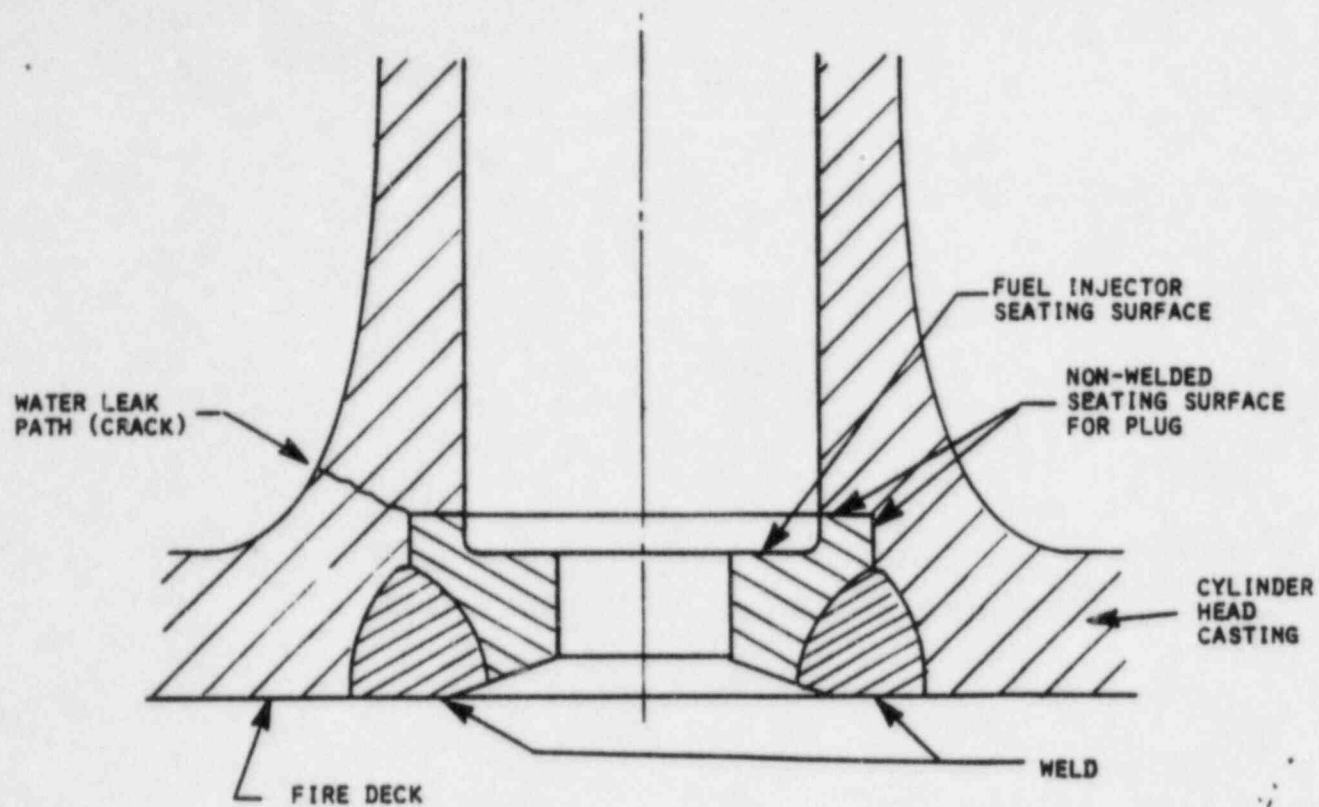
A. OLD HEAD REPAIR

Four cylinder heads at Catawba, one on engine 1A and three on engine 1B, developed small jacket water leaks into the fuel injection cavity. The 1A cylinder head has been examined by FaAA. This investigation (reference 3) revealed that the leak was caused by a crack initiating from the corner of a welded-in plug where it was seated in the cylinder head as shown in Figure 1A. This welded-in plug is reported by TDI to have been used to repair the casting around the fuel injector hole. This head as well as the three heads on engine 1B were replaced. Reference 2, forwarded by reference 1, requested that Duke Power Company replace another head on diesel 1A (head 6L) where it was suspected, based on visual examination, that this head had the same welded-in plug. This head was subsequently replaced on diesel 1A. The remaining heads on both engines were inspected and we therefore believe that none of the cylinderheads on the Catawba Unit 1 diesels have weld repairs.

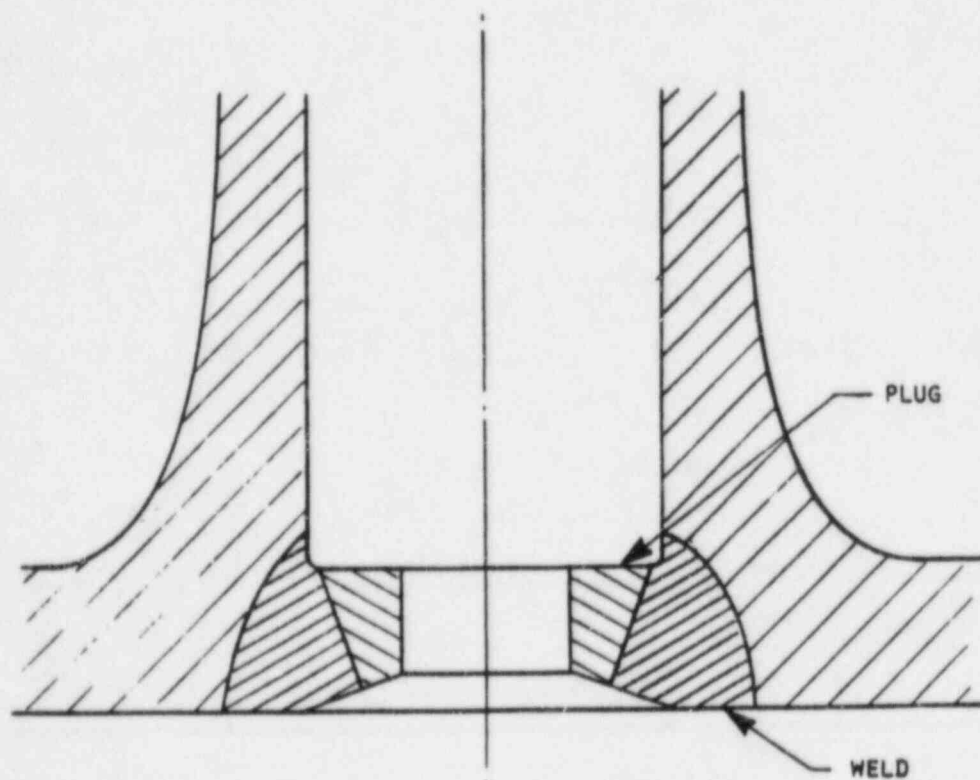
B. NEW HEAD REPAIR

Referring to Figure 1B, the weld repair of the cylinder heads consists of welding a plug into the head, stress relieving the weld and machining the injector port back side of the plug out such that the repair is a full penetration weld. This repair is described on TDI drawing 102718, Rev. 0. Cylinder heads at Catawba that have been repaired in this fashion are stamped 1NR. The full penetration weld eliminates the crack starter found in previous partial penetration weld repaired heads. Post weld stress relieving reduces welding residual stresses to low levels. Thus, weld repaired castings with full penetration welds which are stress relieved are considered equivalent in quality to non weld repaired castings.

Results of both visual and ECT inspections on diesel 2A showed that five heads had been repaired with partial penetration welds. These heads have been replaced. Of the heads replaced three heads (cylinders 6L, 7L and 8L) are heads with no weld repair. The other two replacement heads (cylinders 2R and 3R) have been repaired per Figure 1B. Results of the same inspections on diesel 2B showed that no heads had plug repair welds.
