Maine Yankee

MN-96-163

Subject: Maine Yankee Licensee Event Report 96-031, Plant Trip During Reactor Protection System Surveillance

PLANT TRIP DURING REACTOR PROTECTION SYSTEM SURVEILLANCE

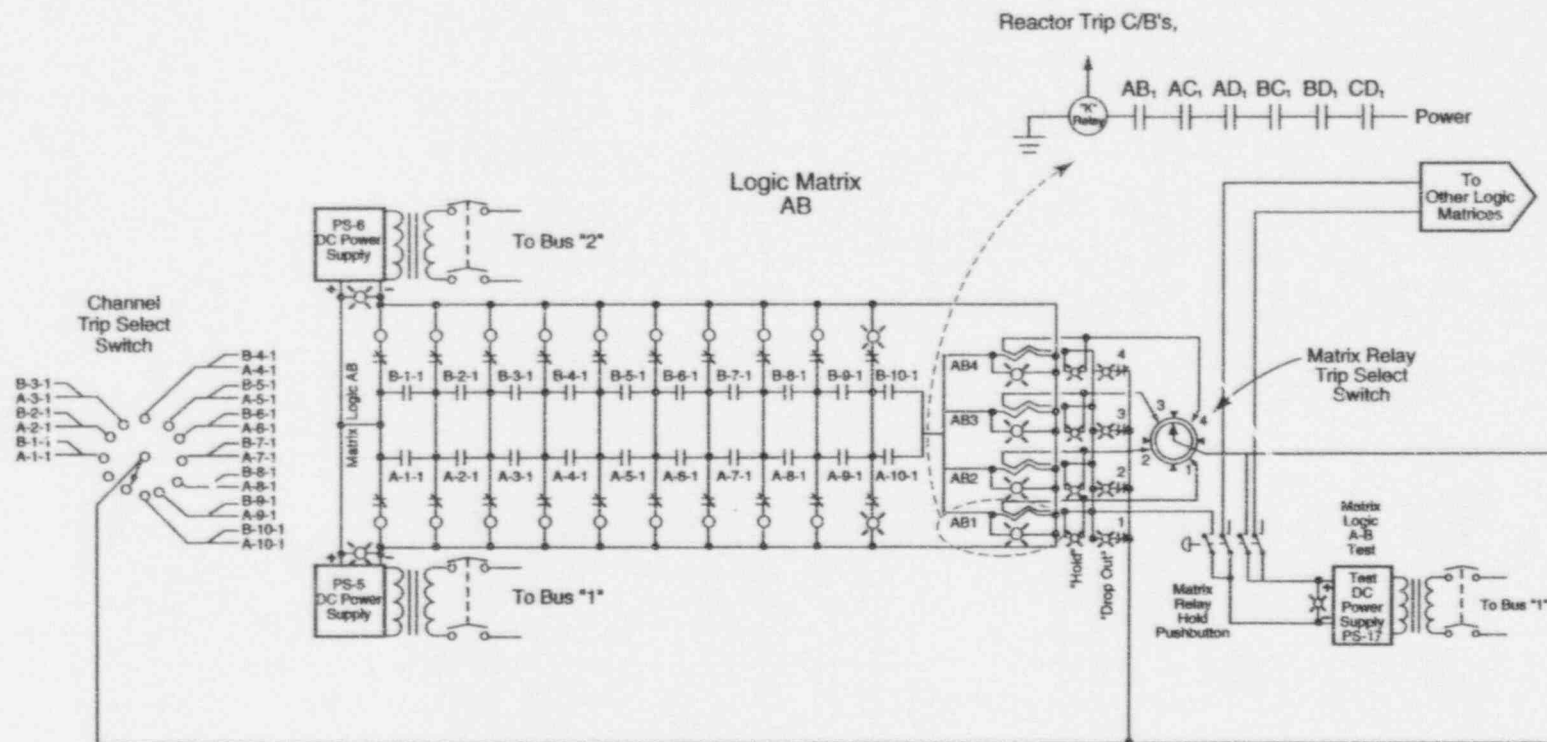
Refer to the attached diagram for the following discussion:

The RPS Logic Trip Relays Test surveillance tests each of four "K" relay (RLY) trip logic circuits. Each "K" relay opens two (of eight total) Reactor Trip Breakers (52). At least four Reactor Trip Breakers must open to cause a reactor trip. There are six logic matrixes (AB, AC, AD, BC, BD and CD), each with four logic matrix relays. Each matrix relay has an associated contact in its respective "K" relay circuit. To allow testing of each of the 24 (four in each of six logic matrixes) matrix relays without causing a reactor trip, only one "K" relay is allowed to de-energize at a time. This is accomplished by applying a hold current to a second coil in the three logic matrix relays not being tested in the specific logic matrix. The logic matrix being tested is then de-energized which in turn de-energizes the one logic relay not being supplied with hold current. This hold current is supplied by a single test power supply. Normally, the logic matrix relays are energized by auctioneered power supplies through the matrix trip circuit.

Conducting the surveillance involves manipulating two rotary contact switches (HS) and a push-button switch: the Channel Trip Select Switch (which selects one of the ten possible trips), the Matrix Relay Trip Select Switch (which selects one of the four Logic matrix relays), and the Matrix Relay Hold push-button switch (which applies a holding current to the non-tested matrix relays and inserts the trip selected by the Channel Trip Select Switch).

A fault tree was constructed to identify possible malfunctions that could cause a plant trip during the surveillance. This analysis identified that an interruption of the hold current for the matrix relays would result in a plant trip. This was verified by test before plant startup. Three components were identified which could result in interruption of the hold current: the power supply itself (or its supply), the Matrix Relay Hold push-button, and the Matrix Relay Trip Select Switch. While the plant was shutdown with the reactor trip breakers closed, each of these components (in the AC logic matrix) were manipulated as they would be in the test, with no problems noted. The power supply and the Matrix Relay Hold push-button switches were replaced before startup as a precautionary measure. The Matrix Relay Trip Select Switch was not replaced as no spare was available before startup.

- The following AC logic matrix components that were undergoing testing at the time of the trip were replaced: the test power supply and the Matrix Relay Hold push-button. The circuitry was thoroughly tested and the RPS surveillance completed before plant restart.
- Additional testing and analysis are being performed to attempt to determine the exact cause of the trip, including bench testing of the circuit to identify any potential design deficiencies that might have contributed to the event.
- Additional monitoring of the circuit during the next surveillance is being considered.
- Combustion Engineering has been consulted on this problem and is providing additional assistance.
