LICENSEE EVENT REPORT (LER) TEXT CONTINUATION

FACILITY NAME (1)	DOCKET NUMBER (2)	LER NUMBER (6)			PAGE (3)
		Year	Sequence Number	Revision Number	
Quad Cities Unit Two	0   5   0   0   0   2   6   5	9   6   -	0   0   2   -	0   0	2   OF   0   6

EVENT IDENTIFICATION: High Pressure Coolant Injection Inoperable Due to Inadequate Venting.

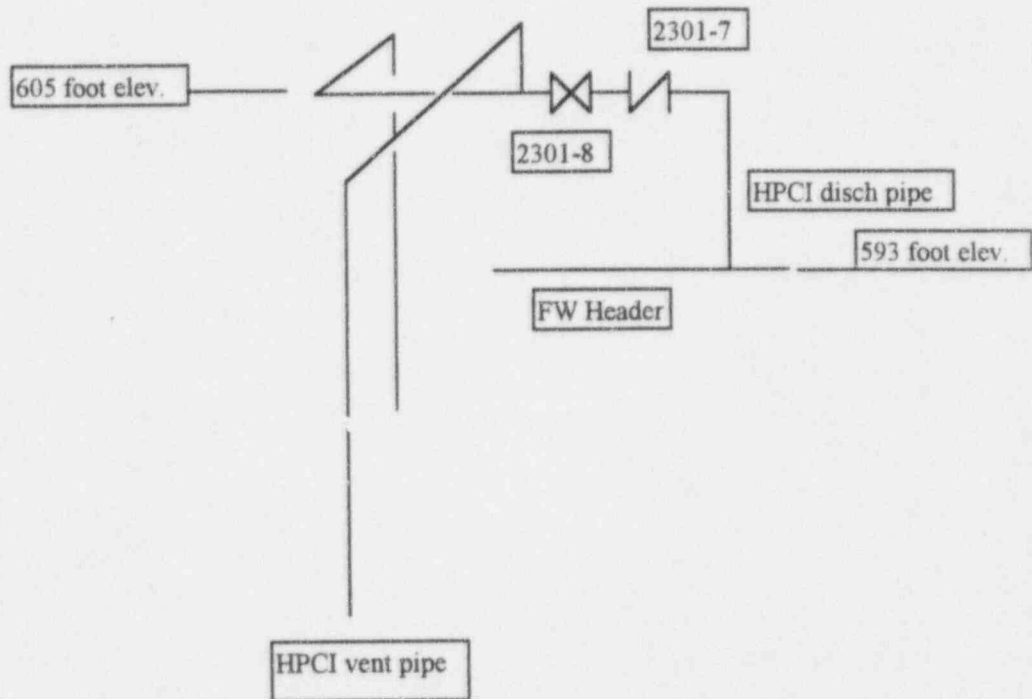
The apparent cause of this event was a failure to properly vent the HPCI injection piping downstream of the system isolation valve (2-2301-8) after maintenance in August 1996 on the system injection check valve (2-2301-7). Refer to Figure 1 for a layout of the HPCI discharge piping high point.

Since these vents are located below the high point of the HPCI discharge piping, the discharge piping was not completely filled. This improper venting left air in the piping downstream of the system isolation valve.

The system isolation valve, 2-2301-8, is opened on a quarterly frequency. The first time that it was opened after this improper venting was on October 8, 1996 per QCOS 2300-6, "Quarterly HPCI System Power Operated Valve Test." When the system isolation valve was opened, the air trapped in the piping migrated to the upstream side of the 2-2301-8 system isolation valve since the upstream piping section was at a lower pressure than the downstream side. Subsequently, on October 9, 1996 when QCOS 2300-09 was attempted, this trapped air prevented the system from venting properly even though there was a static head of water above the high point of the discharge piping.
