RADIOLOGIC AND ENGINEERING ASSESSMENT

DOE ID NO.: GJ-00767-RS
ADDRESS: 1425 HALL AVENUE

AUGUST 1985

BENDIX FIELD ENGINEERING CORPORATION
P.O. Box 1569
Grand Junction, Colorado 81502

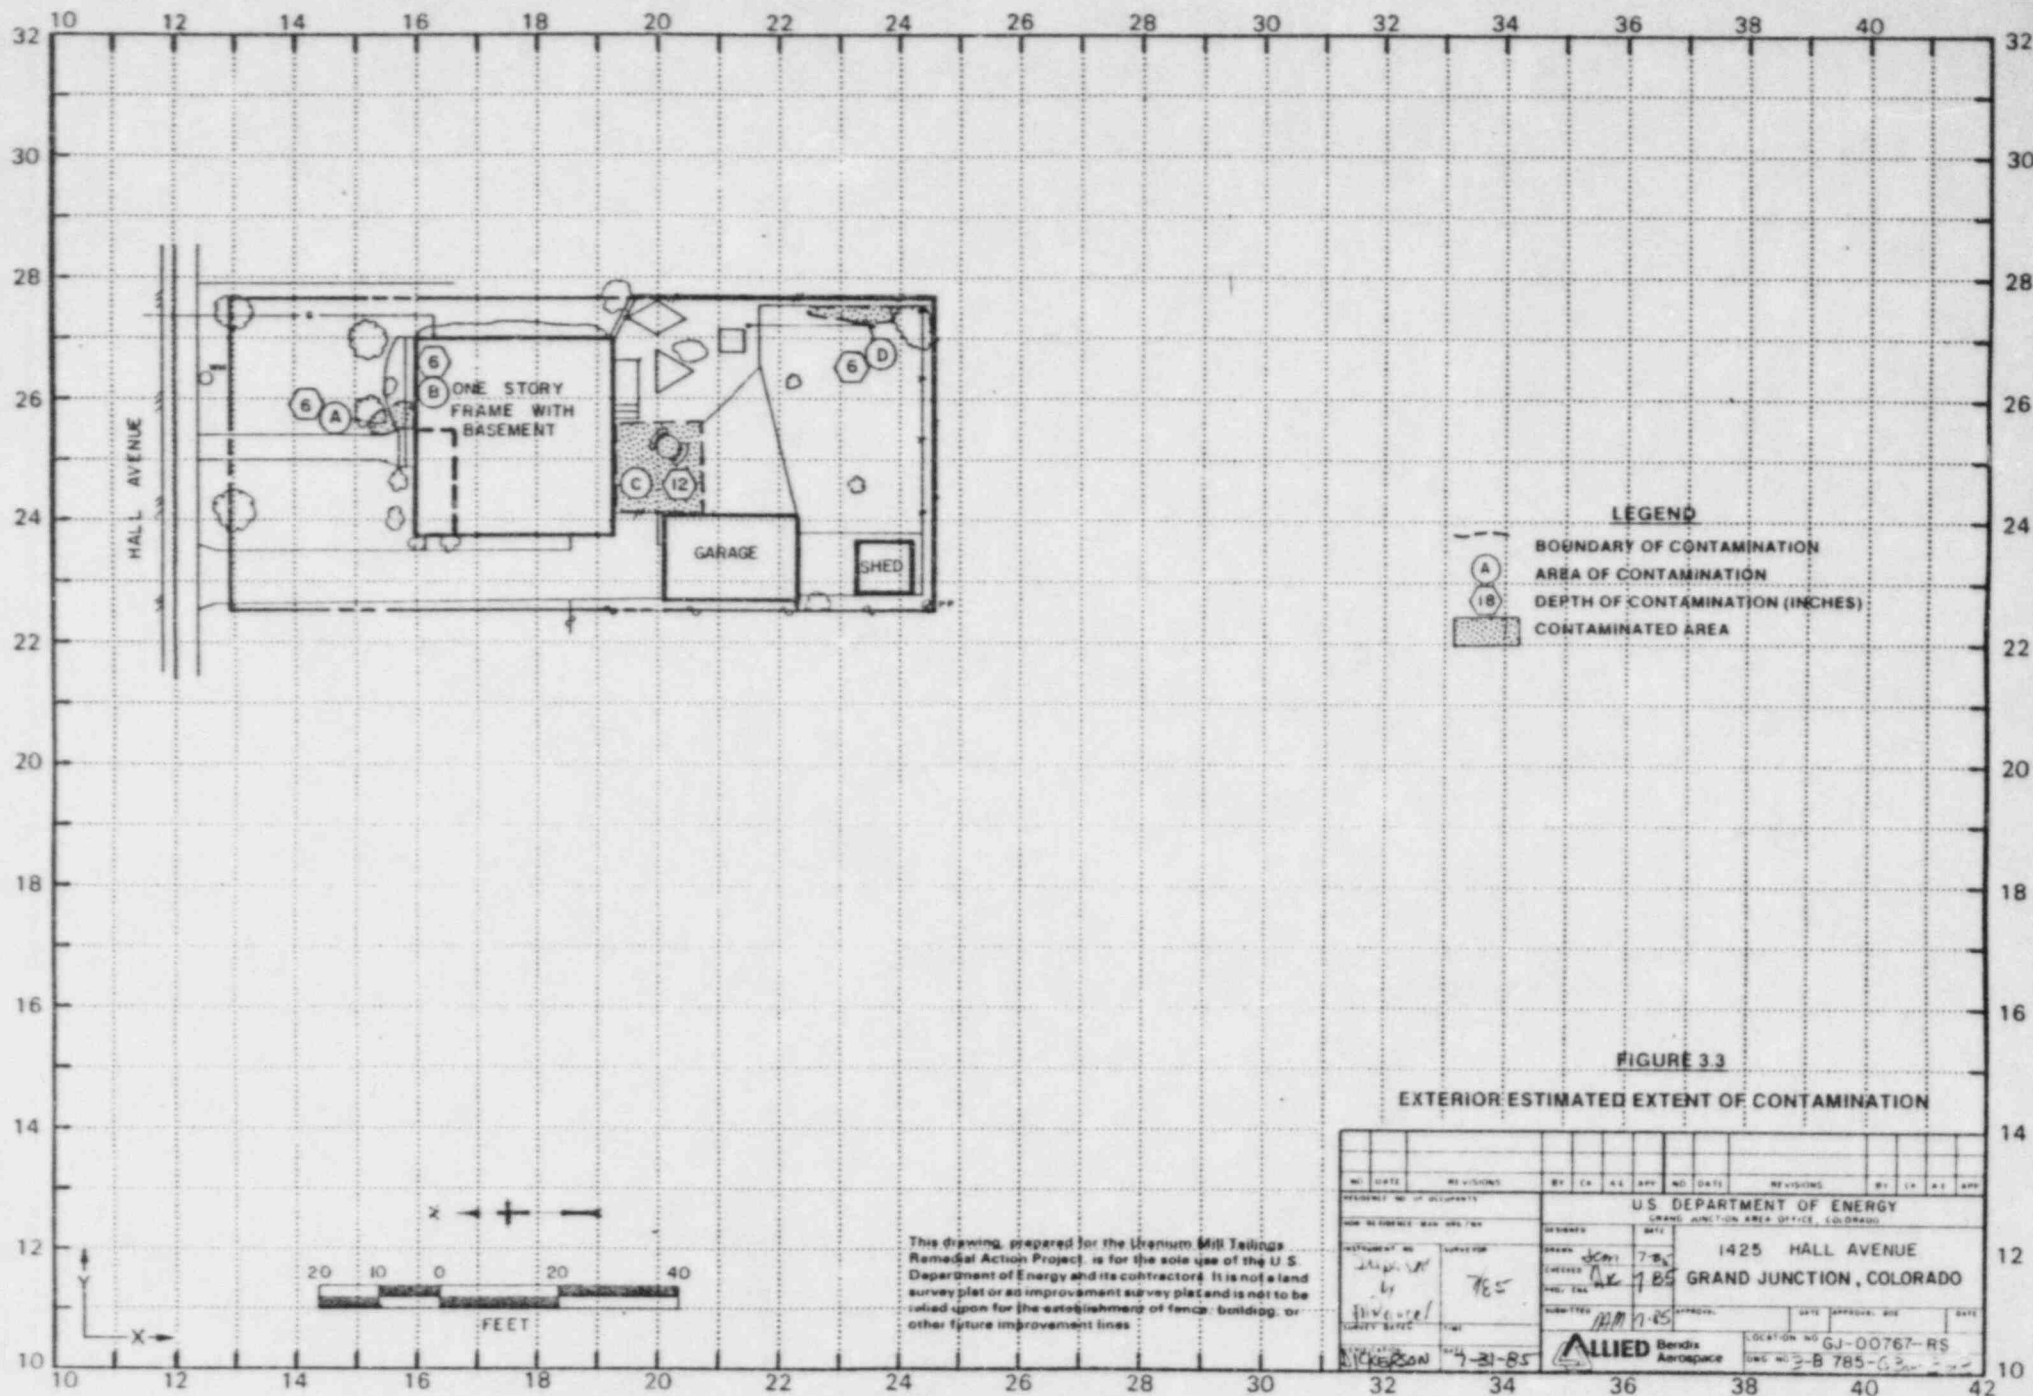
Appendix Figure 3.3 shows identified areas and estimated depths of contamination on this property, based on assessments of all measurements taken. As noted in this figure, areas recommended for remedial action that contain identified residual radioactive materials are:

- (Area A) Surface Material: Grass
Direction From Primary Structure: North
Other Directions: East of front steps
Total Depth of Contamination: 6 inches
Approximate Square Footage: 16
- (Area B) Surface Material: Concrete
Direction From Primary Structure: North
Other Directions: South of Area A
Total Depth of Contamination: Estimated at 6 inches
Other (height or thickness): 4-inch-thick concrete
Comments: Depth of contamination is based on data collected in Area A.
Approximate Square Footage: 16
- (Area C) Surface Material: Concrete
Direction From Primary Structure: South
Total Depth of Contamination: 12 inches
Other (height or thickness): 4-inch-thick concrete
Approximate Square Footage: 208
- (Area D) Surface Material: Grass
Direction From Primary Structure: Southeast
Other Directions: South yard
Total Depth of Contamination: 6 inches
Approximate Square Footage: 45

The recommended remedial action for this property, DOE ID No. GJ-00767-RS, includes removal of all areas identified as containing radioactive material (as discussed in Section 3.5 and shown in Appendix Figure 3.3) and transport of removed material to the disposal site.

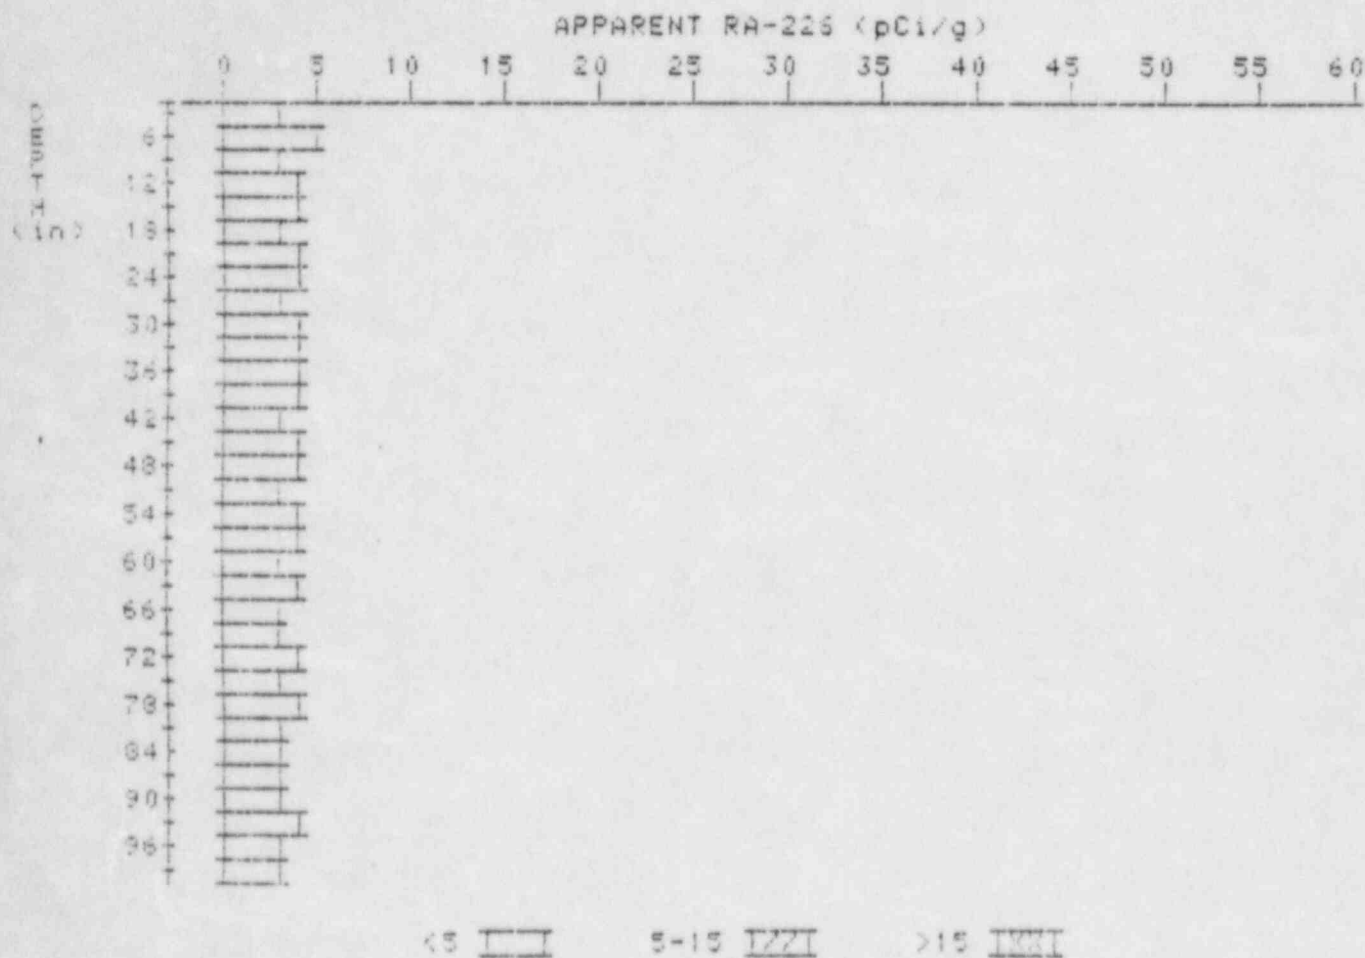
HOLE NUMBER: 6

LOCATION: 178271

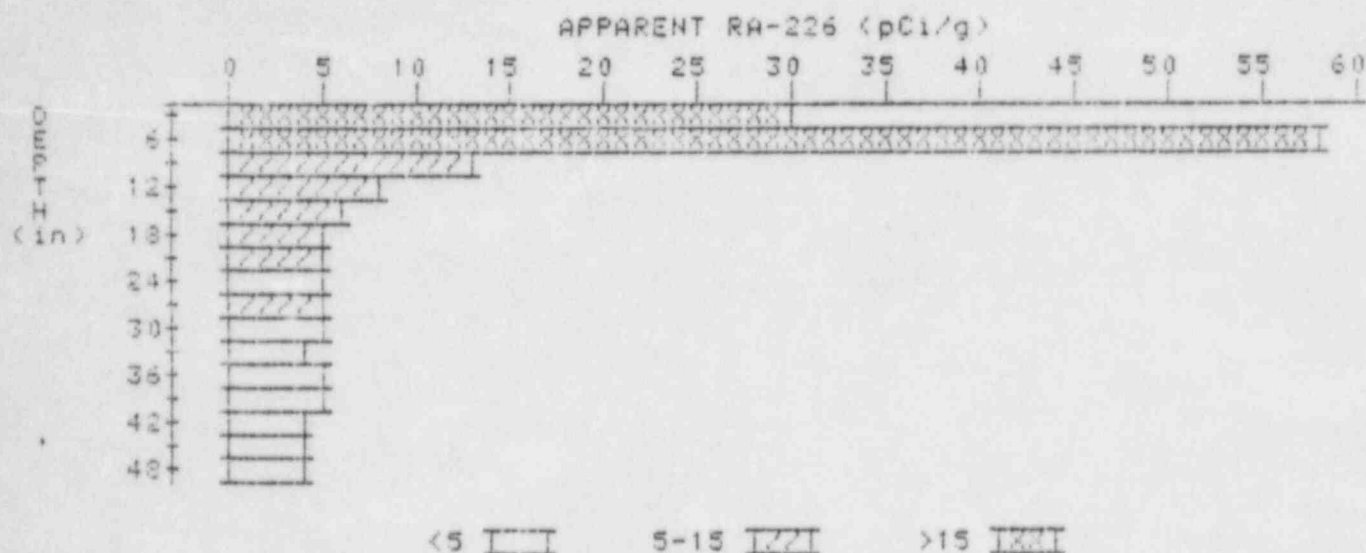
PROPERTY NUMBER: GJ-00767-RS
HOLE NUMBER: 9
LOCATION: 198250
