RADIOLOGIC AND ENGINEERING ASSESSMENT

DOE ID NO.: GJ-05752-RS
ADDRESS: 2495 SOUTH BROADWAY

AUGUST 1985

BENDIX FIELD ENGINEERING CORPORATION
P.O. Box 1569
Grand Junction, Colorado 81502

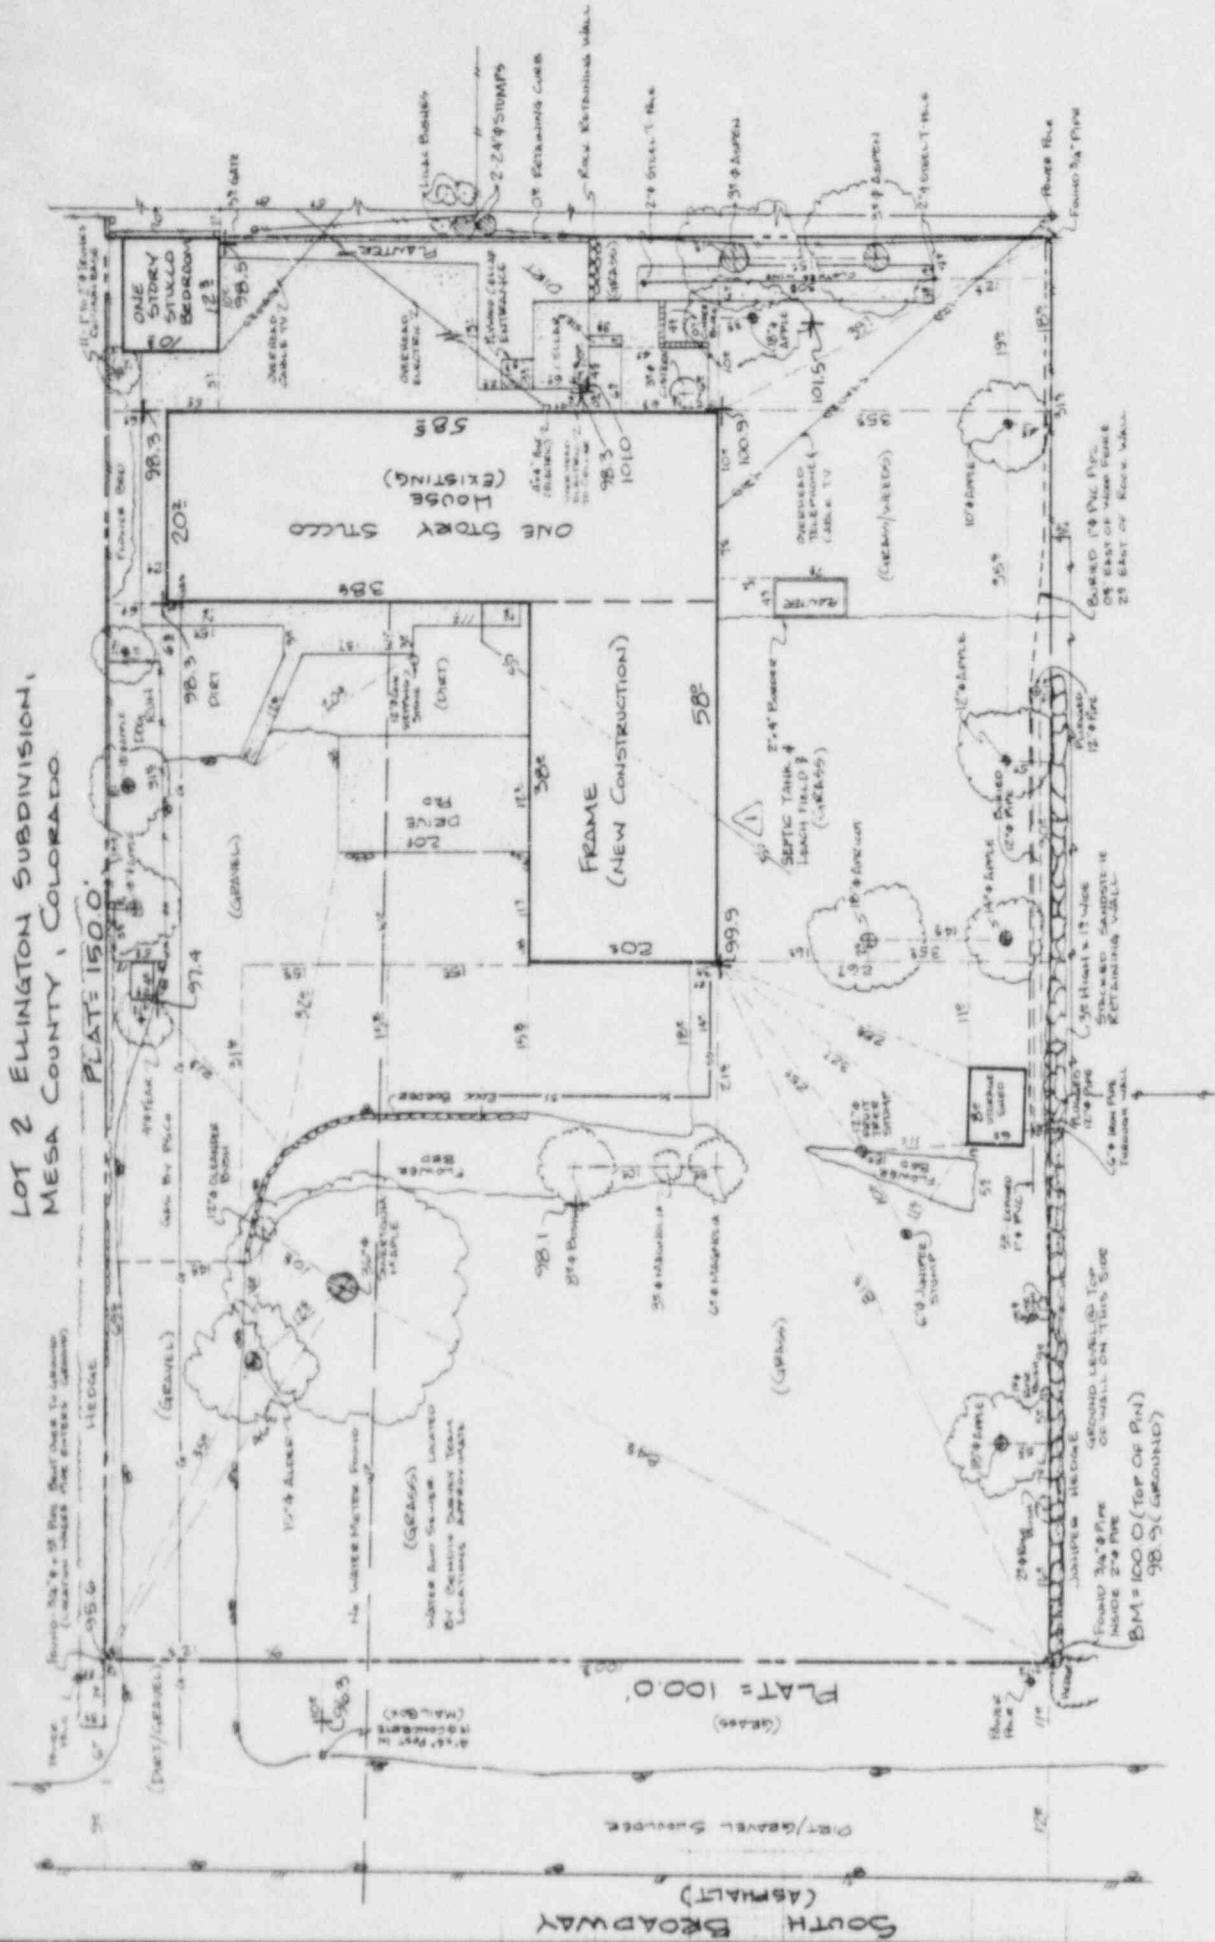
FIGURE 2.2 SITE PLAN

Sewer - The sewer line shown on the map is incorrect. It does not run north to the street. It runs west, under the new section of the house to a septic tank. A hole augered at Location 257255 went through a sewer line. It appeared to be an abandoned line; no flow was observed when the owner flushed the toilet. Therefore, it was covered up without repair. Subsequently the homeowner's husband informed us it was a waste water line from the kitchen sink. A plumber was sent out Monday, 6 May 1985, to repair it. The delta over the broken line was negative. A borehole was augered next to the septic tank.
