FRAMATOME COGEMA FUELS

June 11, 1996

In the April 17 continuing inspection meeting in Washington D.C., we discussed additional information concerning the DCP observed at Three Mile Island and Crystal River 1 and several "weaknesses" that the audit team perceived at FCF. FCF takes exception to one of the "weaknesses". Specifically, we believe that the association of weakness with the FCF design process because the unforeseeable was not foreseen is unwarranted, especially since FCF acknowledged that new performance issues might arise and put in place a program to inspect the fuel after the cycle.

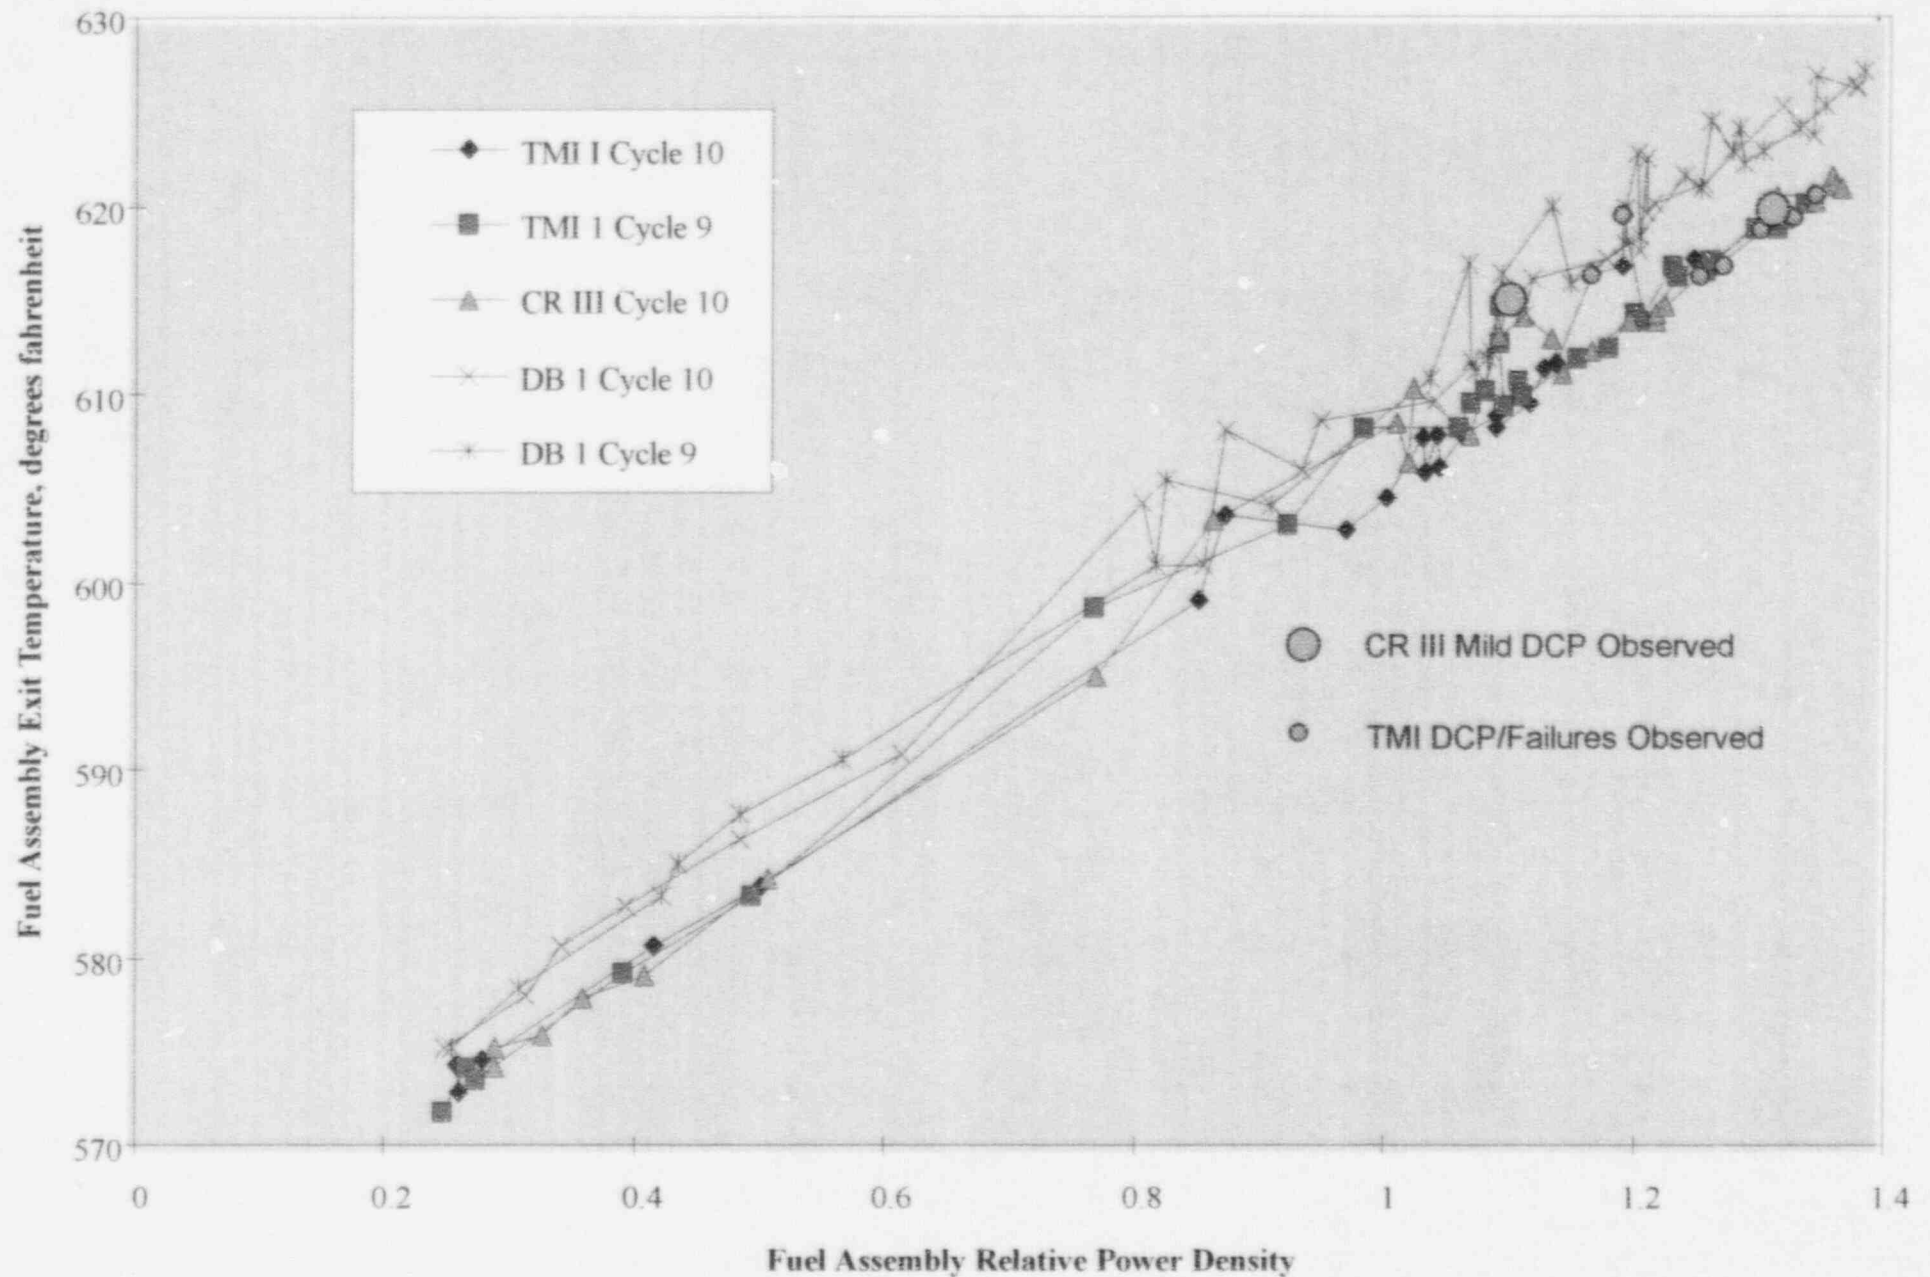
Figure 1
Power verses Temperature, BOC

Power distributions and fuel assembly outlet temperatures for cycle 10 of TMI-1 were consistent with recent designs and are bounded by a similar plant which operates at a slightly higher total power level. This is illustrated in Figure 1. The figure is a plot of the beginning of cycle relative assembly power distribution in one-eighth core

geometry versus fuel assembly outlet temperature. Five cycles are included in the plot as described in the legend. Note that TMI-1 cycle 10, Crystal River III cycle 10, and TMI-1 cycle 9, are all consistent one to the other and are bounded by Davis Besse cycles 9 and 10. The typicality of TMI cycle 10 is further supported by the performance of TMI cycles 8 and 9. Both of these cycles had a "T" type arrangement of the fresh fuel and similar interface power peaking. DCP did not occur in either TMI cycle 8 or 9. In general, conditions for TMI 1 cycle 10 were well within FCF and industry accepted design criteria. The results demonstrate that the TMI-1 cycle 10 design was not overly aggressive relative to FCF and industry design and performance experience.
