RADIOLOGIC AND ENGINEERING ASSESSMENT

DOE ID NO.: GJ-01167-RM
ADDRESS: 626 GUNNISON AVENUE

AUGUST 1985

BENDIX FIELD ENGINEERING CORPORATION
P.O. Box 1569
Grand Junction, Colorado 81502

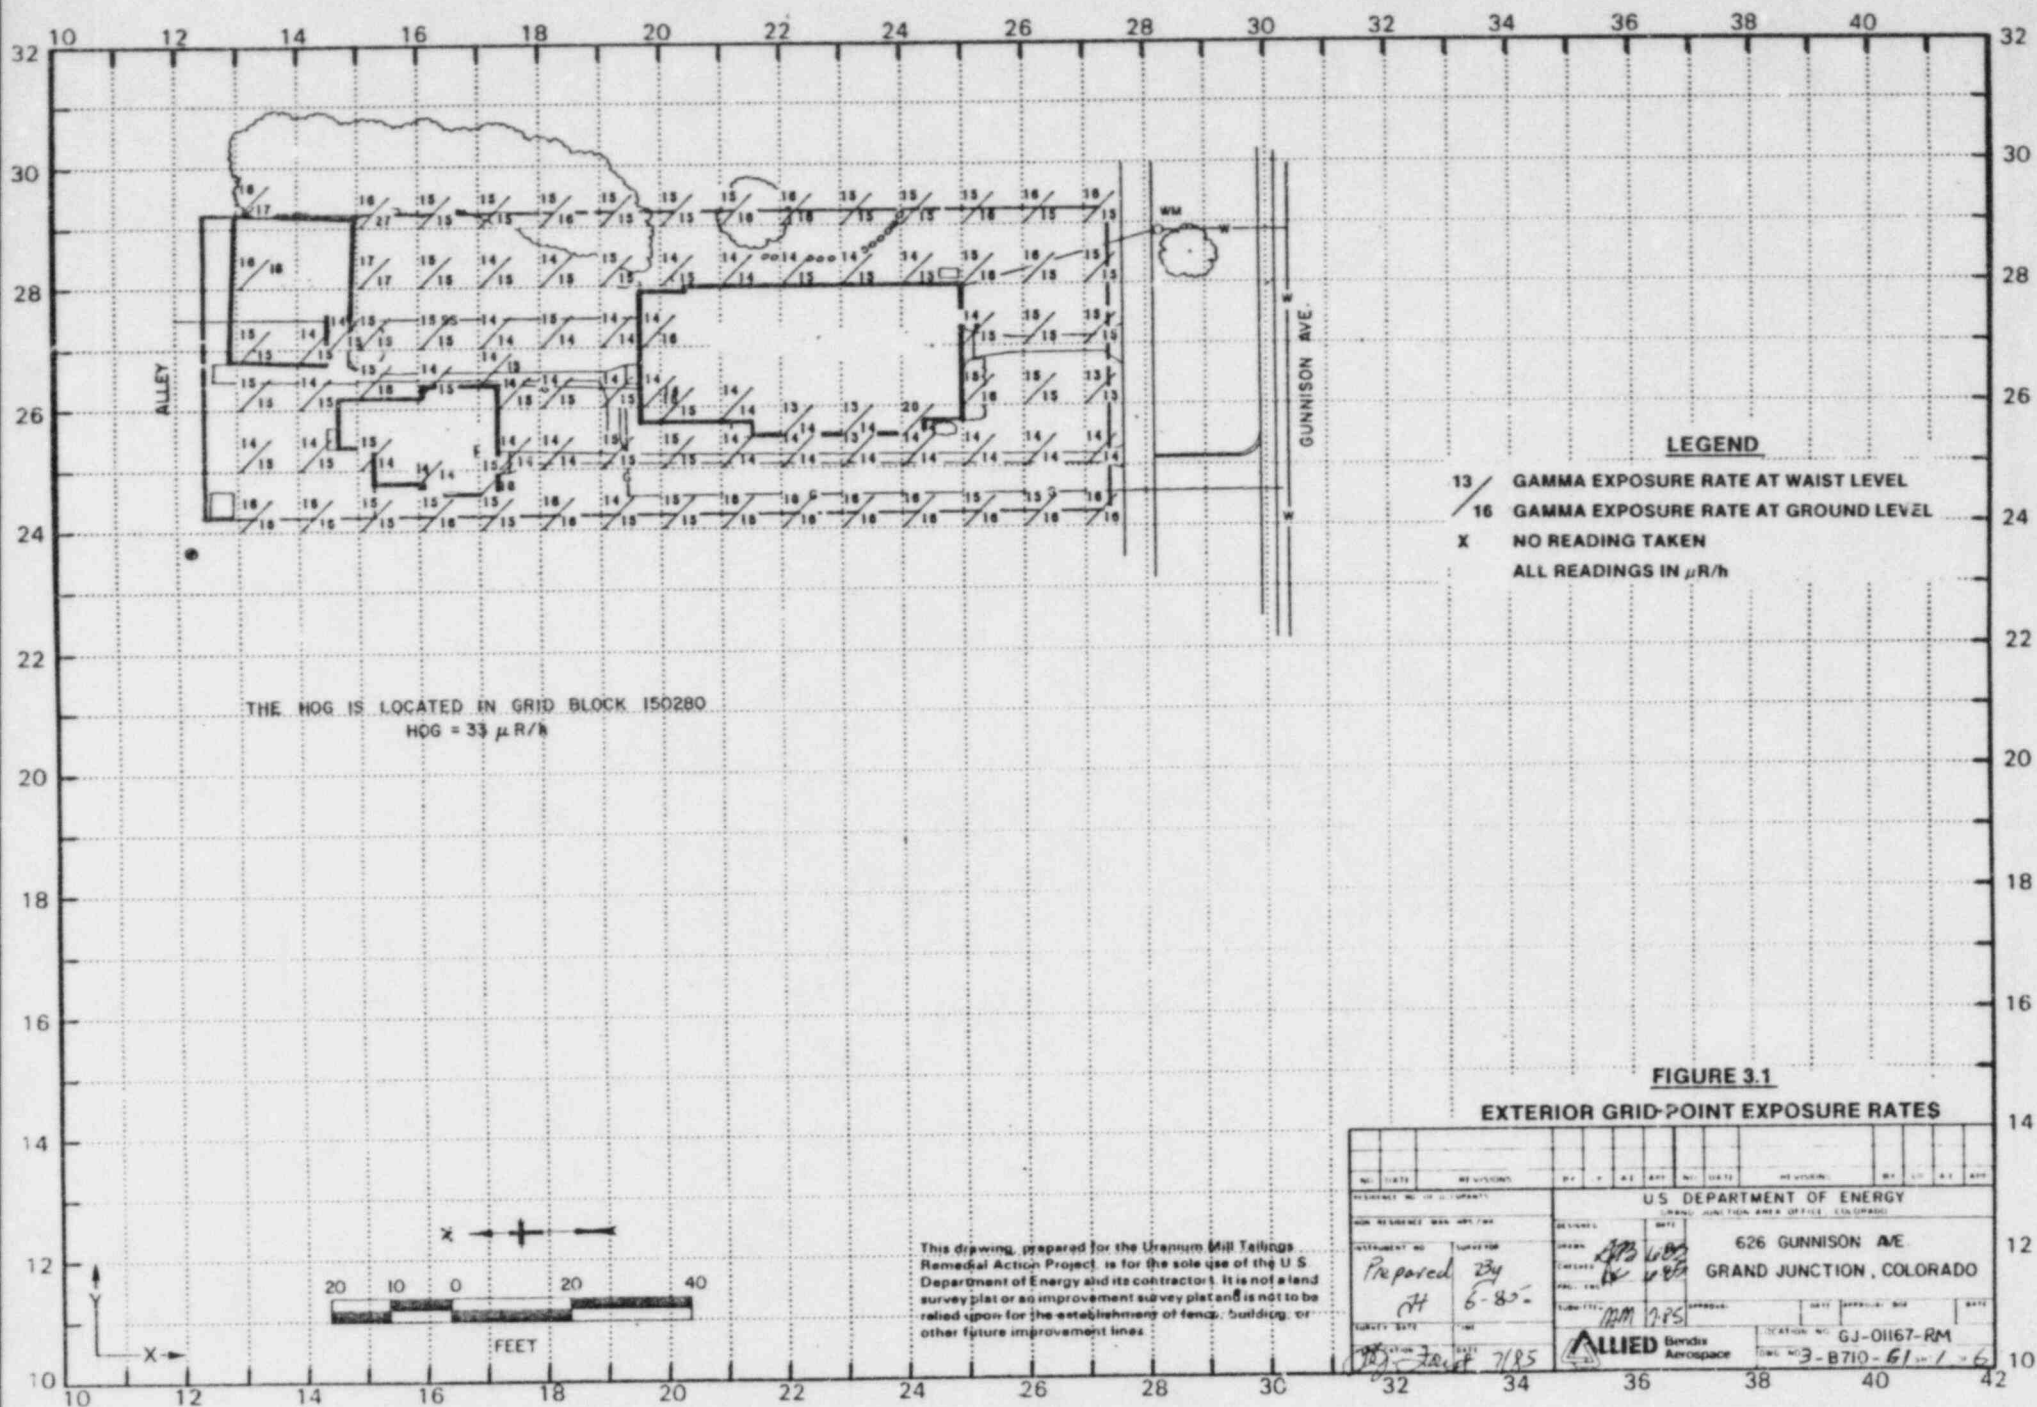
FIGURE 3.1

Background Readings: 13 to 17 uR/h
Highest Outside Gamma Reading (HOG): 33 uR/h

Exterior radium-concentration measurements are presented in Appendix Table 3.1. Grid-point survey results are shown in Appendix Figure 3.1.

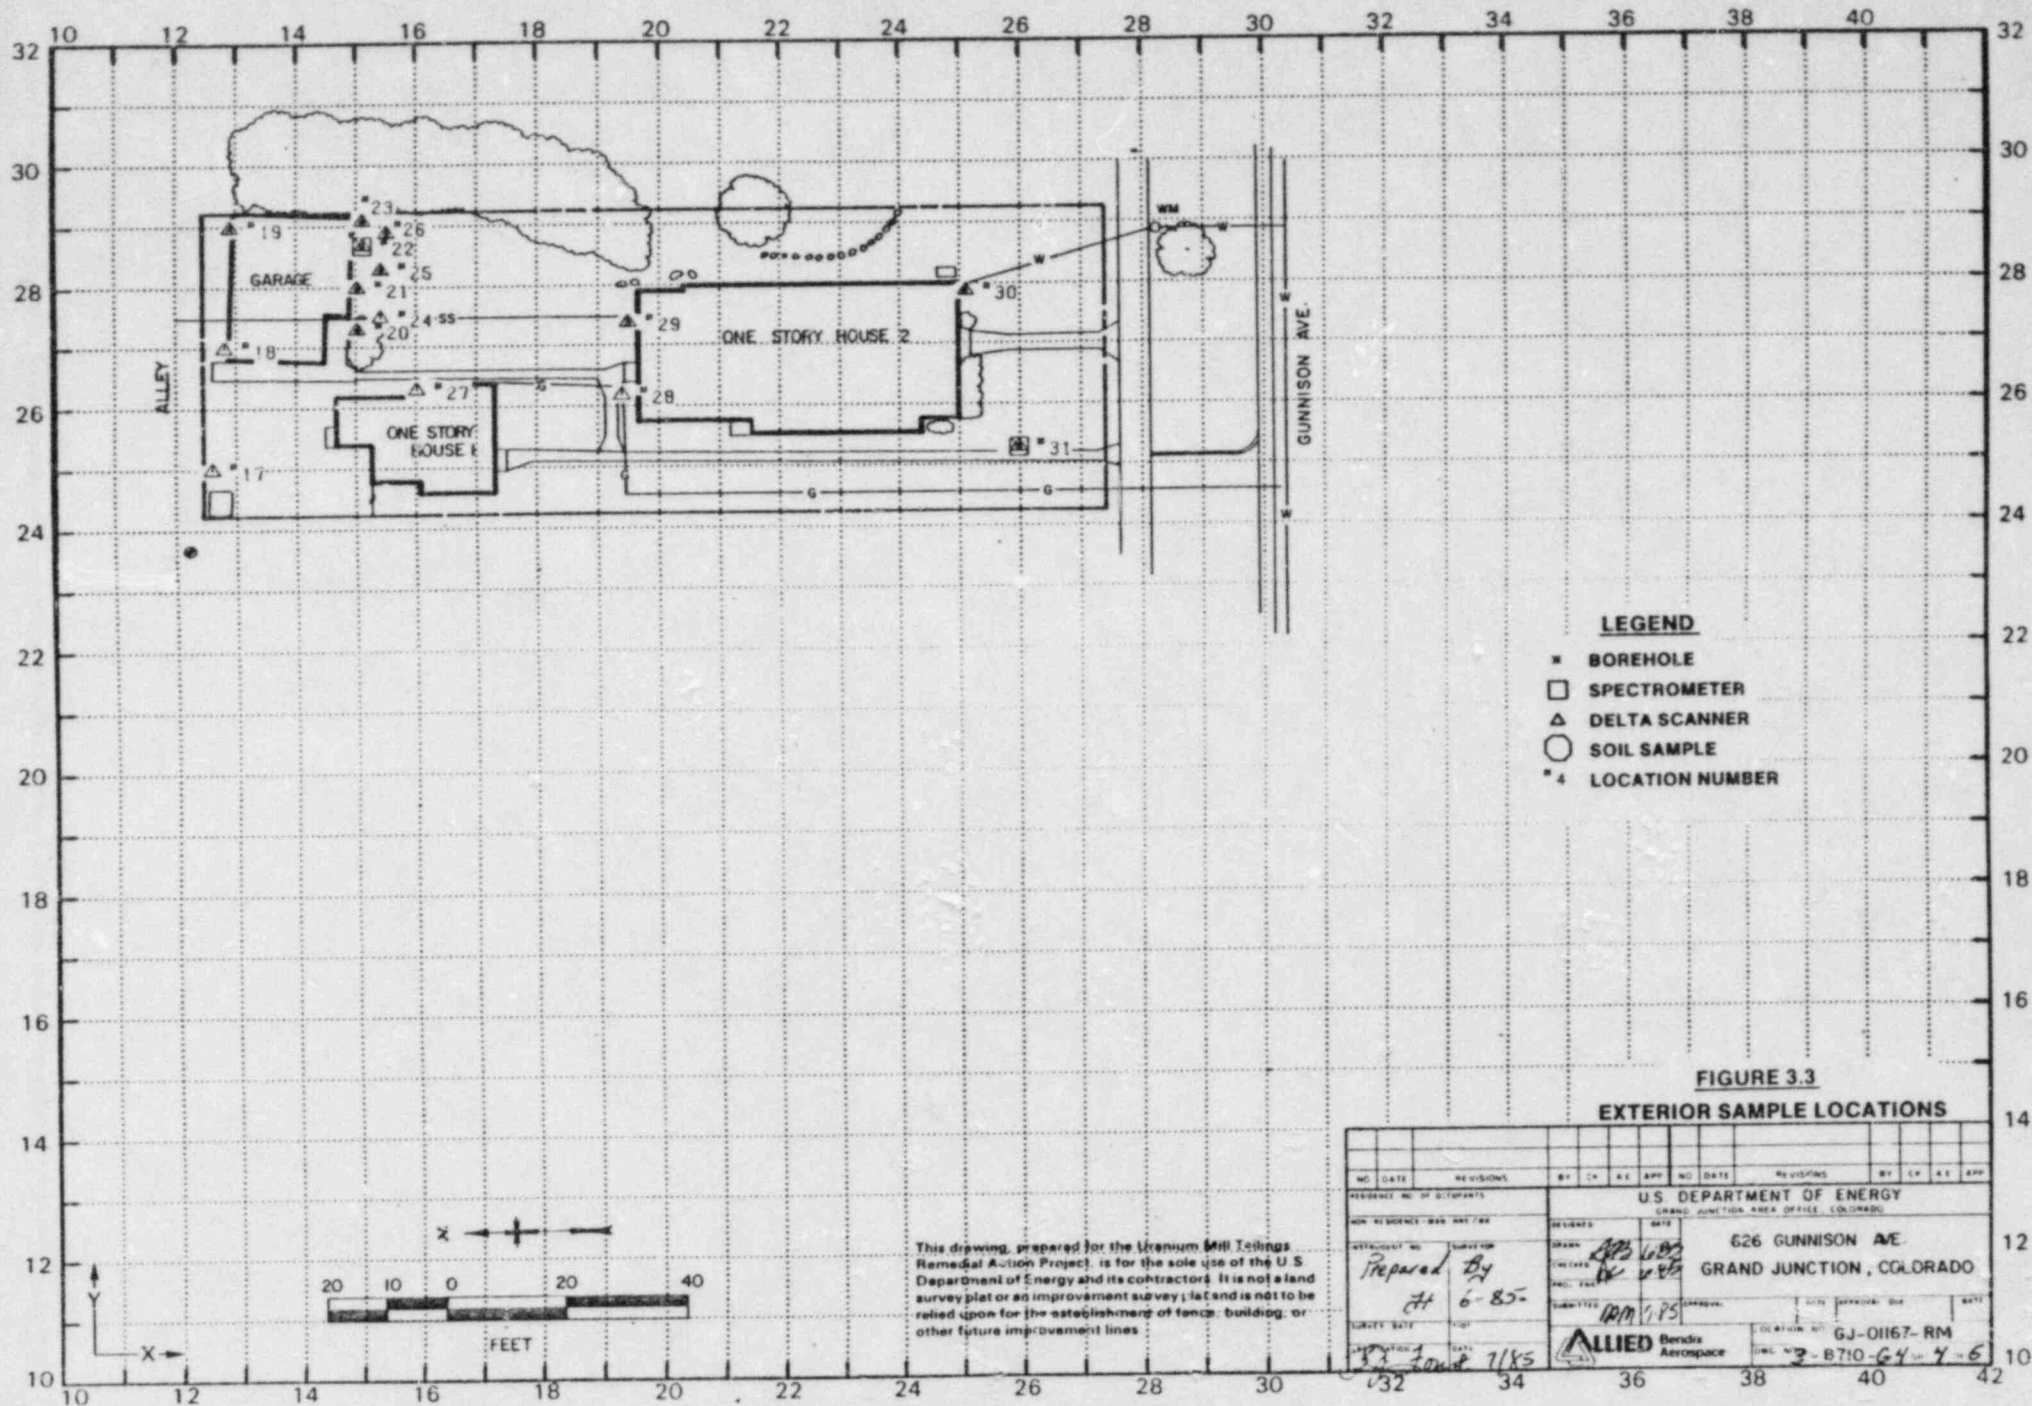
FIGURE 3.3

Areas which displayed elevated gamma levels were further investigated; these areas are shown in Appendix Figures 3.2a, 3.2b, and 3.3. Data from these investigations are included in Appendix Tables 3.1 and 3.2.

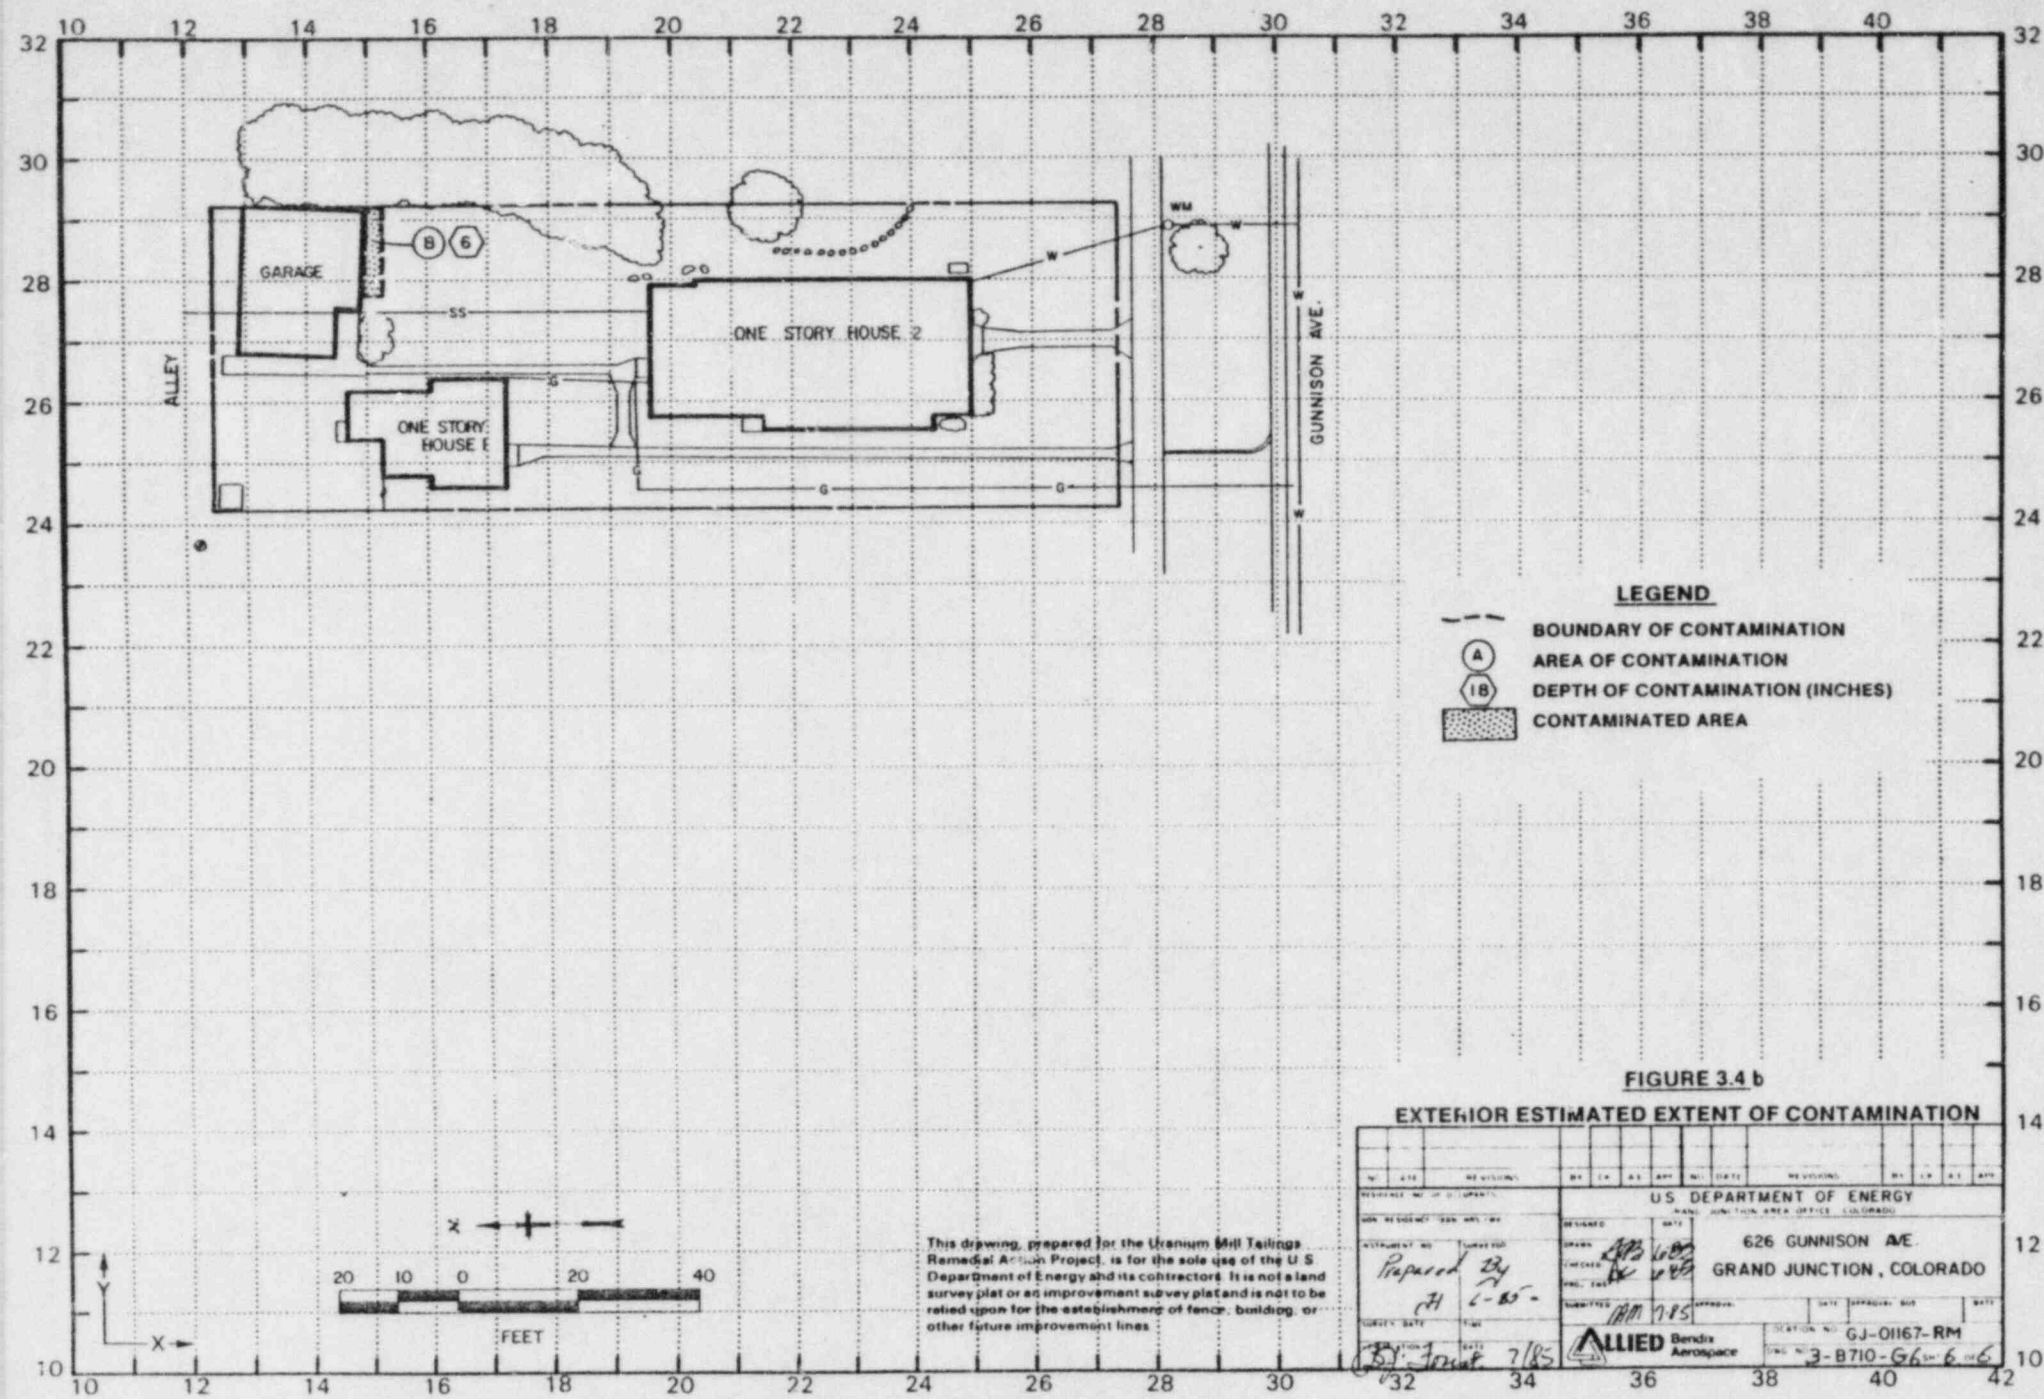
FIGURE 3.4 b

Appendix Figures 3.4a and 3.4b show identified areas and estimated depths of contamination on this property, based on assessments of all measurements taken. As noted in these figures, areas recommended for remedial action that contain identified residual radioactive materials are:

(Area B) Surface Material: Soil
Direction From Primary Structure: North of House 2
Other Directions: South side of garage
Total Depth of Contamination: 6 inches
Approximate Square Footage: 45

The recommended remedial action for this property, DOE ID No. GJ-01167-RM, includes removal of all areas identified as containing radioactive material (as discussed in Section 3.5 and shown in Appendix Figures 3.4a and 3.4b) and transport of removed material to the disposal site.

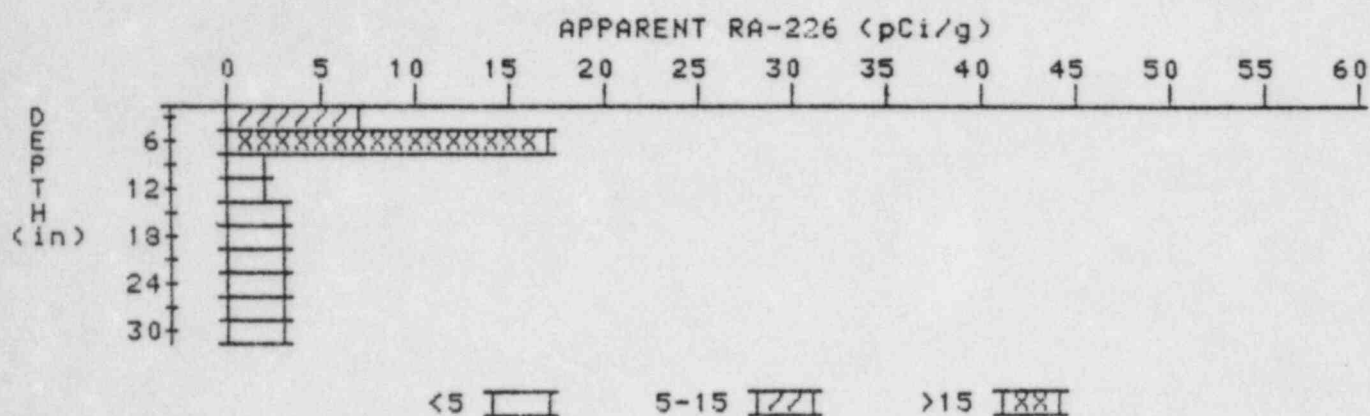
APPARENT RADIUM-226 CONCENTRATION 23

Depth (in)	Apparent Radium-226 (pCi/g) Undeconvolved	Apparent Radium-226 (pCi/g) Deconvolved
3	7.3	7.3
6	8.7	16.9
9	5.5	2.3
12	4.1	2.3
15	3.7	3.3
18	3.5	3.3
21	3.4	3.4
24	3.3	3.1
27	3.3	3.3
30	3.3	3.3

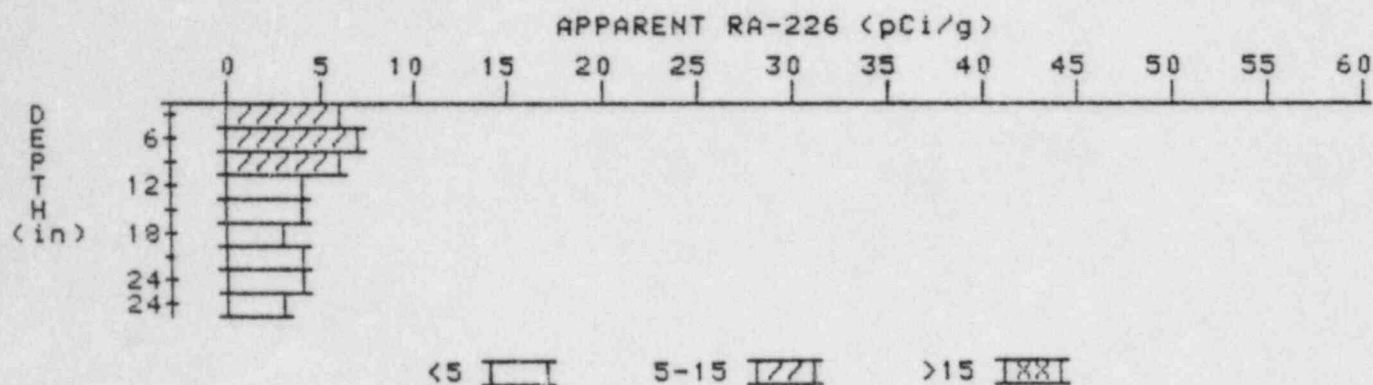
APPARENT RADIUM-226 CONCENTRATION 12 DECONVOLUTION GRAPH

Depth (in)	Apparent Radium-226 (pCi/g) Undeconvolved	Apparent Radium-226 (pCi/g) Deconvolved
3	5.7	5.7
6	5.8	6.7
9	5.4	6.3
12	4.5	3.8
15	4.0	3.8
18	3.6	3.1
21	3.5	3.5
24	3.4	4.1
24	2.9	2.9
