RADIOLOGIC AND ENGINEERING ASSESSMENT

DOE ID NO.: GJ-30306-CS
ADDRESS: 922 NORTH 1ST STREET

AUGUST 1985

BENDIX FIELD ENGINEERING CORPORATION
P.O. Box 1569
Grand Junction, Colorado 81502

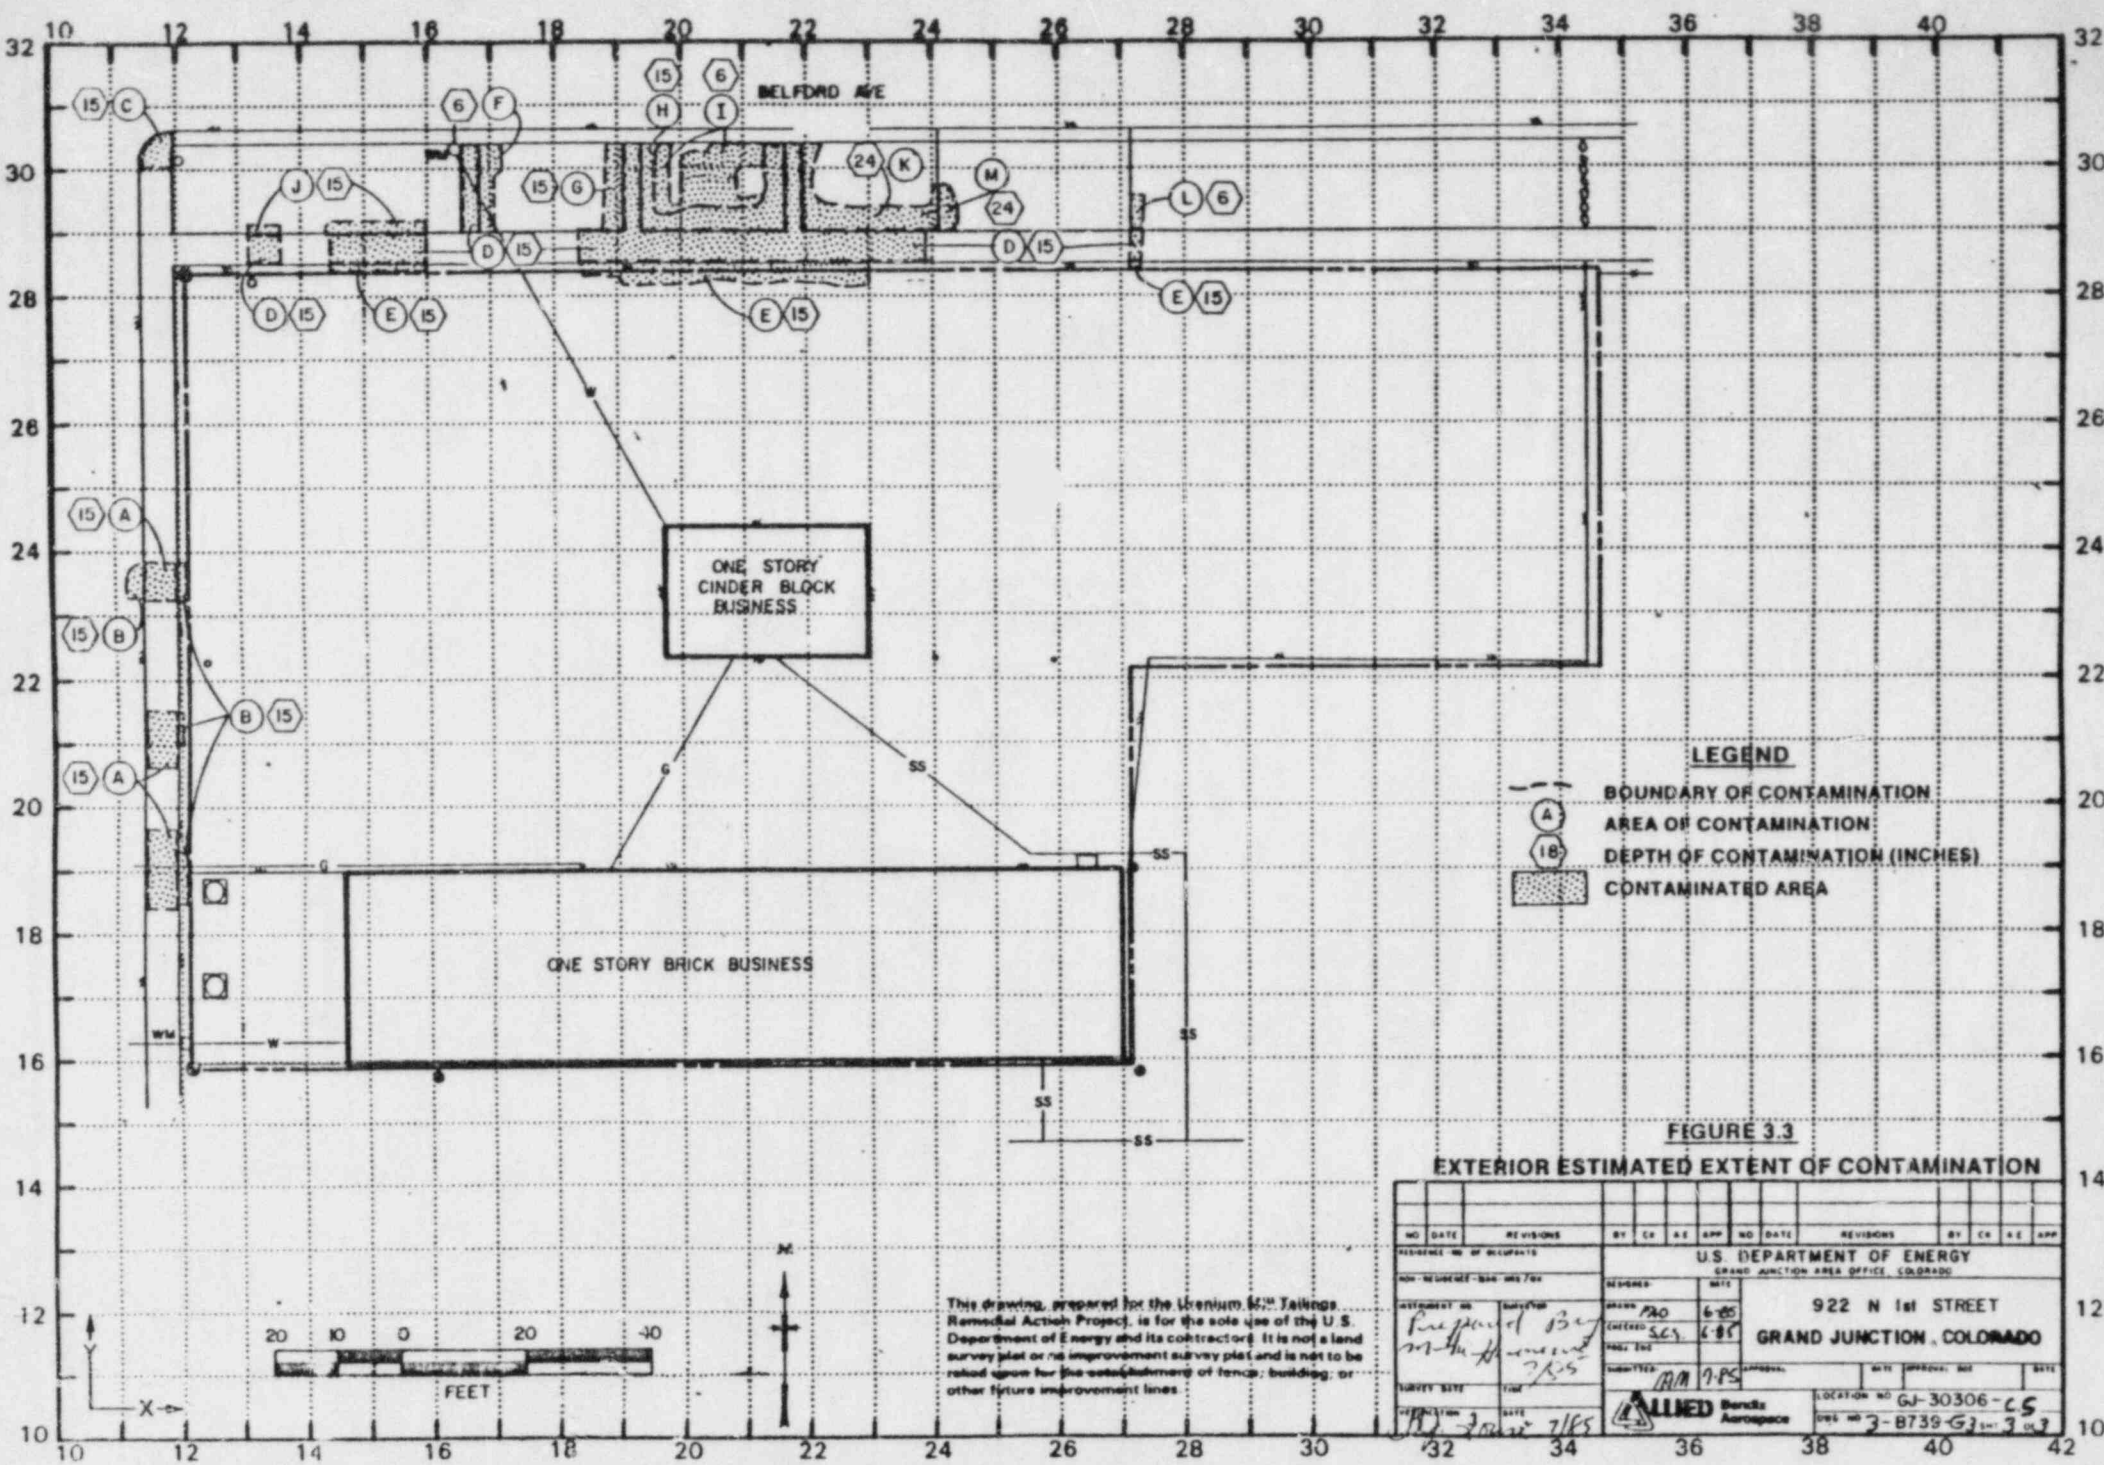
FIGURE 3.3

Appendix Figure 3.3 shows identified areas and estimated depths of contamination on this property, based on assessments of all measurements taken. As noted in this figure, areas recommended for remedial action that contain identified residual radioactive materials are:

- (Area A) Surface Material: Concrete
Direction From Primary Structure: West
Other Directions: Adjacent to North 1st Street
Total Depth of Contamination: 15 inches
Other (height or thickness): 4-inch-thick concrete
Comments: Three deposits are included in this area.
Approximate Square Footage: 135

- (Area B) Surface Material: Asphalt
Direction From Primary Structure: West
Other Directions: Adjacent to city sidewalk
Total Depth of Contamination: Estimated at 15 inches
Other (height or thickness): 2-inch-thick asphalt
Comments: The depth of contamination is based on data collected in Area A. Four deposits are included in this area.
Approximate Square Footage: 44 (The portion of Area B which is located in North 1st Street is excluded from remedial action.)

- (Area C) Surface Material: Concrete
Direction From Primary Structure: Northwest
Other Directions: Northwest corner of property
Total Depth of Contamination: Estimated at 15 inches
Other (height or thickness): 4-inch-thick concrete
Comments: The depth of contamination is based on data collected in Area A.
Approximate Square Footage: 20

- (Area D) Surface Material: Concrete
Direction From Primary Structure: North
Other Directions: Adjacent to the north property line
Total Depth of Contamination: 15 inches
Other (height or thickness): 4-inch-thick concrete
Comments: Five deposits are included in in this area.
Approximate Square Footage: 501

- (Area E) Surface Material: Asphalt
Direction From Primary Structure: North
Other Directions: Adjacent to the north property line
Total Depth of Contamination: Estimated at 15 inches
Other (height or thickness): 2-inch-thick asphalt
Comments: The depth of contamination is based on data collected in Area D. Three deposits are included in this area.
Approximate Square Footage: 214

- (Area F) Surface Material: Decorative rock
Direction From Primary Structure: North
Other Directions: North of the north property line
Total Depth of Contamination: 6 inches
Approximate Square Footage: 51

- (Area G) Surface Material: Decorative rock
Direction From Primary Structure: North
Other Directions: North of the north property line
Total Depth of Contamination: 15 inches
Comments: The depth of contamination is based on data collected in Area D.
Approximate Square Footage: 51

- (Area H) Surface Material: Decorative rock
Direction From Primary Structure: North
Other Directions: North of the north property line
Total Depth of Contamination: Estimated at 15 inches
Comments: The depth of contamination is based on data collected in Area D.
Approximate Square Footage: 154

- (Area I) Surface Material: Decorative rock
Direction From Primary Structure: North
Other Directions: North of the north property line
Total Depth of Contamination: 6 inches
Approximate Square Footage: 120

- (Area J) Surface Material: Decorative rock
Direction From Primary Structure: North
Other Directions: North of the north property line
Total Depth of Contamination: Estimated at 15 inches
Comments: The depth of contamination is based on data collected in Area D.
Approximate Square Footage: 42

- (Area K) Surface Material: Decorative rock
Direction From Primary Structure: North
Other Directions: North of the north property line
Total Depth of Contamination: 24 inches
Approximate Square Footage: 102

- (Area L) Surface Material: Decorative rock
Direction From Primary Structure: North
Other Directions: North of the north property line
Total Depth of Contamination: 6 inches
Approximate Square Footage: 10
- (Area M) Surface Material: Concrete
Direction From Primary Structure: North
Other Direction: In the north driveway
Total Depth of Contamination: Estimated at 24 inches
Other (height or thickness): 4-inch-thick concrete
Comments: The depth of contamination is based on data
collected in Area K.
Approximate Square Footage: 21

The recommended remedial action for this property, DOE ID No. GJ-30306-CS, includes removal of all areas identified as containing radioactive material (as discussed in Section 3.5 and shown in Appendix Figure 3.3) and transport of removed material to the disposal site.

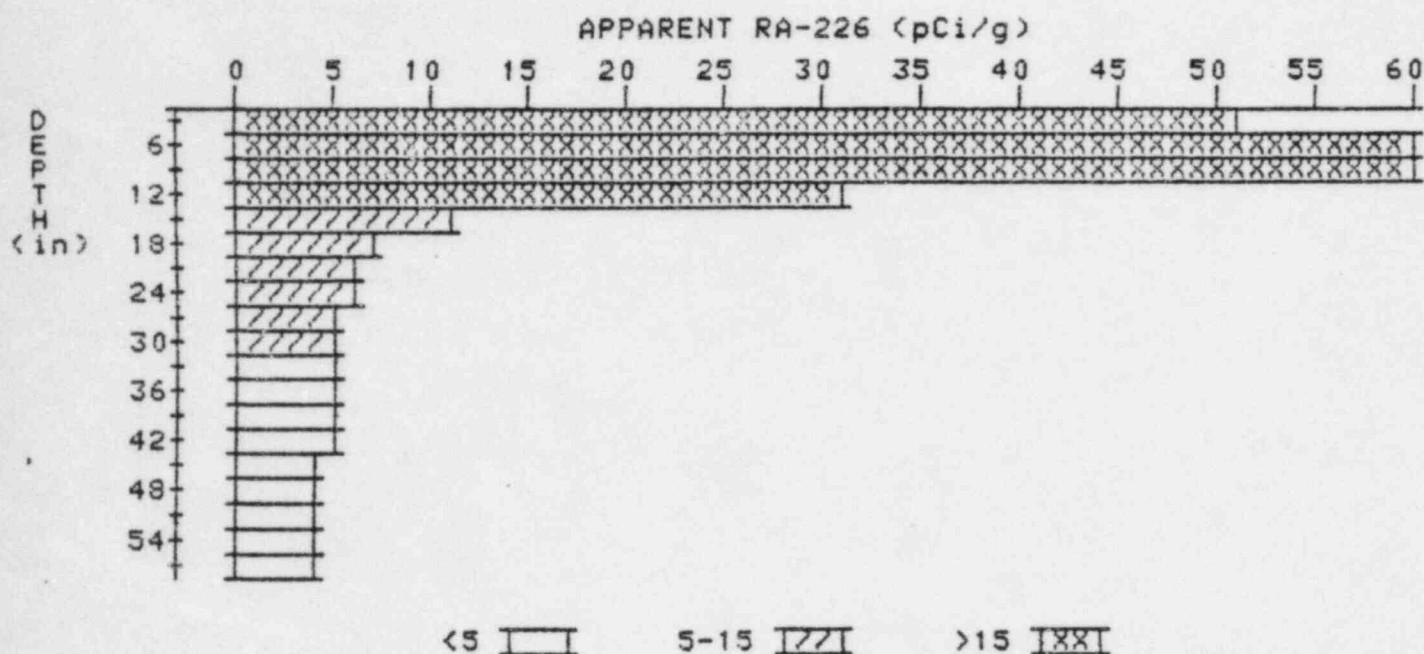
HOLE NUMBER: 1

Depth (in)	Apparent Radium-226 (pCi/g) Undeconvolved	Apparent Radium-226 (pCi/g) Deconvolved
3	51.4	51.4
6	68.3	112.9
9	60.1	82.0
12	39.6	31.4
15	23.7	11.3
18	14.8	7.2
21	10.2	6.5
24	7.7	5.7
27	6.3	5.1
30	5.6	5.2
33	5.1	4.6
36	4.9	4.7
39	4.8	5.0
42	4.6	4.6
45	4.4	4.4
48	4.2	3.8
51	4.2	4.4
54	4.1	4.1

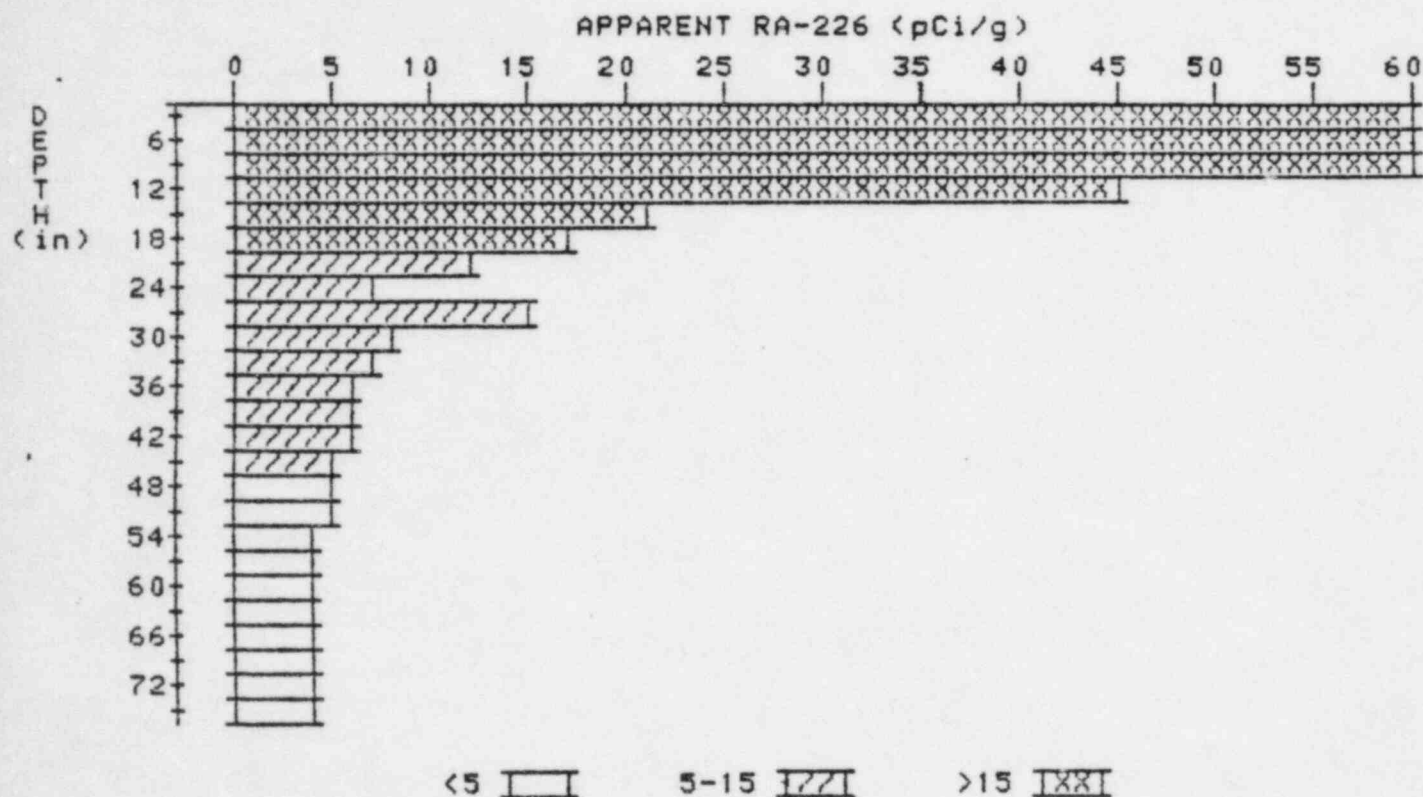
HOLE NUMBER: 20

Depth (in)	Apparent Radium-226 (pCi/g)	Apparent Radium-226 (pCi/g)
	Undeconvolved	Deconvolved
3	104.9	104.9
6	139.1	236.0
9	118.8	163.2
12	73.5	44.9
15	44.3	20.7
18	28.4	16.7
21	19.1	12.0
24	13.8	6.9
27	12.4	14.7
30	9.7	7.9
33	8.0	6.9
36	6.9	6.2
39	6.2	5.8
42	5.7	5.7
