Edwin I. Hatch Nuclear Plant
Reply to a Notice of Violation

Edwin I. Hatch Nuclear Plant
Violation 96-14-03 and GPC Response

VIOLATION 96-14-03

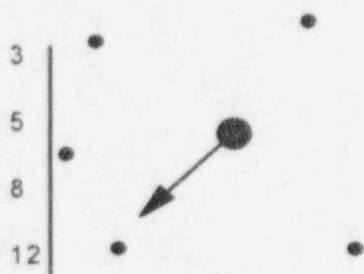
The fourth example of the Notice of Violation was caused by an inadequate breaker trip device label. Specifically, the manufacturer-installed labels on the face of the breaker trip device selector switch are misleading. An individual setting the trip device to point to the numeral 12 on the face of the selector switch would actually be setting it to a dot corresponding to an incorrect trip setpoint of 8X instead of the desired setpoint of 12X. (Comparing Figure 1 with Figure 2 shows the labeling problem which led to the breaker trip device being set incorrectly.) The inadequate label resulted in the installed overcurrent trip device for the normal supply breaker to Motor Control Center 1R24-S026 having a setting which differed from the electrical single line diagram and from procedure 52PM-R24-002-0S, "Air Circuit Breaker, Type LA-600, Maintenance," both of which required a trip setpoint of 12X.

Figure 1
Actual Appearance of
Selector Switch Face

For the fourth example, a temporary modification was implemented on 11/10/96 in which a 150-amp, non-safety related load was removed from Unit 1 Motor Control Center 1R24-S026 and powered from another bus. The incorrectly set trip device installed on the

600V feeder breaker in Motor Control Center 1R24-S026 then was disabled and the appropriate breakers set to accommodate the remaining loads on the bus. These actions were taken in response to potential concerns regarding proper breaker coordination with the instantaneous overcurrent trip device installed and resulted in the "B" Emergency Diesel Generator being returned to operable status. Breaker settings for similar breakers in the plant have been checked by the system engineer; they were found to be correct.

5. A permanent design change will be made to Unit 1 Motor Control Center 1R24-S026 to remove the existing trip devices from the primary and alternate feeder breakers on this bus. Thereafter, circuit protection will be provided for this 600V bus by upstream 4160V breakers. The load which was removed from this 600V bus will be returned to the bus. These actions will be completed by 6/15/97.

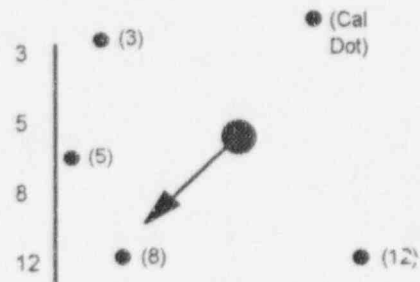
Figure 2
Selector Switch Face With
(Numbers) Added to Show
What Each Dot Represents
