U. S. NUCLEAR REGULATORY COMMISSION

Report No. 50-312/85-16

Facility Name: Rancho Seco Unit 1

Inspection between June 1-July 14 and July 20-31, 1985 (Report No. 50-312/85-16)

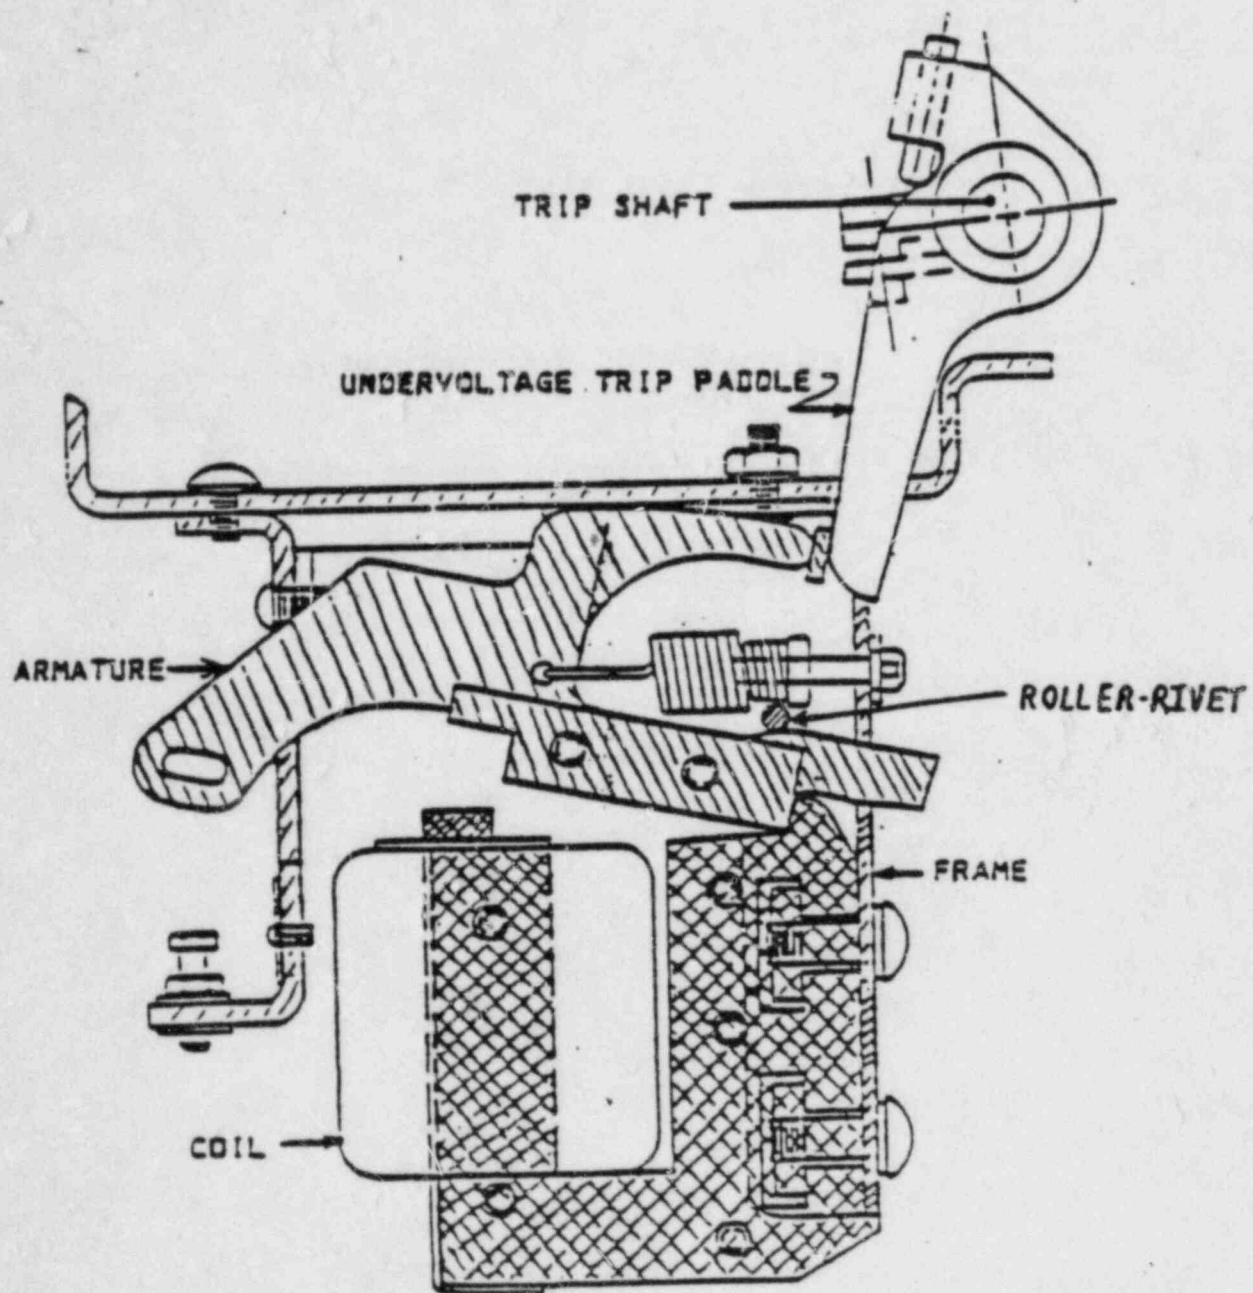
FIGURE 1

On June 5, 1985, while the licensee was performing surveillance and calibration on the "C" channel of the Reactor Protection System (RPS), the reactor trip breaker (RTB), see Figure 1, failed to trip open when its undervoltage trip attachment (UVTA) was actuated. The licensee stopped the test being performed, and observed that the undervoltage (UV)

armature was physically stuck in the energized condition. The licensee proceeded to the next portion of the surveillance test, actuated the shunt trip device of the RTB, and successfully tripped the RTB. Therefore, although the RTB had failed to trip with the undervoltage condition, the breaker was operable using the shunt trip device.

On June 6, 1985 the inspectors observed a bench check of the RTB that failed. The licensee was able to trip the breaker several times using the UVTA; but it was noted that the trip paddle (see figure 1) appeared to be loose. The licensee was able to move the trip paddle over the armature and prevent the armature from moving out of the energized position. This configuration appeared to have simulated the original failed condition of June 5, 1985, because the armature, could not engage the trip paddle when the UVTA was deenergized. However, the shunt trip was able to trip the breaker. The licensee then rotated the trip paddle to its proper position and was able to trip the breaker using the UVTA.

After successful completion of STP-944 it was determined that the licensee had six operable RTBs and that the cause of the breaker failure

appeared to be an excessive armature to rivet gap clearance. The armature to rivet gap was determined to be approximately .059 inches. The specification range was .001 to .010 inches. The greater armature to rivet gap has been shown to allow the trip paddle to move freely and possibly interfere with the proper operation of the armature.

It appears to date that the excessive armature to rivet gap could have been caused by vibrations of the breaker during transportation to and from the GE and B&W facilities.

The licensee identified that the GE Service Bulletin recommended the measurement of the armature to rivet gap, but did not specify the proper position of the armature when measured. The licensee discovered that GE technicians always measured this gap with the armature in the energized position.

The licensee has incorporated the guidance of the GE Service Bulletin into their surveillance procedure for the RTBs. Additionally it appears that the failure mechanism, excessive armature to rivet gap, has been appropriately identified and the corrective actions performed satisfactorily tested all RTBs before the licensee began withdrawing control rods.
