RADIOLOGIC AND ENGINEERING ASSESSMENT

DOE ID NO.: GJ-12406-RS
ADDRESS: 555 ASHLEY LANE

AUGUST 1985

BENDIX FIELD ENGINEERING CORPORATION
P.O. Box 1569
Grand Junction, Colorado 81502

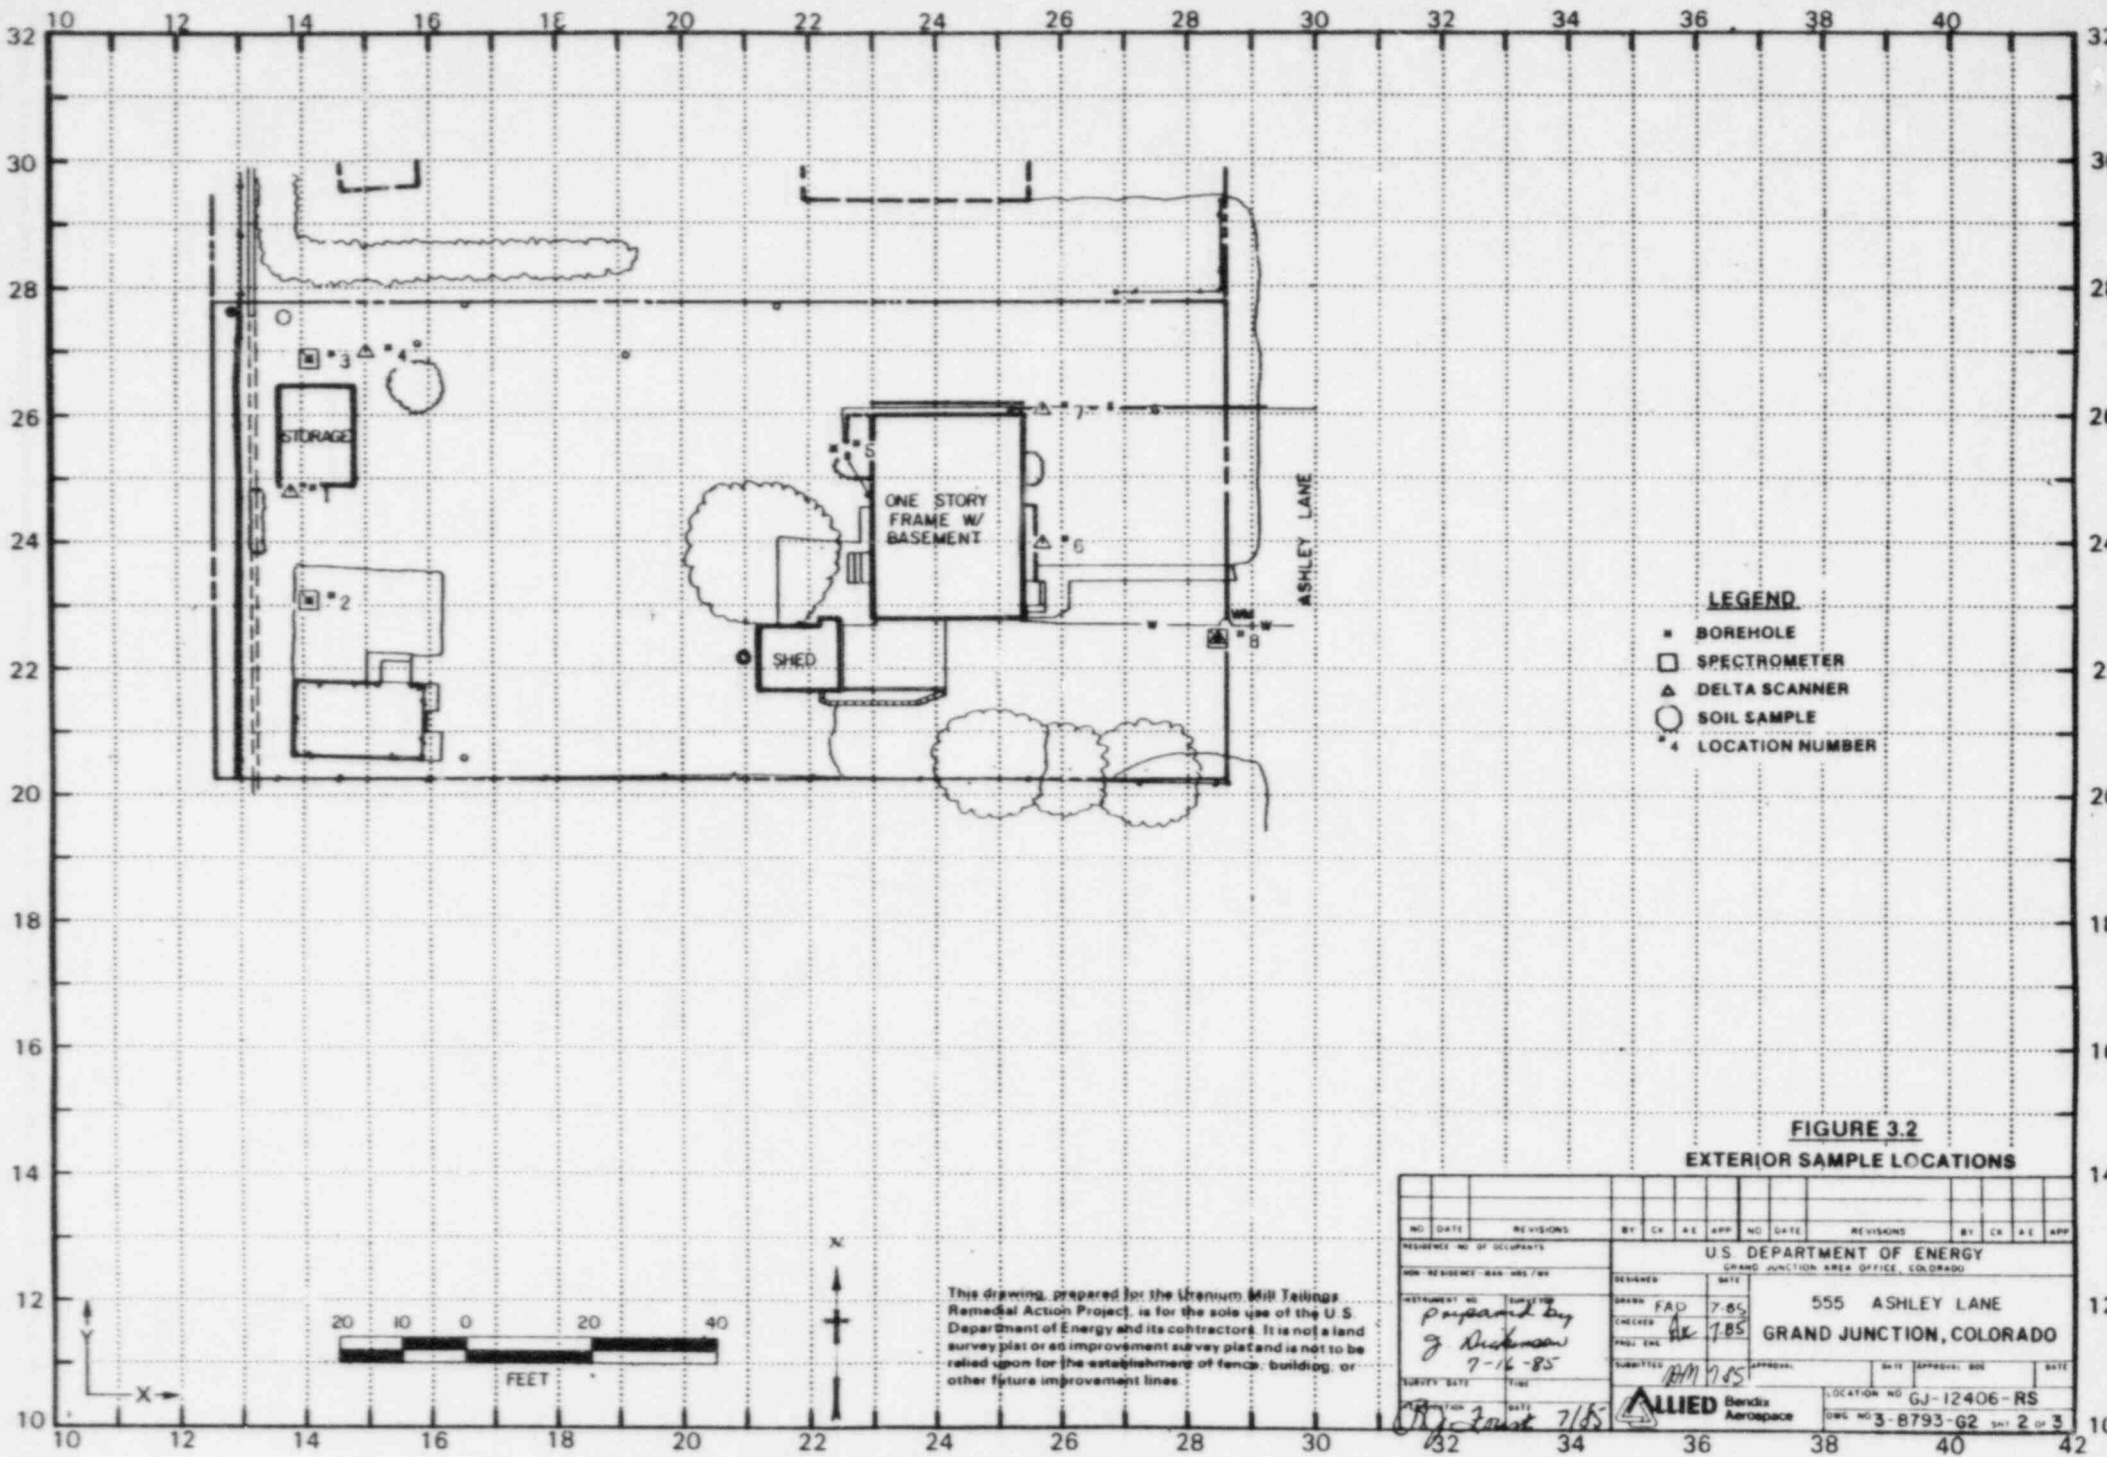
FIGURE 3.2
EXTERIOR SAMPLE LOCATIONS

Areas which displayed elevated gamma levels were further investigated; these areas are shown in Appendix Figure 3.2. Data from these investigations are included in Appendix Table 3.1.
