RADIOLOGIC AND ENGINEERING ASSESSMENT

DOE ID NO.: GJ-05975-CS  
ADDRESS: 3256.5 F ROAD  
CLIFTON, COLORADO

MAY 1985

BENDIX FIELD ENGINEERING CORPORATION  
P.O. Box 1569  
Grand Junction, Colorado 81502

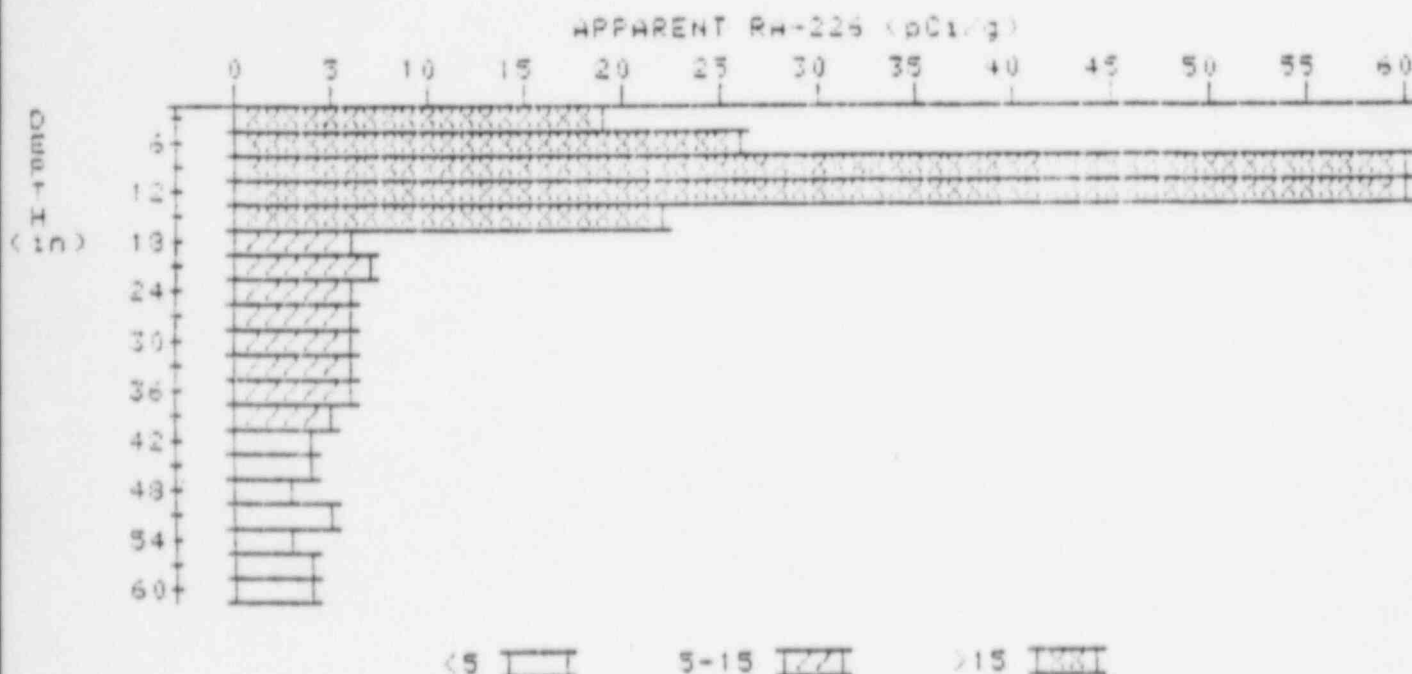
HOLE NUMBER: 1

Depth (in)	Apparent Radium-226 (pCi/g) Undeconvolved	Apparent Radium-226 (pCi/g) Deconvolved
3	19.3	19.3
6	36.6	25.6
9	60.1	105.3
12	58.2	95.2
15	35.8	22.0
18	20.4	6.4
21	13.2	7.0
24	9.5	6.3
27	7.6	6.0
30	6.6	5.9
33	5.0	5.6
36	5.6	5.6
39	5.1	5.4
42	4.3	4.1
45	4.1	3.9
48	3.8	3.1
51	3.9	4.6
54	3.6	2.9

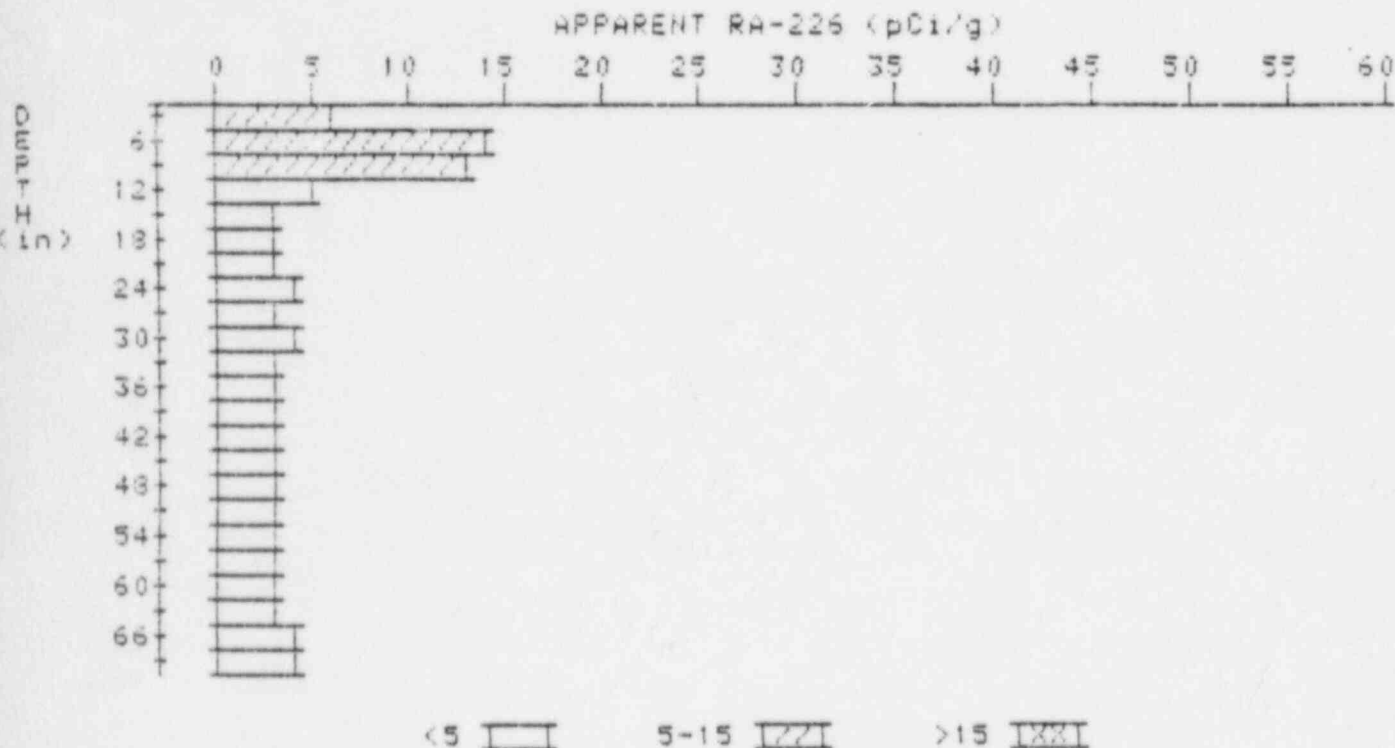
PROPERTY NUMBER: QJ-05975-C3  
HOLE NUMBER: 5  
LOCATION: 155255

Depth (in)	Apparent Radium-226 (pCi/g) Undeconvolved	Apparent Radium-226 (pCi/g) Deconvolved
3	6.2	6.2
6	8.9	13.9
9	8.0	12.9
12	6.4	5.0
15	4.0	3.4
18	4.0	3.1
21	3.7	3.3
24	3.6	3.6
27	3.8	3.6
30	3.8	3.7
33	3.4	3.4
36	3.3	3.1
39	3.3	3.6
42	3.0	3.0
45	3.2	3.2
