RADIOLOGIC AND ENGINEERING ASSESSMENT

DOE ID NO.: GJ-00316-RS
ADDRESS: 2428 HALL AVENUE

AUGUST 1985

BENDIX FIELD ENGINEERING CORPORATION
P.O. Box 1569
Grand Junction, Colorado 81502

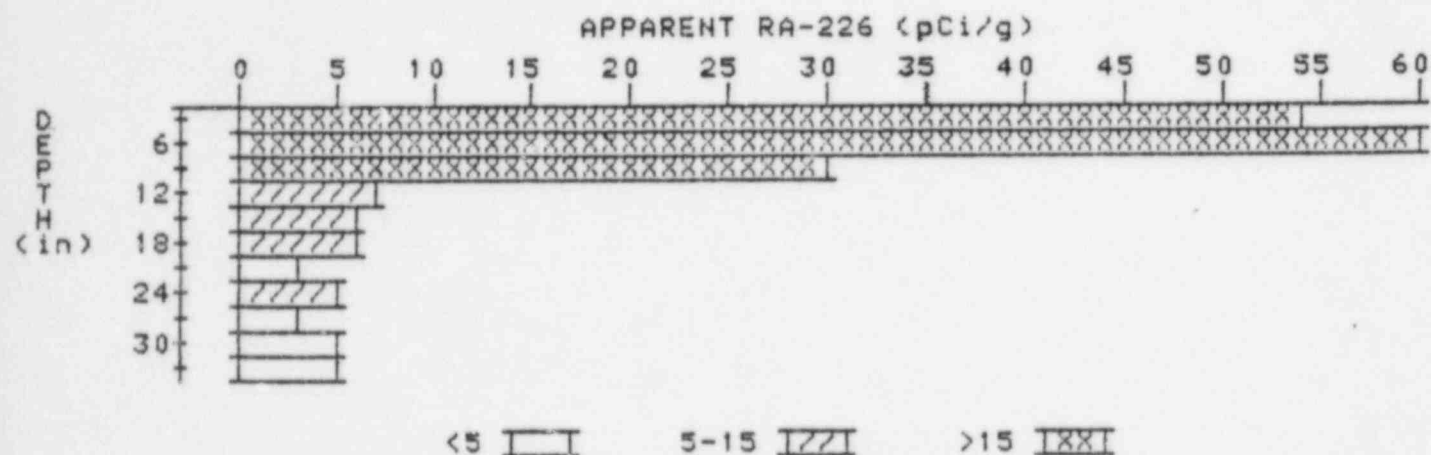
HOLE NUMBER: 3

Depth (in)	Apparent Radium-226 (pCi/g) Undeconvolved	Apparent Radium-226 (pCi/g) Deconvolved
3	54.3	54.3
6	53.7	34.8
9	35.6	30.4
12	20.4	7.2
15	12.6	5.8
18	8.6	5.8
21	6.2	3.4
24	5.4	5.4
27	4.6	3.2
30	4.6	4.3
33	4.5	4.5

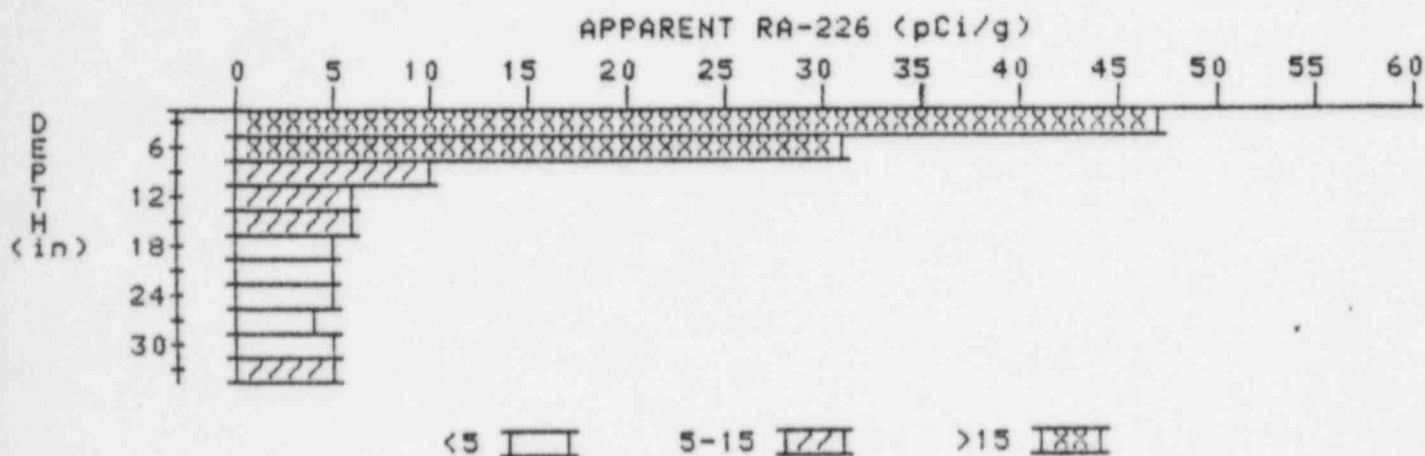
HOLE NUMBER: 4

Depth (in)	Apparent Radium-226 (pCi/g) Undeconvolved	Apparent Radium-226 (pCi/g) Deconvolved
3	46.6	46.6
6	32.6	30.6
9	19.7	9.9
12	12.3	5.5
15	8.7	5.9
18	6.7	4.9
21	5.7	4.3
24	5.2	4.3
27	4.9	4.4
30	4.9	4.5
33	5.1	5.1

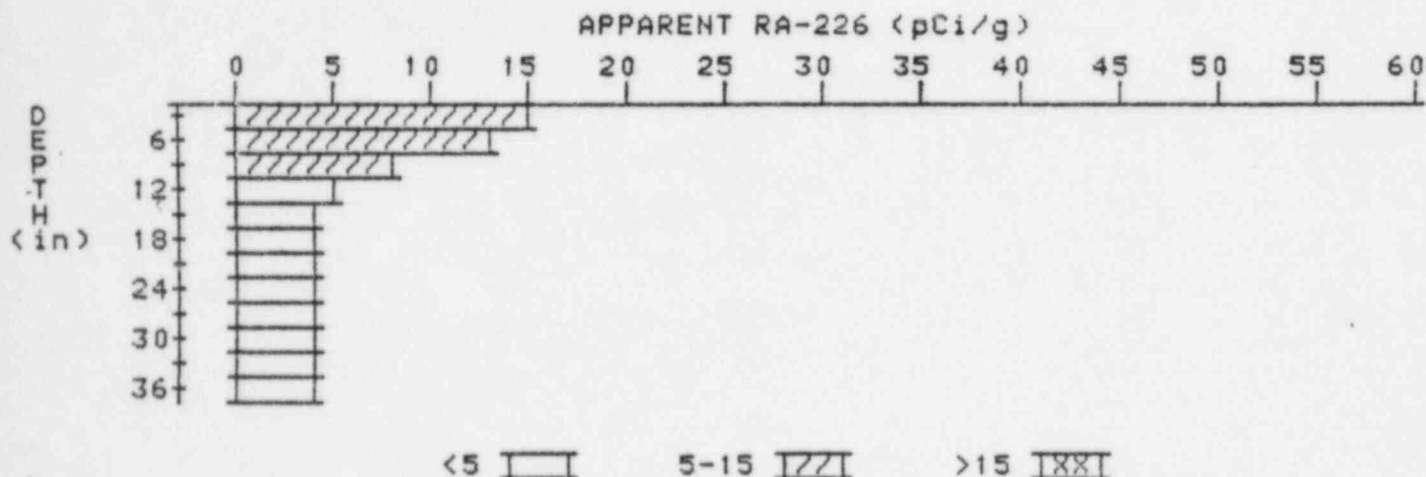
HOLE NUMBER: 6

Depth (in)	Apparent Radium-226 (pCi/g) Undeconvolved	Apparent Radium-226 (pCi/g) Deconvolved
3	14.8	14.8
6	12.2	12.9
9	9.2	8.3
12	6.7	4.9
15	5.2	3.6
18	4.6	4.1
21	4.3	4.3
24	4.0	3.6
27	3.9	3.9
30	3.8	3.8
33	3.7	3.5
36	3.7	3.7

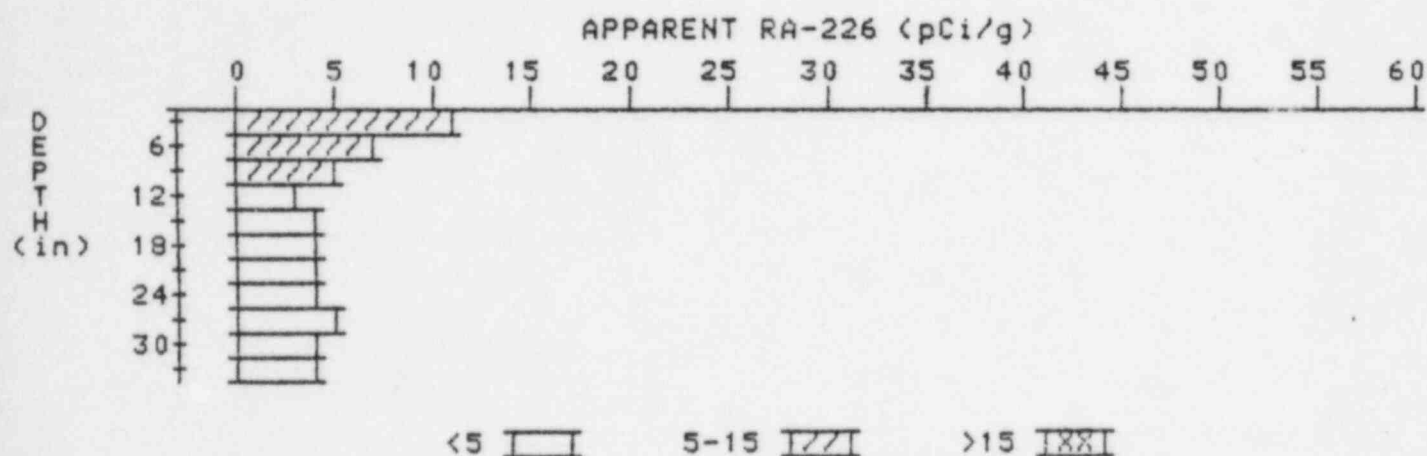
HOLE NUMBER: 8

Depth (in)	Apparent Radium-226 (pCi/g) Undeconvolved	Apparent Radium-226 (pCi/g) Deconvolved
3	10.9	10.9
6	8.1	6.5
9	6.2	5.1
12	4.9	3.3
15	4.5	4.3
18	4.2	3.7
21	4.2	4.2
24	4.2	4.0
27	4.3	4.7
30	4.2	3.8
33	4.3	4.3

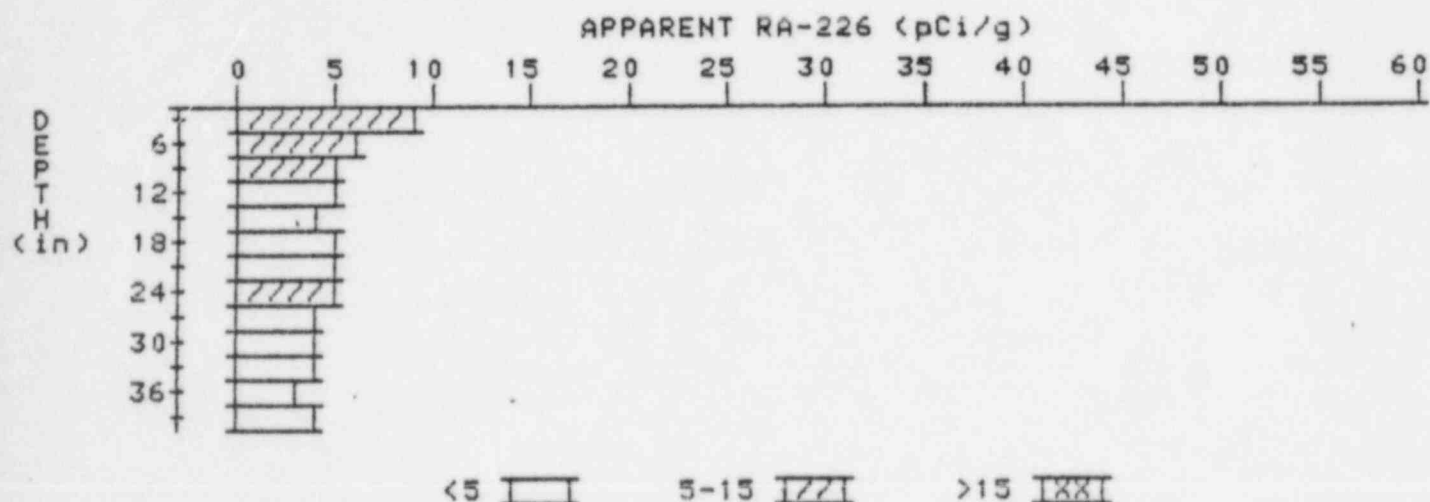
HOLE NUMBER: 12

Depth (in)	Apparent Radium-226 (pCi/g) Undeconvolved	Apparent Radium-226 (pCi/g) Deconvolved
3	8.7	8.7
6	7.0	5.9
9	5.9	5.2
12	5.2	4.7
15	4.8	4.1
18	4.8	5.0
21	4.7	4.7
24	4.6	5.1
27	4.2	3.3
30	4.0	3.6
33	4.0	4.4
36	3.3	3.3
39	3.9	3.9

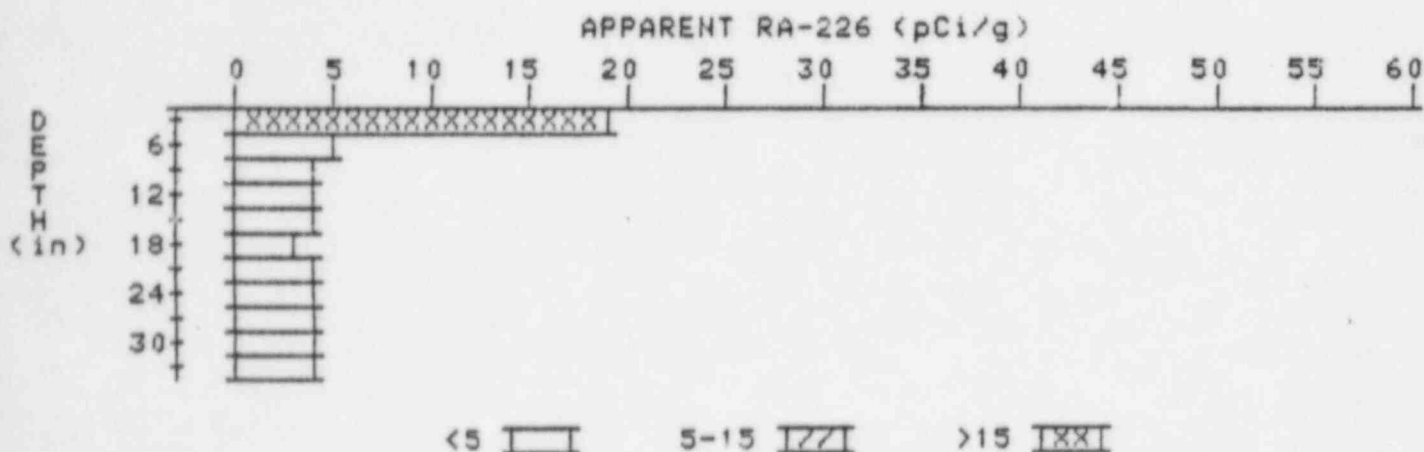
PROPERTY NUMBER: GJ-00316-RS
HOLE NUMBER: 27
LOCATION: 275290

Depth (in)	Apparent Radium-226 (pCi/g) Undeconvolved	Apparent Radium-226 (pCi/g) Deconvolved
3	18.7	18.7
6	11.2	4.6
9	7.4	4.0
12	5.5	3.7
15	4.6	3.9
18	4.1	3.4
21	4.0	3.8
24	4.0	3.8
27	4.1	4.5
30	4.0	3.6
33	4.1	4.1
