RADIOLOGIC AND ENGINEERING ASSESSMENT

DOE ID NO.: GJ-11552-RS
ADDRESS: 2856 BUNTING AVENUE

AUGUST 1985

BENDIX FIELD ENGINEERING CORPORATION
P.O. Box 1569
Grand Junction, Colorado 81502

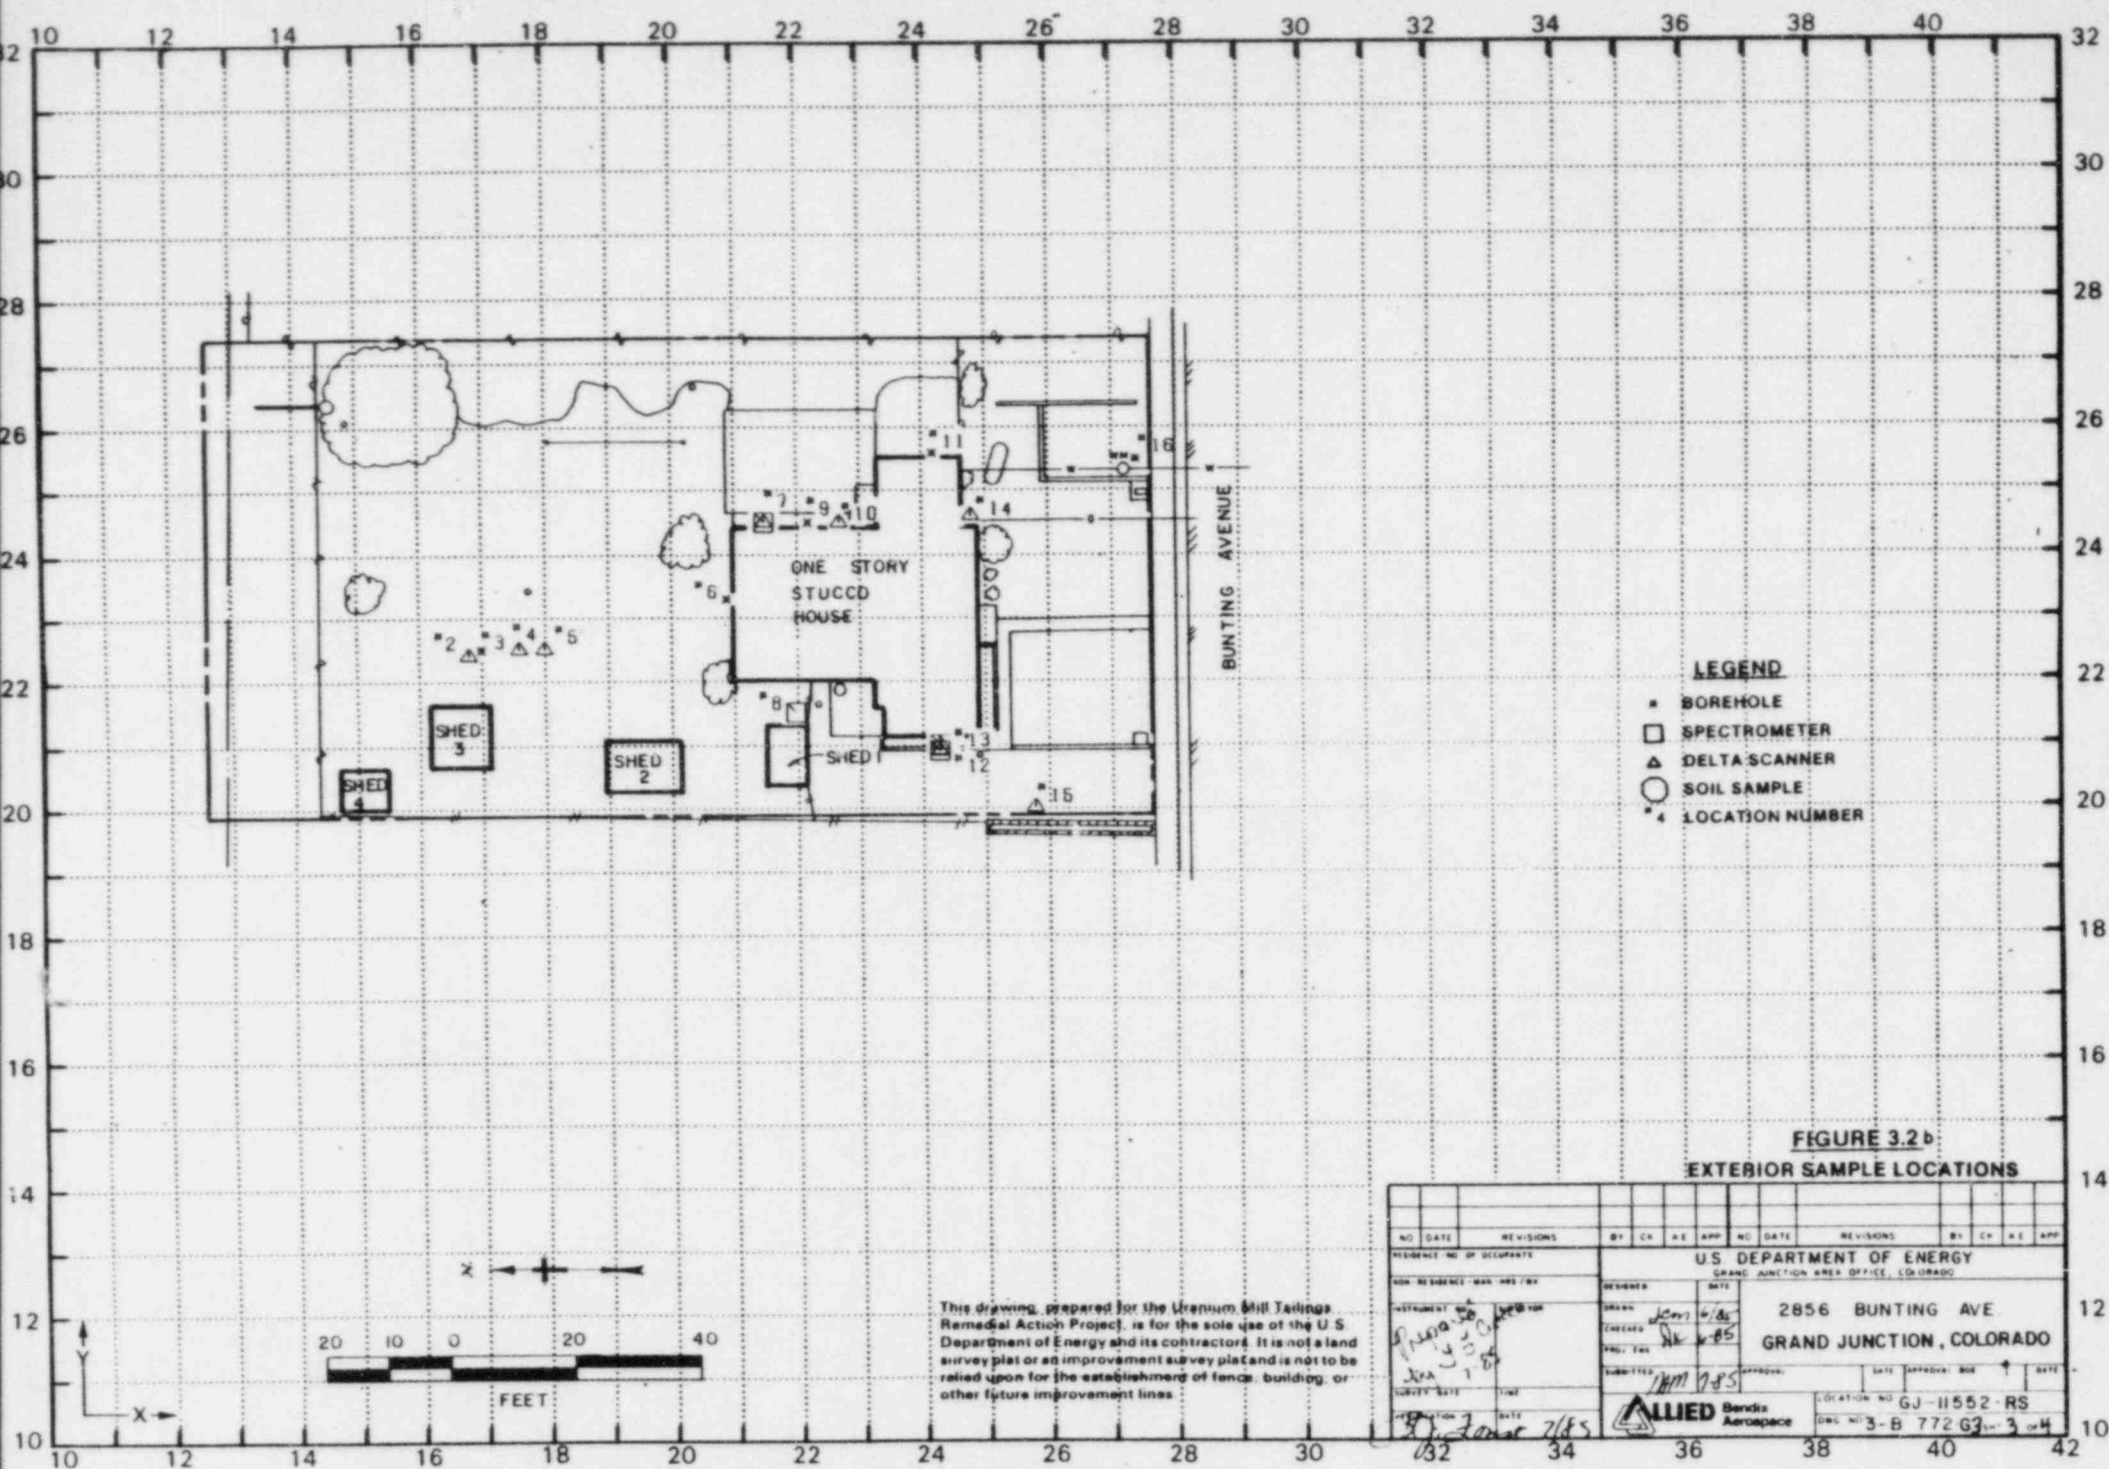
FIGURE 3.2 b
EXTERIOR SAMPLE LOCATIONS

Areas which displayed elevated gamma levels were further investigated; these areas are shown in Appendix Figures 3.2a and 3.2b. Data from these investigations are included in Appendix Tables 3.1 and 3.2.

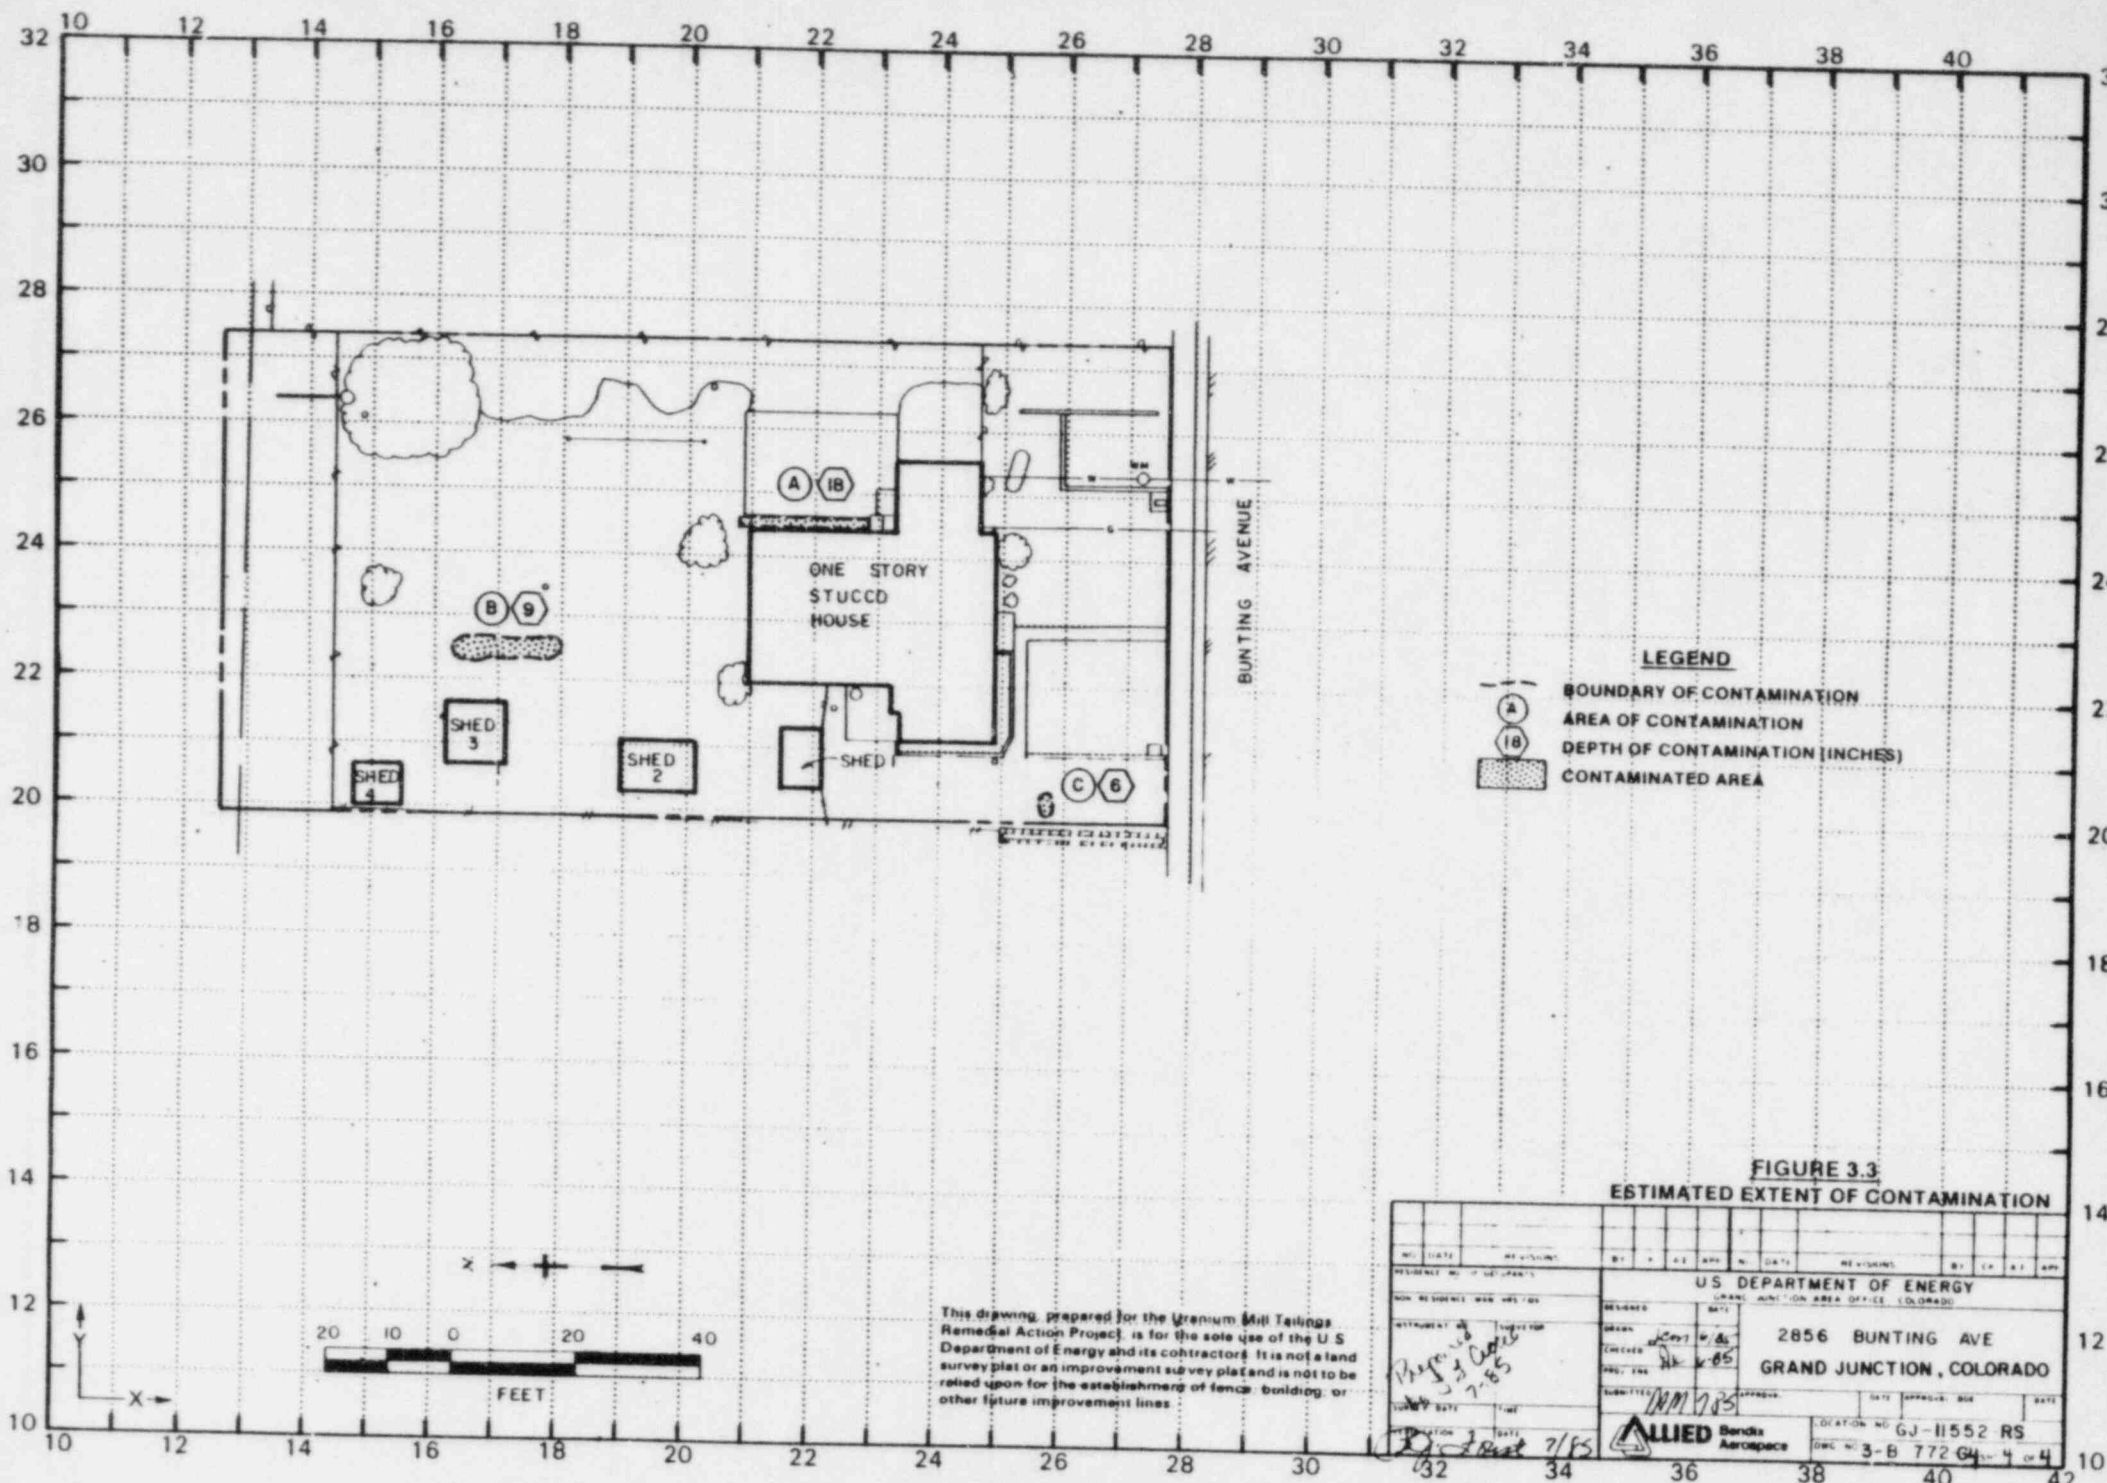
FIGURE 3.3
ESTIMATED EXTENT OF CONTAMINATION

Appendix Figure 3.3 shows identified areas and estimated depths of contamination on this property, based on assessments of all measurements taken. As noted in this figure, areas that contain identified residual radioactive materials are:

- (Area A) Surface Material: Soil
Direction From Primary Structure: East
Other Directions: West of patio
Total Depth of Contamination: 18 inches
Comments: Flower bed
Approximate Square Footage: 40
- (Area B) Surface Material: Lawn
Direction From Primary Structure: North
Other Directions: Central part of north yard
Total Depth of Contamination: 9 inches
Comments: On top of an unused septic tank
Approximate Square Footage: 68
- (Area C) Surface Material: Road base
Direction From Primary Structure: Southwest
Other Directions: In driveway near west property line
Total Depth of Contamination: 6 inches
Approximate Square Footage: 12

It is recommended that no remedial action be performed and that an indoor RDC measurement be completed on this property. If the RDC measurement exceeds EPA Standards, then the REA will be revised and remedial action accomplished in accordance with the Vicinity Property Management and Implementation Manual. If EPA Standards are not exceeded, then the no-action recommendation will be considered valid, and a Property Completion Report will be prepared for DOE certification.

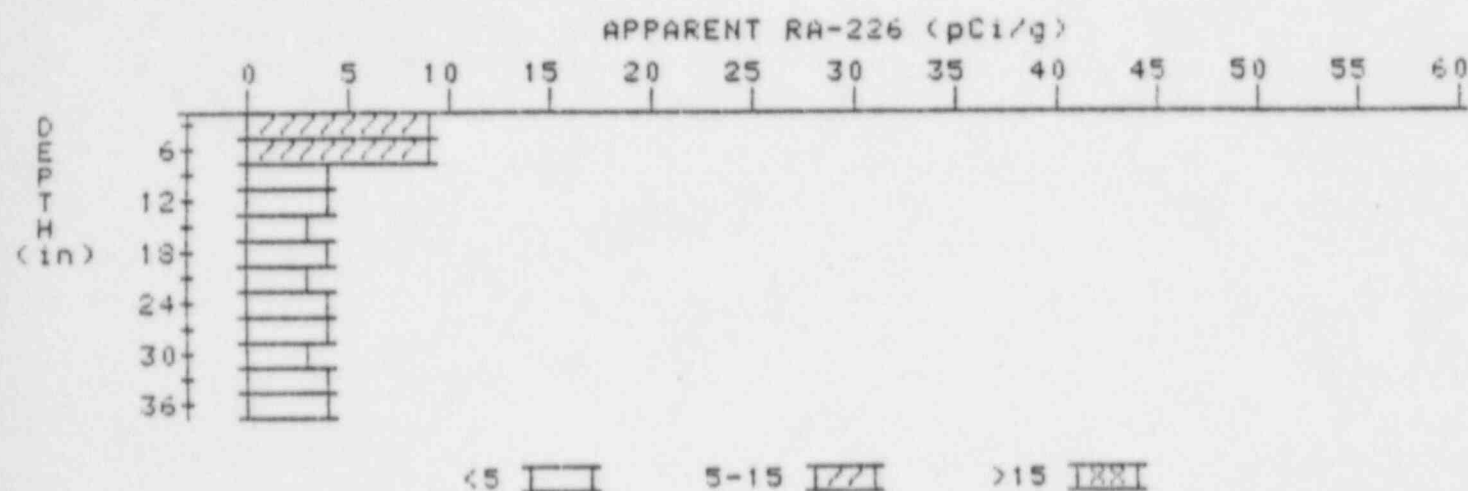
APPARENT RADIUM-226 CONCENTRATION DECONVOLUTION GRAPH

Depth (in)	Apparent Radium-226 (pCi/g) Undeconvolved	Apparent Radium-226 (pCi/g) Deconvolved
3	8.6	3.6
6	7.4	3.6
9	5.5	3.9
12	4.5	3.6
15	4.0	3.5
18	3.8	3.6
21	3.6	3.2
24	3.6	3.6
27	3.6	3.6
30	3.6	3.4
33	3.7	3.9
36	3.7	3.7

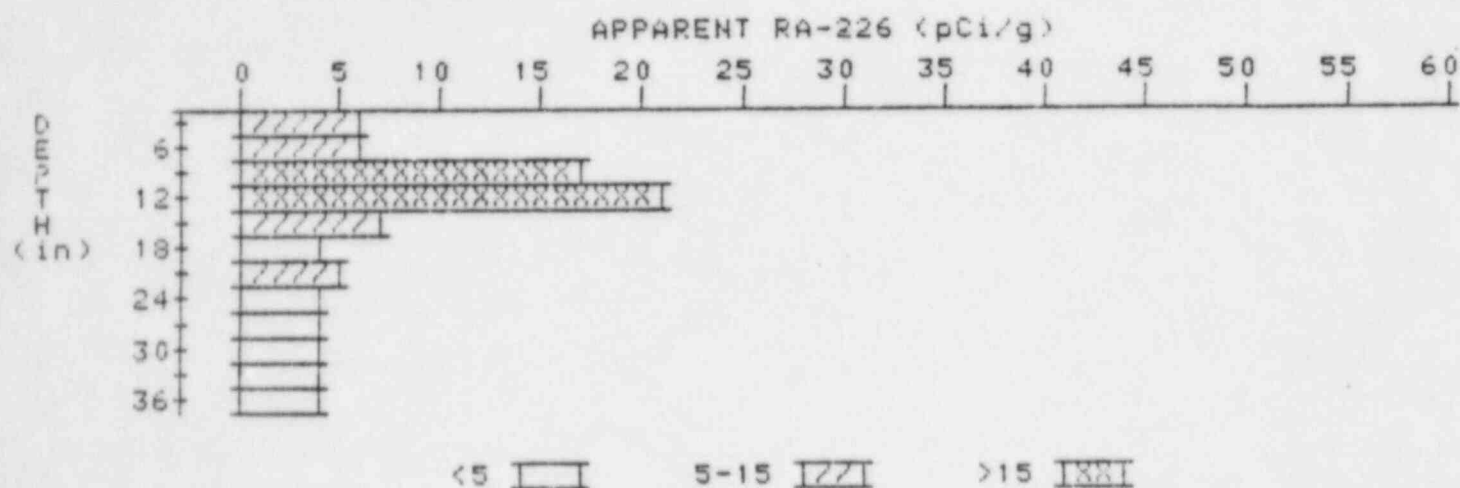
APPARENT RADIUM-226 CONCENTRATION DECONVOLUTION GRAPH

Depth (in)	Apparent Radium-226 (pCi/g) Undeconvolved	Apparent Radium-226 (pCi/g) Deconvolved
3	5.8	5.8
6	8.3	6.3
9	11.9	16.7
12	12.8	20.8
15	9.2	7.4
18	6.6	3.8
21	5.6	5.1
24	4.9	4.4
27	4.5	4.1
30	4.3	4.3
33	4.1	4.1
36	3.9	3.9
