RADIOLOGIC AND ENGINEERING ASSESSMENT

DOE ID NO.: GJ-12375-RM  
ADDRESS: 2890 ORCHARD AVENUE

AUGUST 1985

BENDIX FIELD ENGINEERING CORPORATION  
P.O. Box 1569  
Grand Junction, Colorado 81502

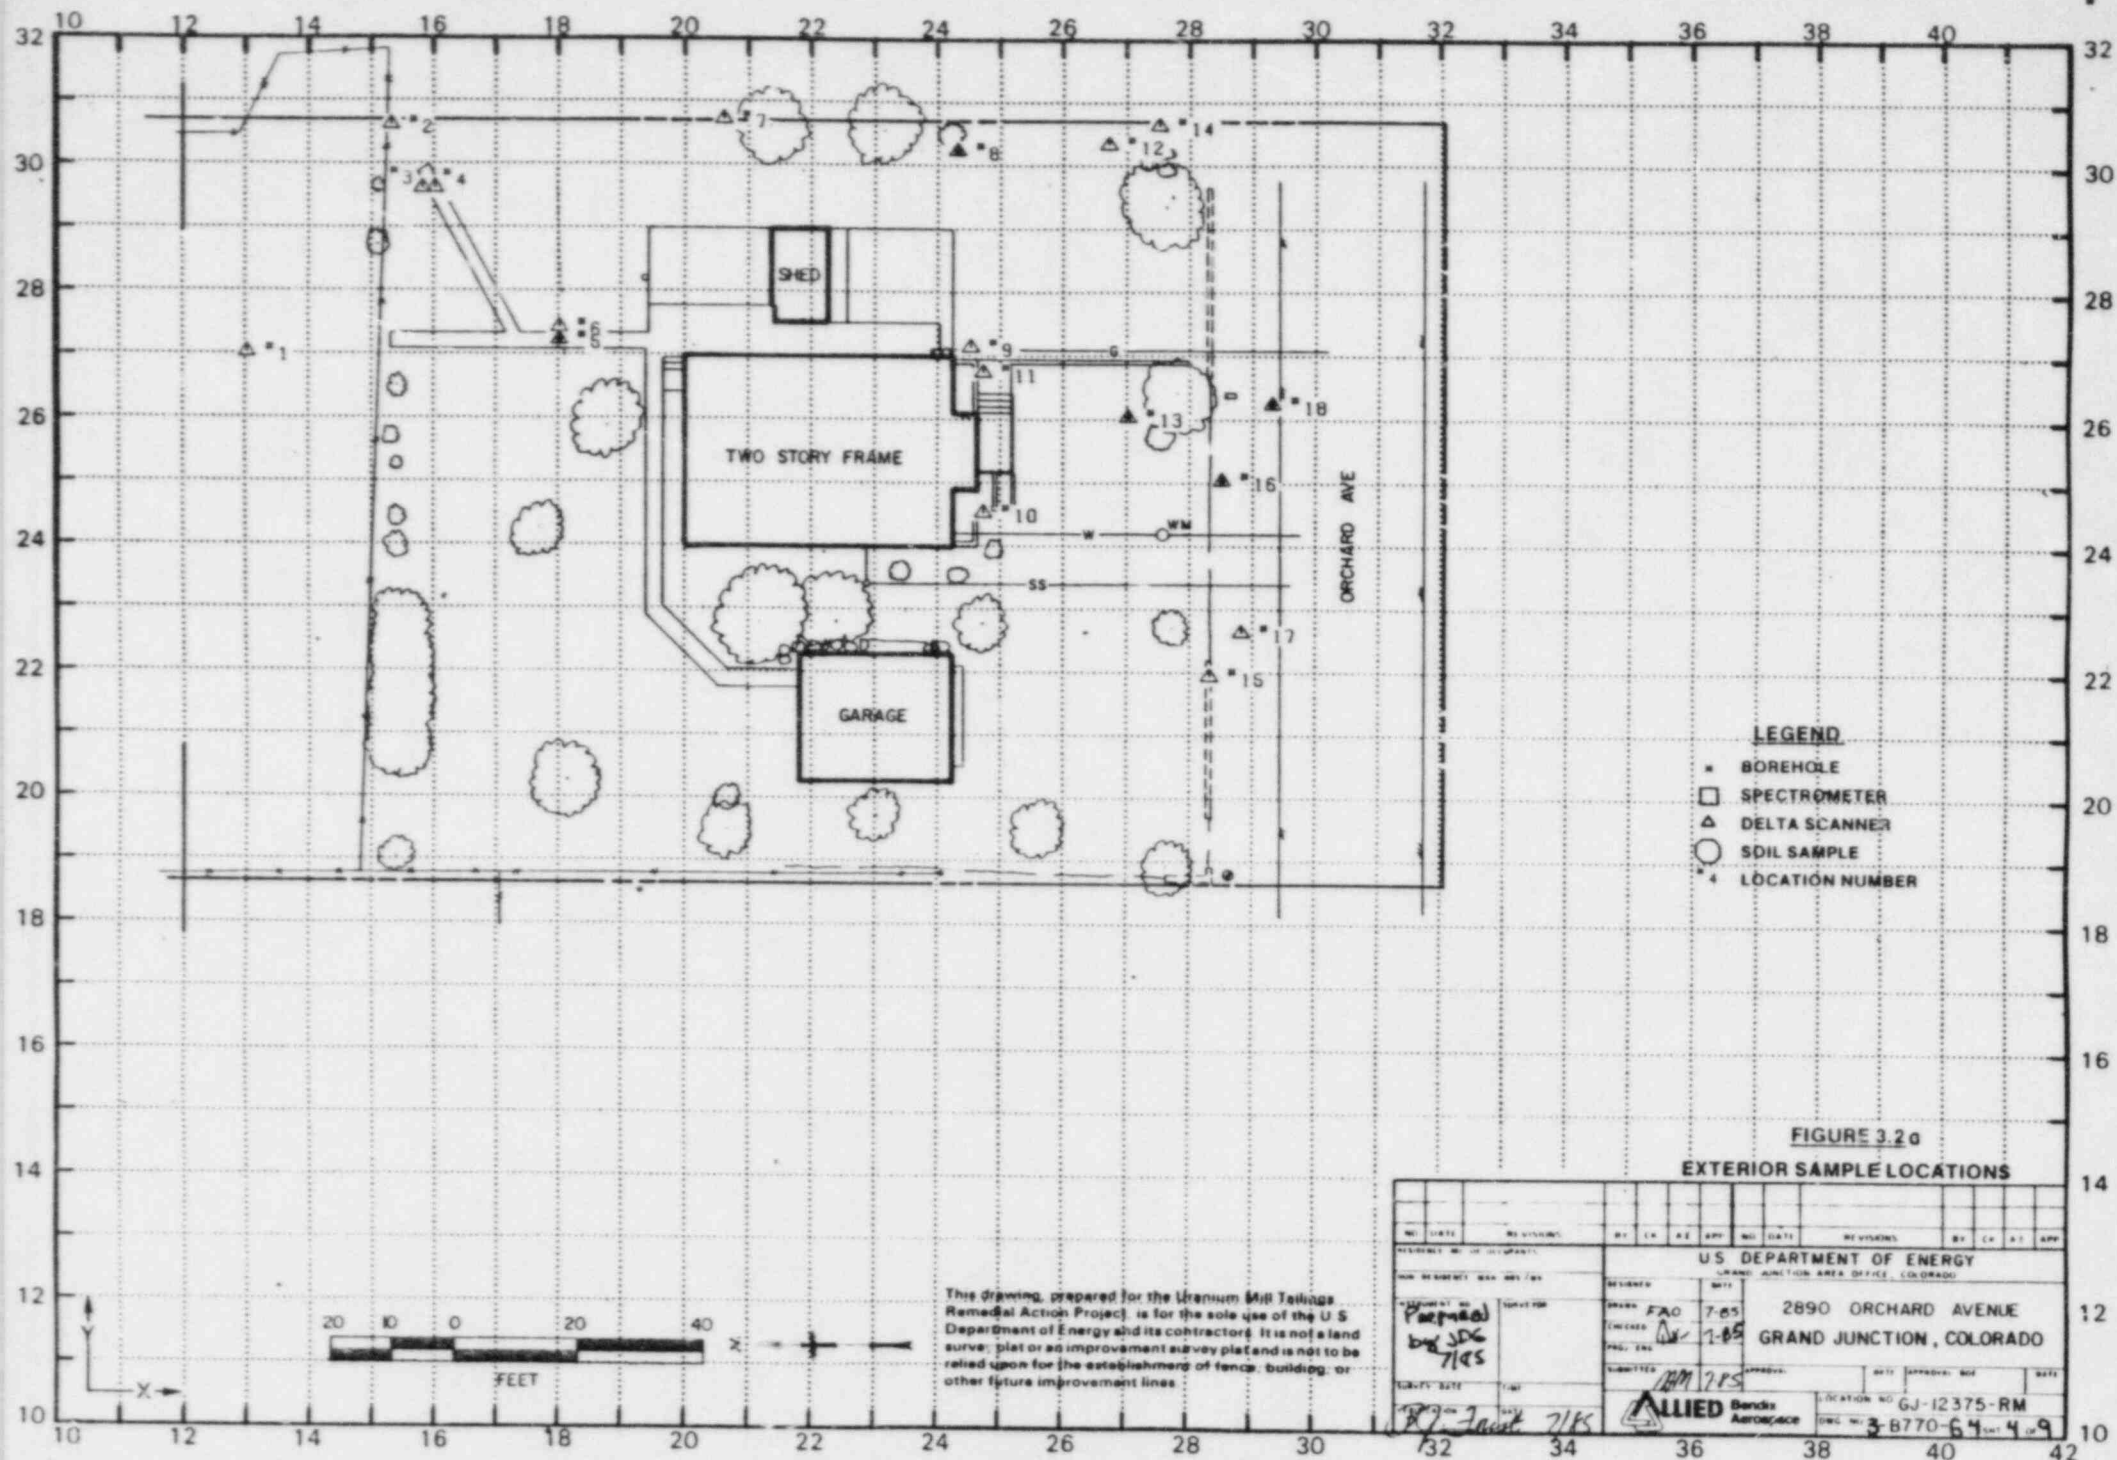
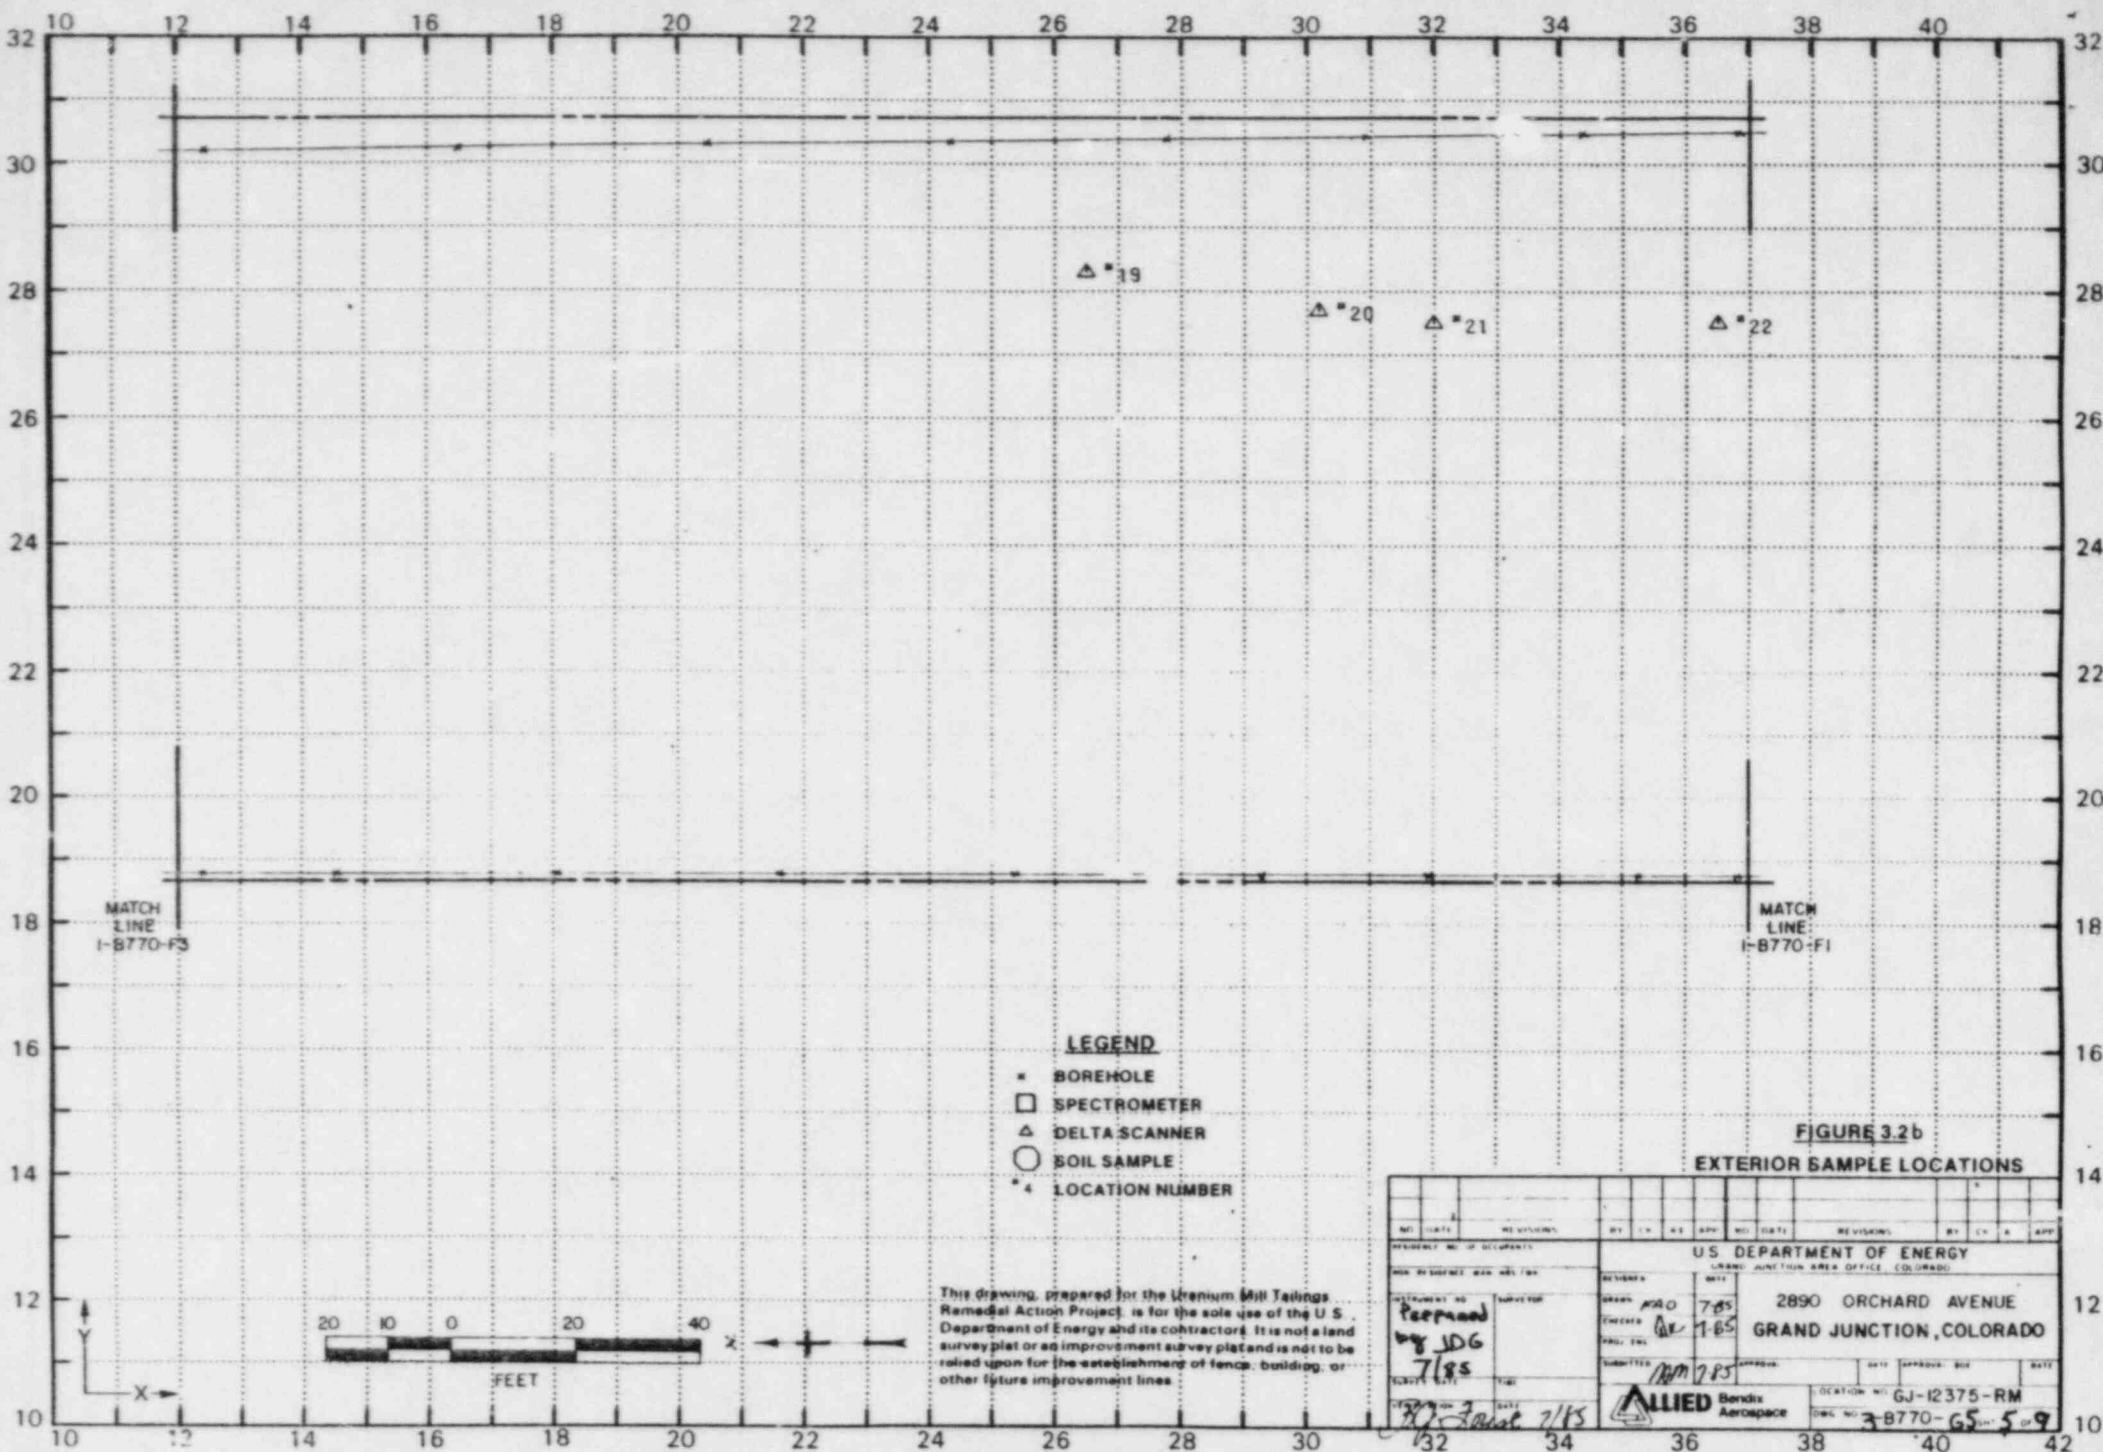
FIGURE 3.2b  
EXTERIOR SAMPLE LOCATIONS

Areas which displayed elevated gamma levels were further investigated; these areas are shown in Appendix Figures 3.2a, 3.2b, and 3.2c. Data from these investigations are included in Appendix Tables 3.1a, 3.1b, and 3.1c.

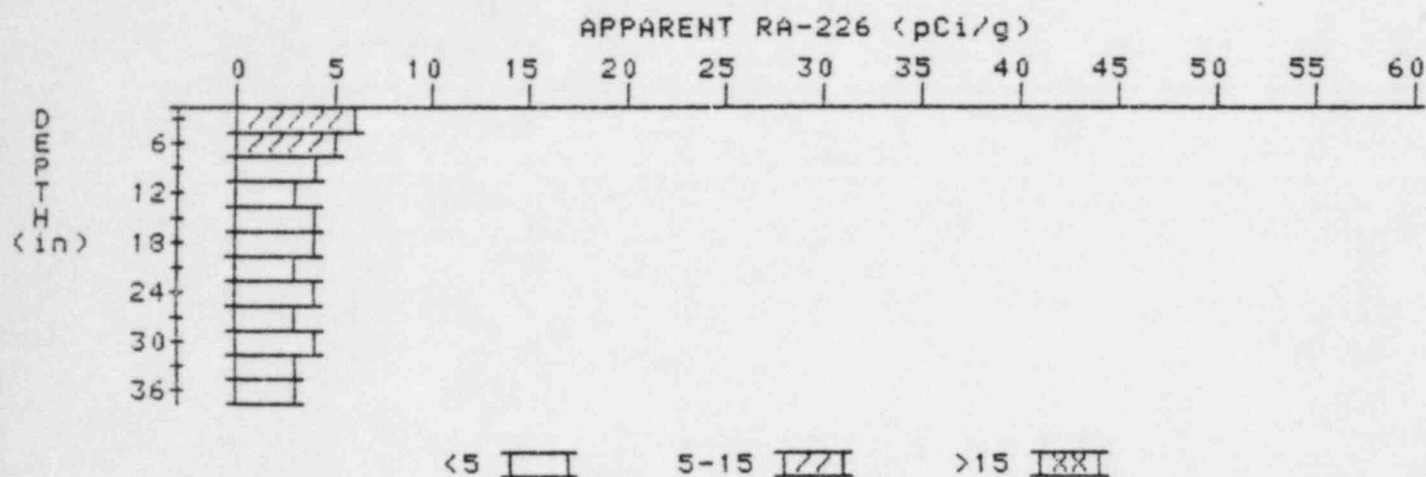
HOLE NUMBER: 5

Depth (in)	Apparent Radium-226 (pCi/g) Undeconvolved	Apparent Radium-226 (pCi/g) Deconvolved
3	5.8	5.8
6	5.2	5.4
9	4.5	4.1
12	4.0	3.5
15	3.8	3.6
18	3.7	3.7
21	3.6	3.4
24	3.6	4.0
27	3.4	3.0
30	3.4	3.6
33	3.3	3.1
36	3.3	3.3

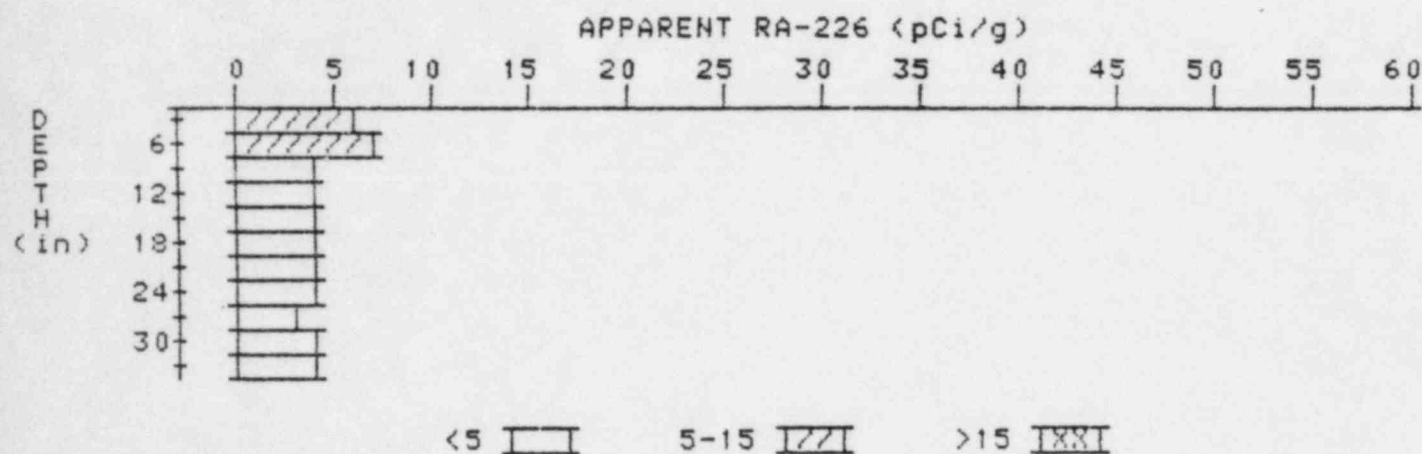
HOLE NUMBER: 8

Depth (in)	Apparent Radium-226 (pCi/g)	Apparent Radium-226 (pCi/g)
	Undeconvolved	Deconvolved
3	6.4	6.4
6	6.1	7.3
9	5.1	4.4
12	4.5	4.1
15	4.1	3.6
18	4.0	4.2
21	3.8	3.6
24	3.7	3.7
27	3.6	3.4
30	3.6	3.6
33	3.6	3.6

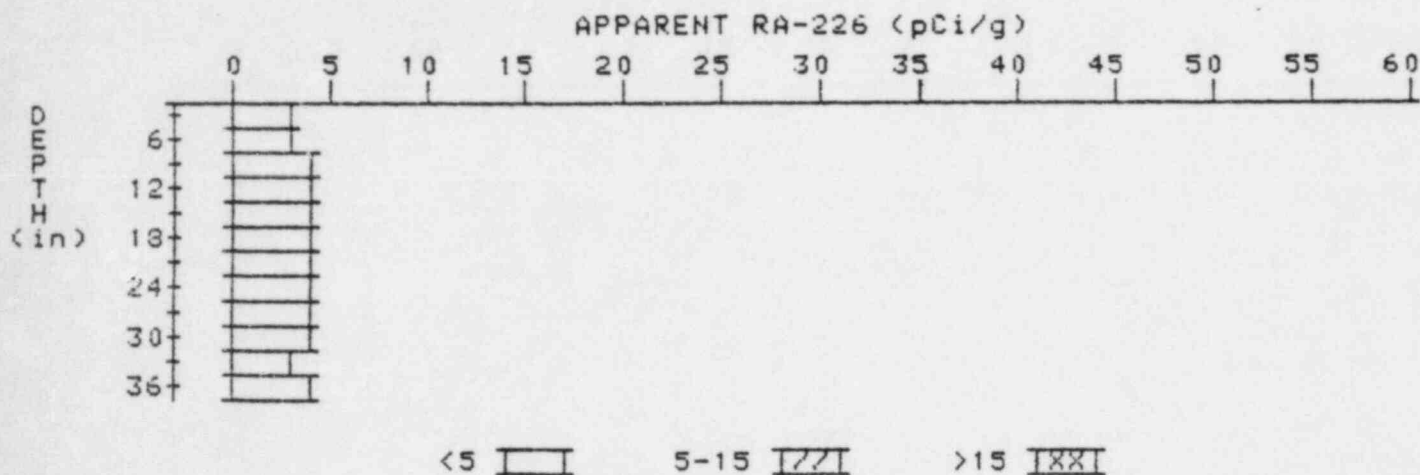
HOLE NUMBER: 13

Depth (in)	Apparent Radium-226 (pCi/g) Undeconvolved	Apparent Radium-226 (pCi/g) Deconvolved
3	3.1	3.1
6	3.4	3.4
9	3.7	4.1
12	3.8	3.8
15	3.9	4.1
18	3.9	3.9
21	3.9	3.9
24	3.9	4.1
27	3.8	3.8
30	3.7	3.7
33	3.6	3.4
36	3.6	3.6

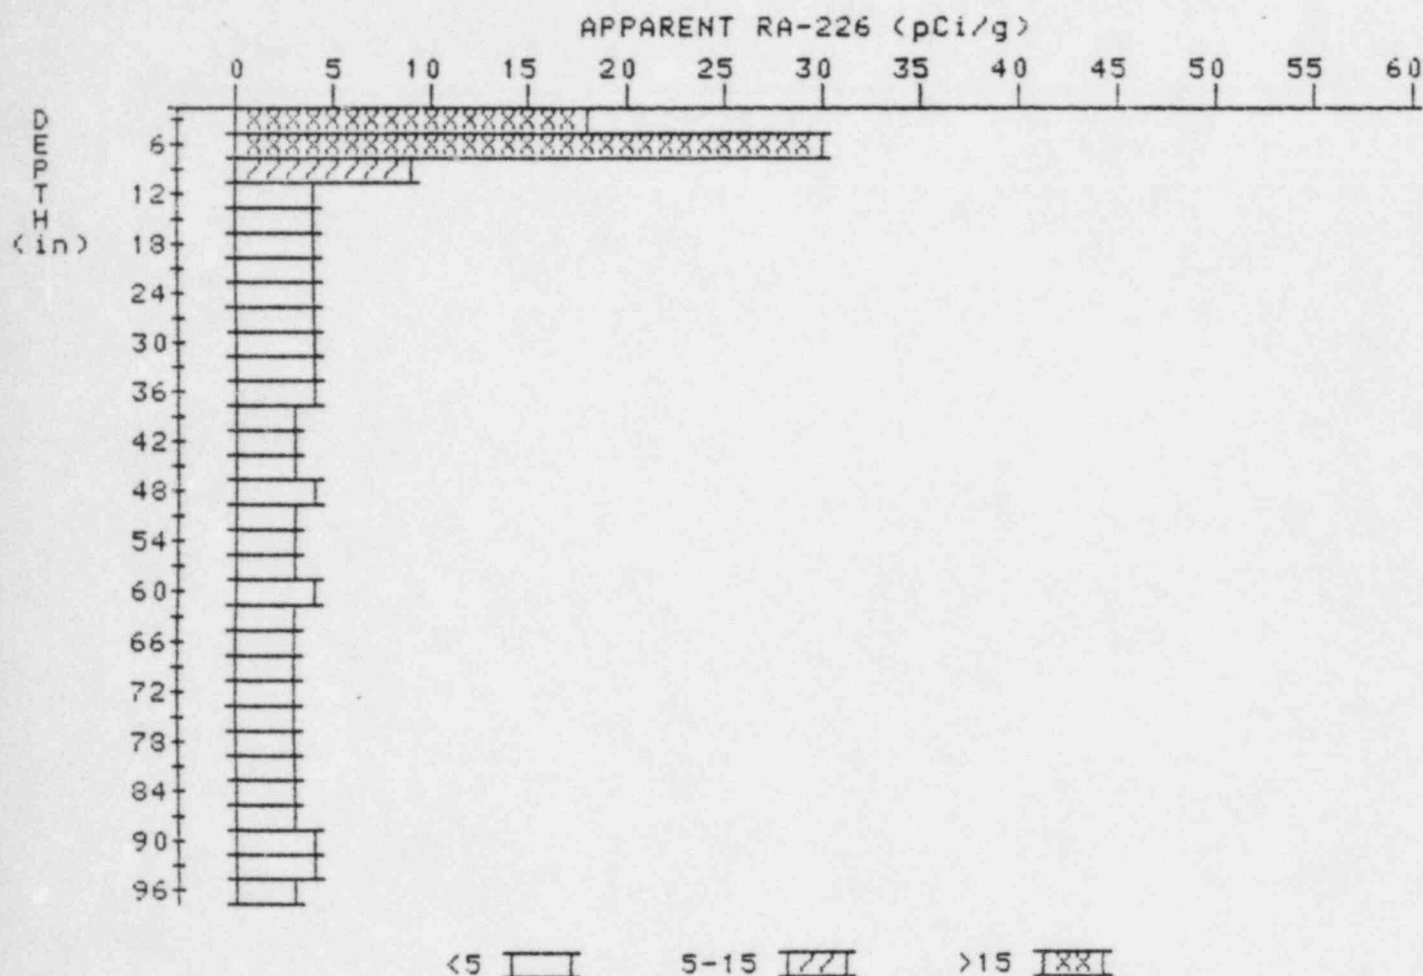
PROPERTY NUMBER: GJ-12375-RM  
HOLE NUMBER: 16  
LOCATION: 285250

Depth (in)	Apparent Radium-226 (pCi/g) Undeconvolved	Apparent Radium-226 (pCi/g) Deconvolved
3	17.9	17.9
6	18.3	30.0
9	12.1	8.5
12	7.9	4.0
15	5.9	4.3
18	4.8	3.7
21	4.3	3.8
24	4.1	4.1
27	3.9	3.9

30	3.7	3.5
33	3.6	3.6
36	3.5	3.5
39	3.4	3.2
42	3.4	3.4
45	3.4	3.4
48	3.4	3.6
51	3.3	3.1
54	3.3	3.5
57	3.2	2.8
60	3.3	3.7
63	3.2	3.0
66	3.2	3.0
69	3.3	3.5
72	3.3	3.3
75	3.3	3.3
78	3.3	3.3
81	3.3	3.3
84	3.3	3.1
87	3.4	3.4
90	3.5	3.7
93	3.5	3.7
96	3.4	3.4

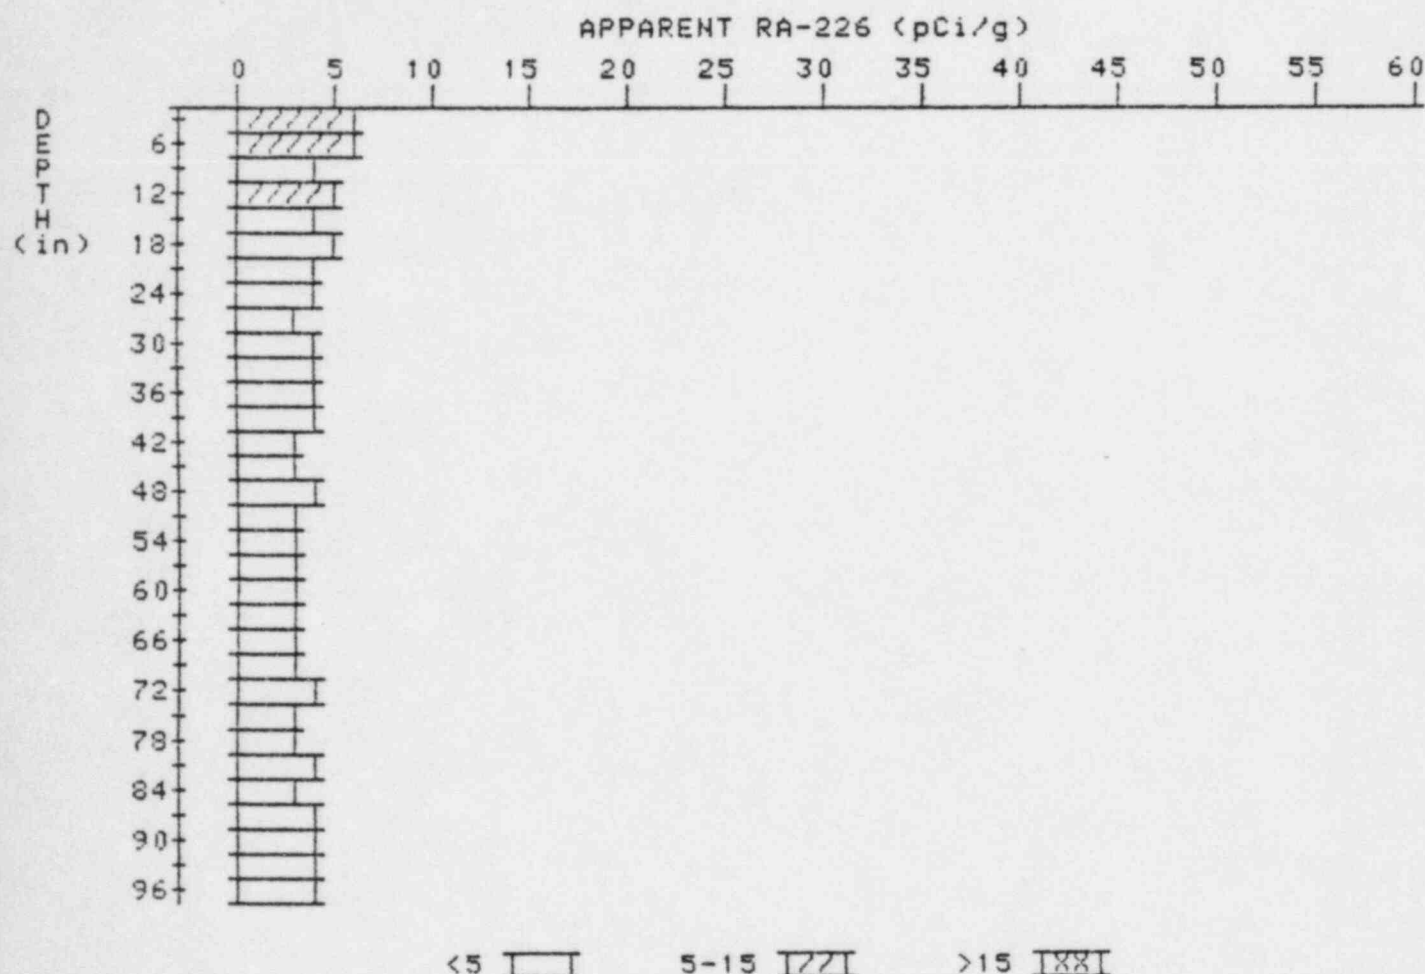
PROPERTY NUMBER: GJ-12375-RM  
HOLE NUMBER: 18  
LOCATION: 293262

Depth (in)	Apparent Radium-226 (pCi/g) Undeconvolved	Apparent Radium-226 (pCi/g) Deconvolved
3	5.6	5.6
6	5.5	6.2
9	5.0	4.3
12	4.9	5.4
15	4.5	4.0
18	4.4	4.8
21	4.1	3.7
24	4.0	4.2
27	3.8	3.4

30	3.8	4.0
33	3.7	3.5
36	3.7	3.7
39	3.7	4.1
42	3.5	3.3
45	3.4	3.2
48	3.4	3.6
51	3.3	3.1
54	3.3	3.5
57	3.2	3.0
60	3.2	3.2
63	3.2	3.2
66	3.2	3.0
69	3.3	3.3
72	3.4	3.8
75	3.3	2.9
78	3.4	3.4
81	3.5	3.7
84	3.5	3.3
87	3.6	3.8
90	3.6	3.6
93	3.6	3.8
96	3.5	3.5
