RADIOLOGIC AND ENGINEERING ASSESSMENT

DOE ID NO.: GJ-02172-RS
ADDRESS: 1320 NORTH 17TH STREET

AUGUST 1985

BENDIX FIELD ENGINEERING CORPORATION
P.O. Box 1569
Grand Junction, Colorado 81502

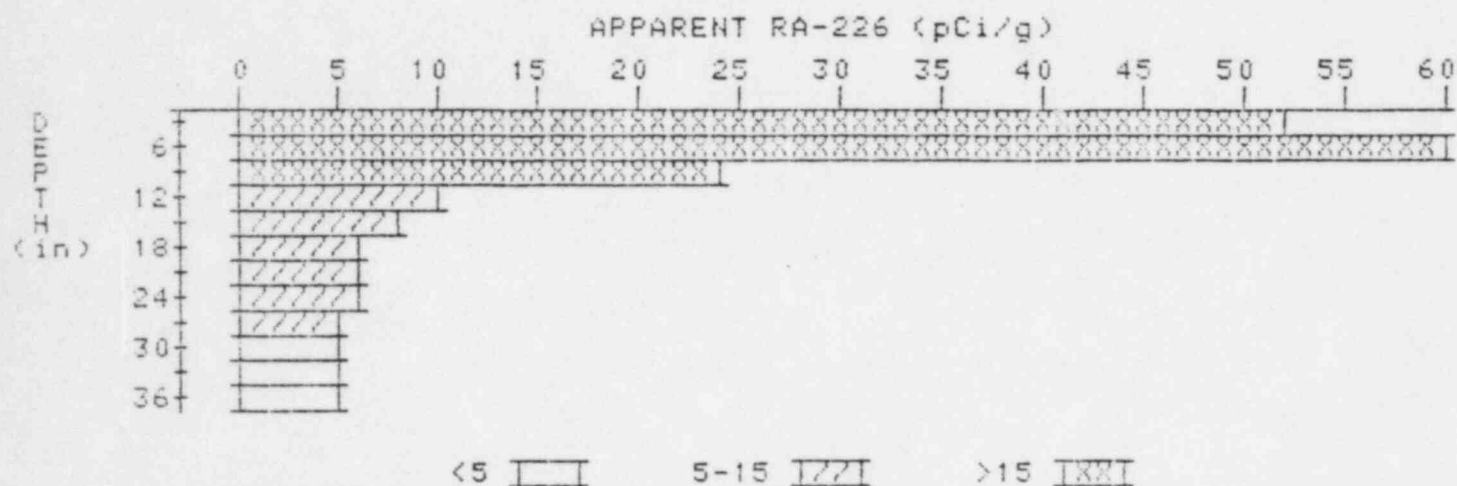
PROPERTY NUMBER: GJ-02172-RS
HOLE NUMBER: 3
LOCATION: 164246

The city sidewalk has tailings beneath it. The gamma reading before removing the core was 500 counts per second (cps). The reading in the hole was 900 cps. There is a small contaminated section east of the city sidewalk that is contaminated, it measures 3- by 5-feet.

Depth (in)	Apparent Radium-226 (pCi/g) Undeconvolved	Apparent Radium-226 (pCi/g) Deconvolved
3	52.0	52.0
6	54.3	93.1
9	34.8	24.1
12	21.3	10.5
15	13.9	8.2
18	9.7	6.0
21	7.6	5.8
24	6.5	5.8
27	5.8	5.4
30	5.3	4.9
33	5.0	4.6
36	4.9	4.9
