RADIOLOGIC AND ENGINEERING ASSESSMENT

DOE ID NO.: GJ-04298-RS  
ADDRESS: 224 OURAY AVENUE

AUGUST 1985

URANIUM MILL TAILINGS REMEDIAL ACTION PROJECT OFFICE

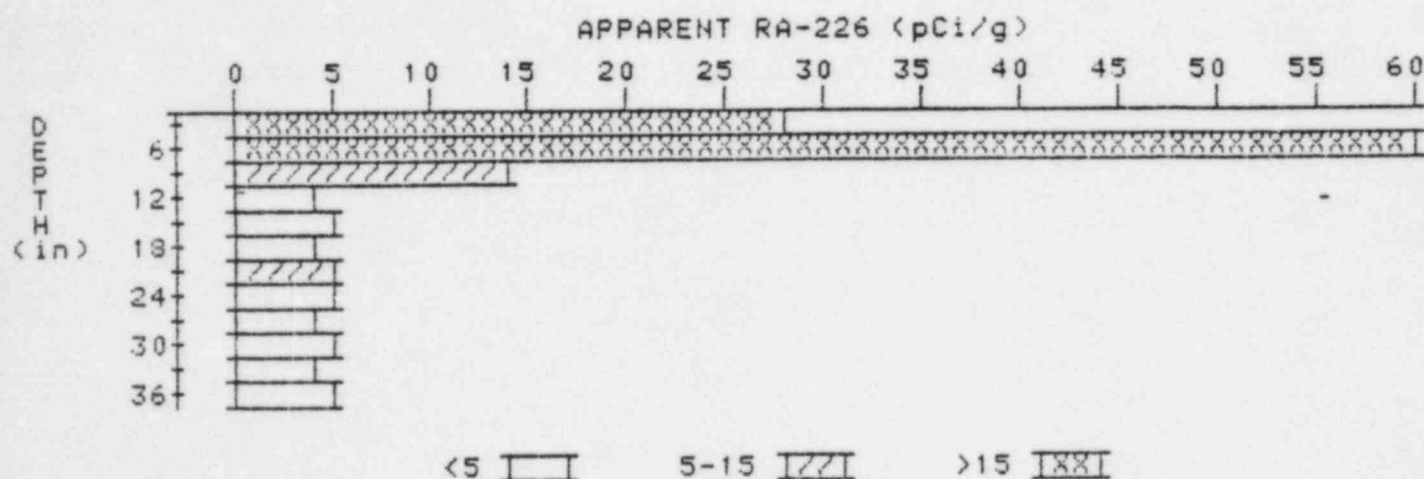
HOLE NUMBER: 6

Depth (in)	Apparent Radium-226 (pCi/g) Undeconvolved	Apparent Radium-226 (pCi/g) Deconvolved
3	27.8	27.8
6	31.8	59.5
9	20.2	14.0
12	12.1	4.5
15	8.3	4.9
18	6.4	4.4
21	5.6	5.1
24	5.1	4.7
27	4.8	4.4
30	4.7	4.9
33	4.5	4.1
36	4.5	4.5

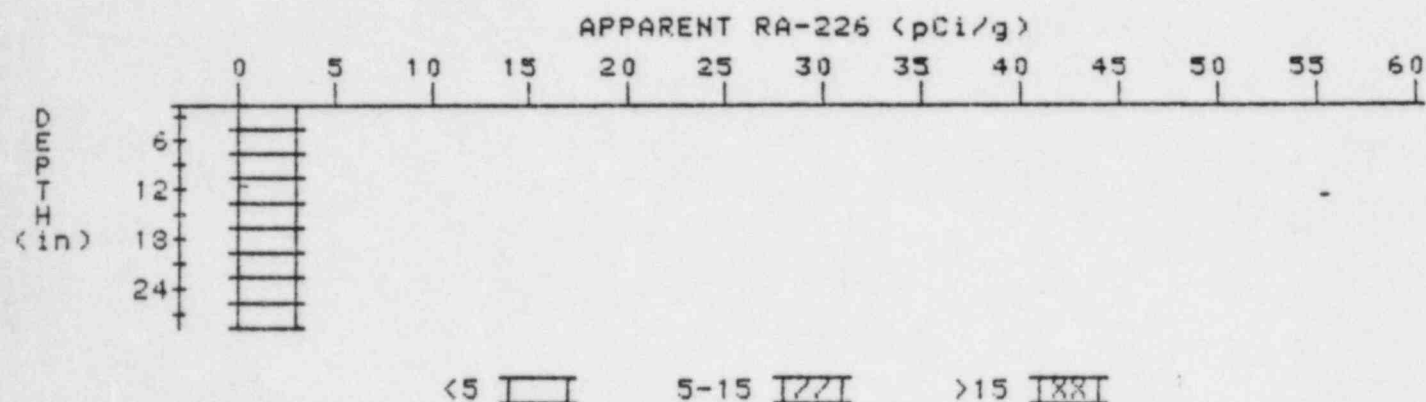
HOLE NUMBER: 9

Depth (in)	Apparent Radium-226 (pCi/g) Undeconvolved	Apparent Radium-226 (pCi/g) Deconvolved
3	3.4	3.4
6	3.3	3.3
9	3.2	3.2
12	3.1	2.9
15	3.1	3.1
18	3.1	3.3
21	3.0	2.8
24	3.0	2.6
27	3.2	3.2
