**Subject:** HGA Relay Armature Binding

**Reference:** GE Relay Service Advice Letter (SAL) 516.1, "HGA Armature Binding," October 25, 1996.

### **RELAY SERVICE ADVICE LETTER**

Number: 516.1  
Date: 10/25/96

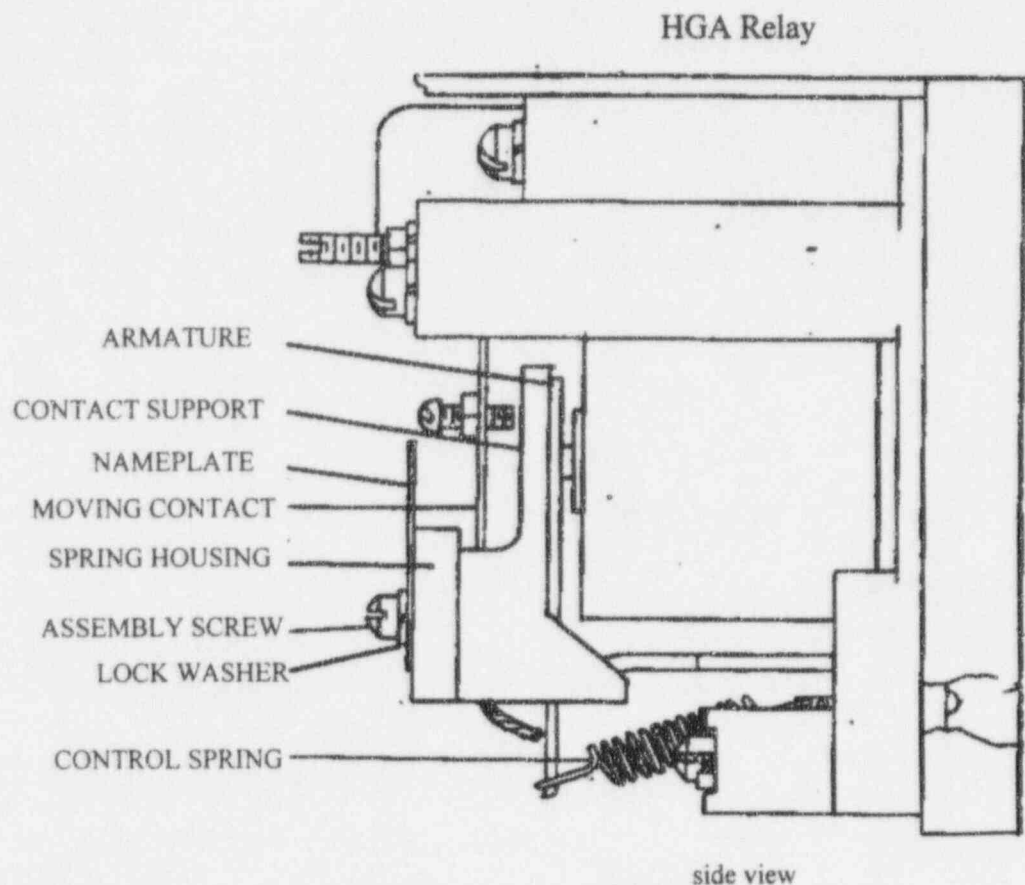
FIGURE 1

1. De-energize the relay, coil and contacts.
2. Close the armature fully by hand, (push armature against the pole, see Fig. 1), and gradually release. For correct operation, the armature should move to the fully open position with no binding and with correct contact action. The normally open contacts should open and the normally closed contacts should close. If binding is detected, we recommend the following:

The contact support should be replaced as follows: (Refer to Fig. 1)

1. Disengage the control spring from the armature end. (Note the groove location of the spring hook on the armature).
2. Remove the assembly screw with its lockwasher.

3. Remove the nameplate and spring housing assembly.
4. Remove the moving contacts from the contact support and note their location for correct reassembly.

5. Remove the contact support.
6. Install the new contact support. Make sure the armature is seated properly in the contact support.
7. Locate the moving contacts in the contact support.

8. Install the nameplate and spring housing assembly.
9. Tighten the assembly screw and lockwasher (16 in-lbs. approx.). Hold contact support and spring housing assembly together while tightening assembly screw.

10. Engage the control spring on the same groove on the armature of the relay.
11. Operate the armature of the relay by hand to make sure that there is no binding.
